TECHNICAL BULLETIN
Bell Helicopter **TEXTRON**

No. 205-06-121

MODEL AFFECTED: 205A & 205A-1

SUBJECT: VERTICAL FIN COVER HINGE PIN IMPROVED
INSTALLATION

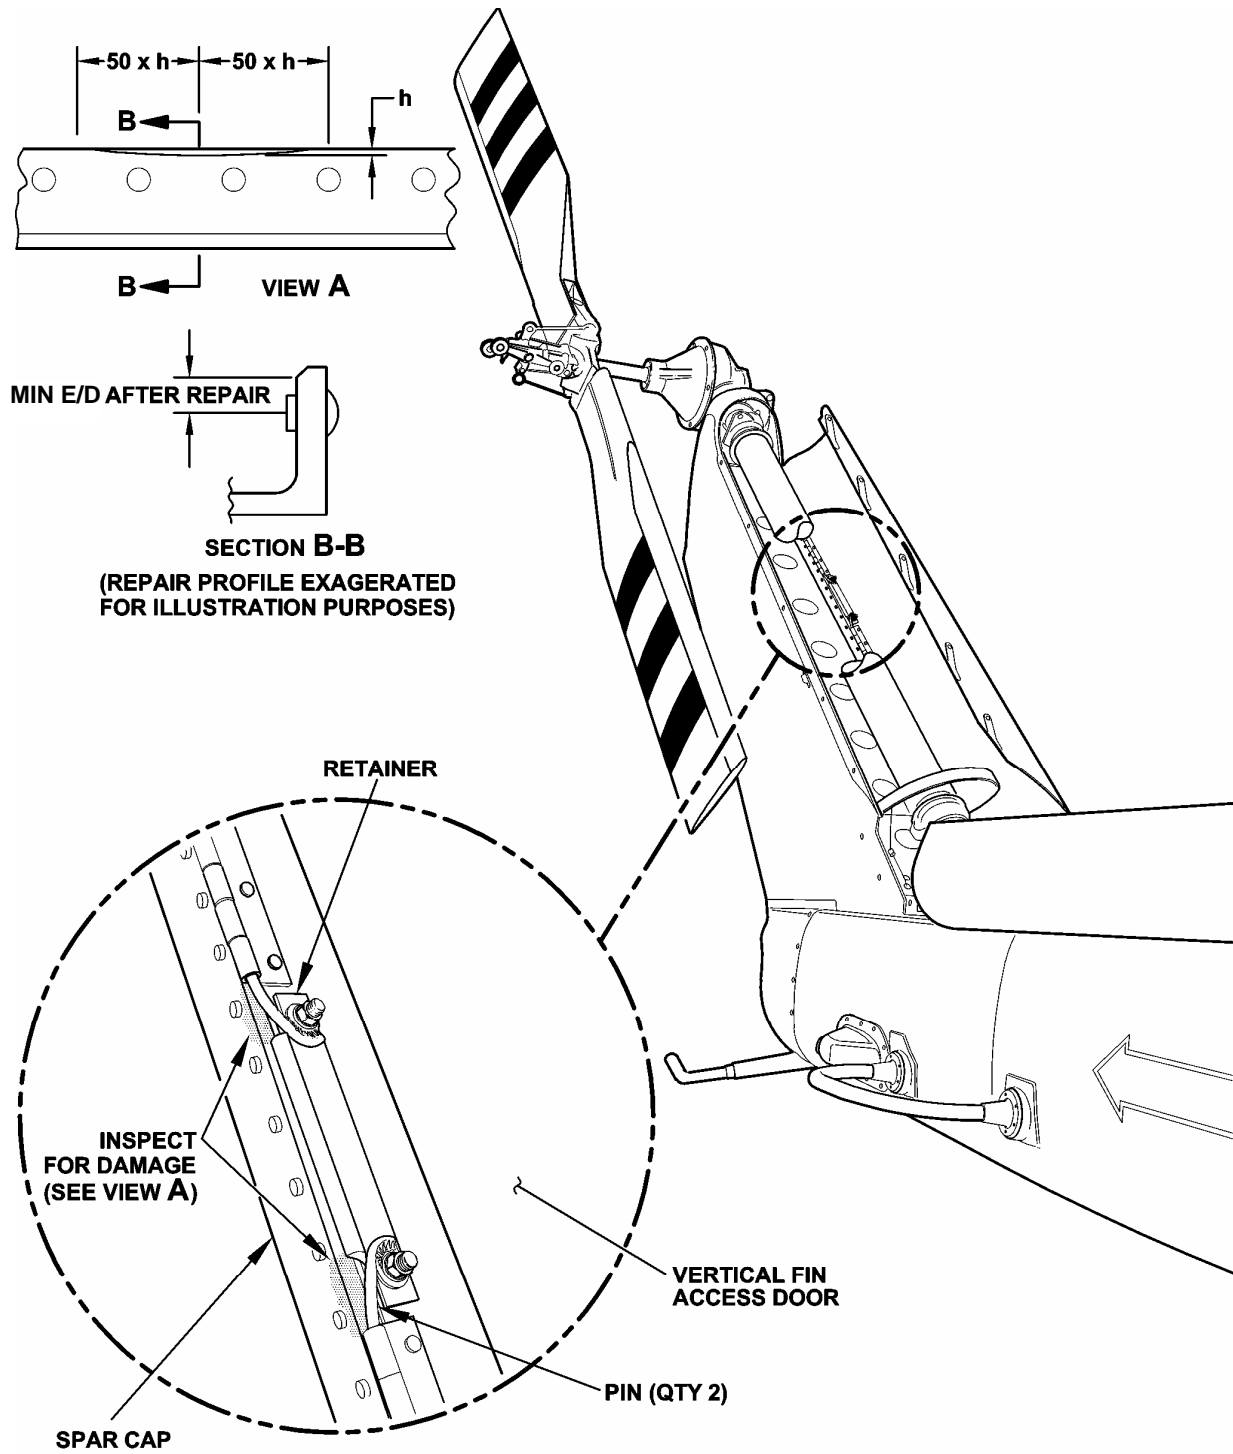
Figure 1
New Hinge Pin Installation

Bell Helicopter has designed a new installation for the vertical fin cover to prevent chaffing damage to the left hand spar cap caused by improperly bent hinge pins. This technical bulletin allows retrofit of the installation on 205A and 205A-1 aircraft.

5. Inspect spar cap as indicated in Figure 1, View A, for any chafing damage caused by improperly installed hinge pins.
 - a. Chafing damage of 0.040 inch-deep or less (up to the full width of the flange) may be blended to a length-to-depth ratio of 50:1 (in each direction from the deepest point) and refinished, provided the distance between the center of the nearest rivet and the repaired area is at least 1.5 time the rivet diameter (min E/D). Remove minimum amount of material and polish repair area using 400-grit sandpaper. Removal of the hinge from the fin may be required.

- b. Perform a Fluorescent Penetrant Inspection per Standard Practices Manual, followed by application of chemical film to the repaired area per Structural Repair Manual Section 3-2-14. Refinish area in accordance with Standard Practices Manual.

- c. Report any damage in excess of 0.040 inch-deep to Product Support Engineering.

6. Reinstall door by inserting Pins P/N 209-031-816-119. Attach pins to door using existing screws, 209-031-816-123 Retainer and MS21042L3 Nuts, as shown on Figure 1. Close door.
7. Make an entry in helicopter historical records indicating compliance with this technical bulletin.
8. Make helicopter safe for flight.
