# TECHNICAL BULLETIN

## **Bell** Helicopter

No. 206-07-190

**SUBJECT:** MAIN ROTOR MAST NUT INSTALLATION  
PROCEDURE, IMPROVEMENT OF

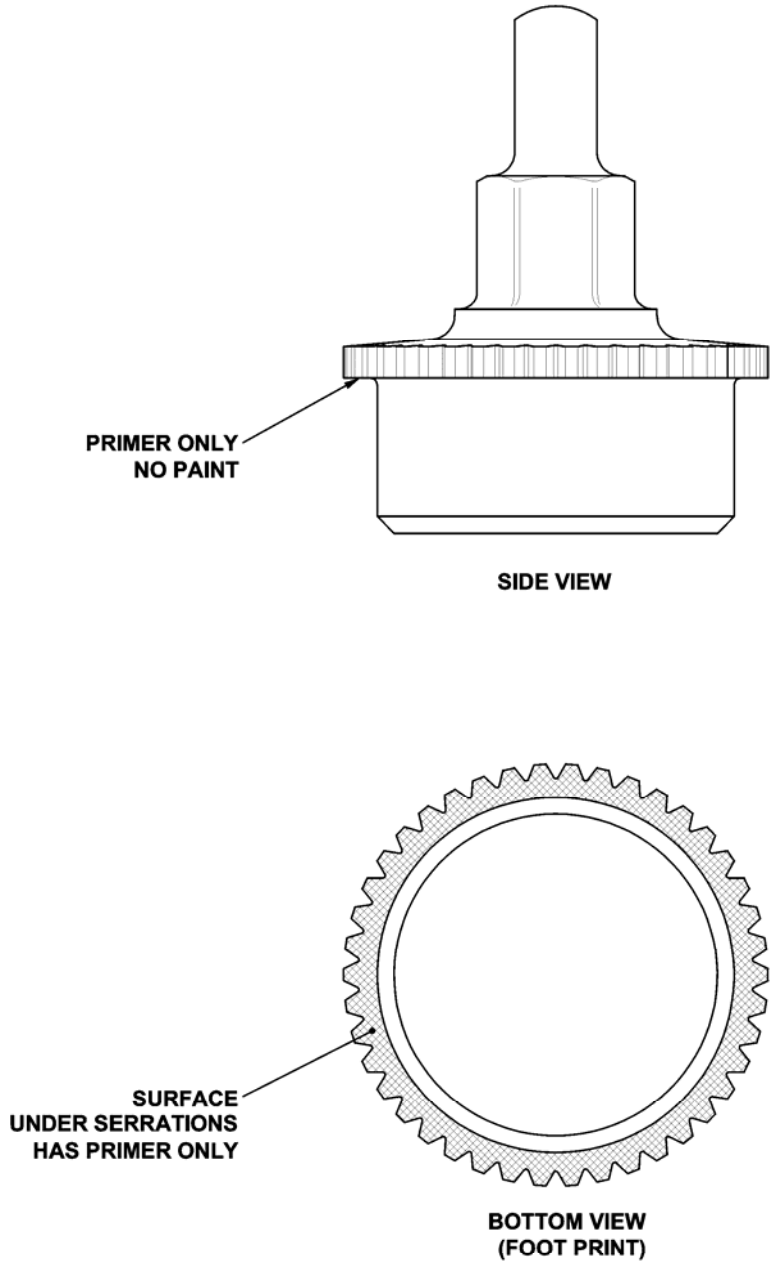
FIGURE 1: Mast Nut Paint Scheme (sheet 1)

Bell Helicopter has received reports from operators indicating difficulties to stabilize the mast nut torque. It has been determined that the mast nut torque instability was due to the paint applied to the mating surfaces of the hub attaching components that peel or compress when the nut is tightened.

PRIMER ONLY ON SURFACE IN CONTACT  
WITH MAST NUT FOOT PRINT

1. Ensure the paint and primer are applied to the mast nut P/N 206-011-007 or 206-011-152 as per new paint scheme (Refer to Figure 1, sheet 1). Failure to adhere to the new paint scheme requirement may result in difficulties to stabilize the mast nut torque.
2. Install the washer 206-010-140-003 and mast nut as follows:
  - a. Apply a thin coat of unreduced polyamide epoxy primer (C-204) between the faying surfaces of the main rotor trunnion and the washer (Refer to Figure 2, detail 2).

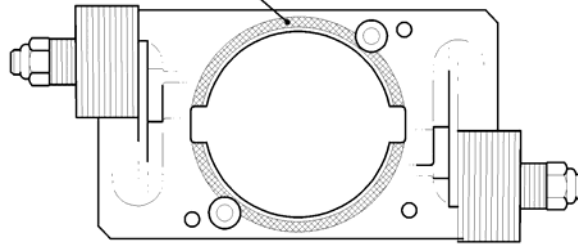
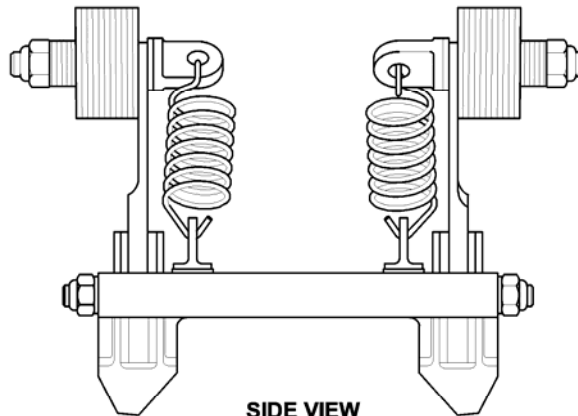
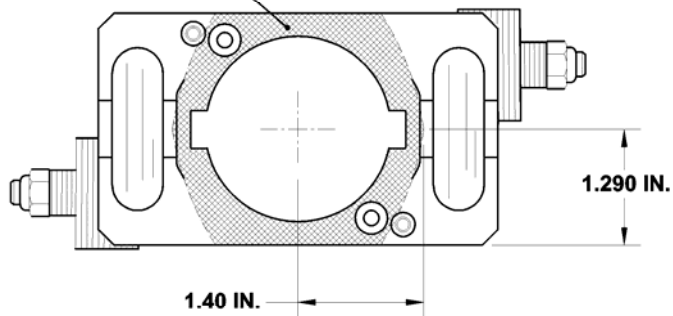
FIGURE 1: Flap Restraint Paint Scheme (sheet 2)

PRIMER ONLY ON SURFACE  
IN CONTACT WITH TRUNNION

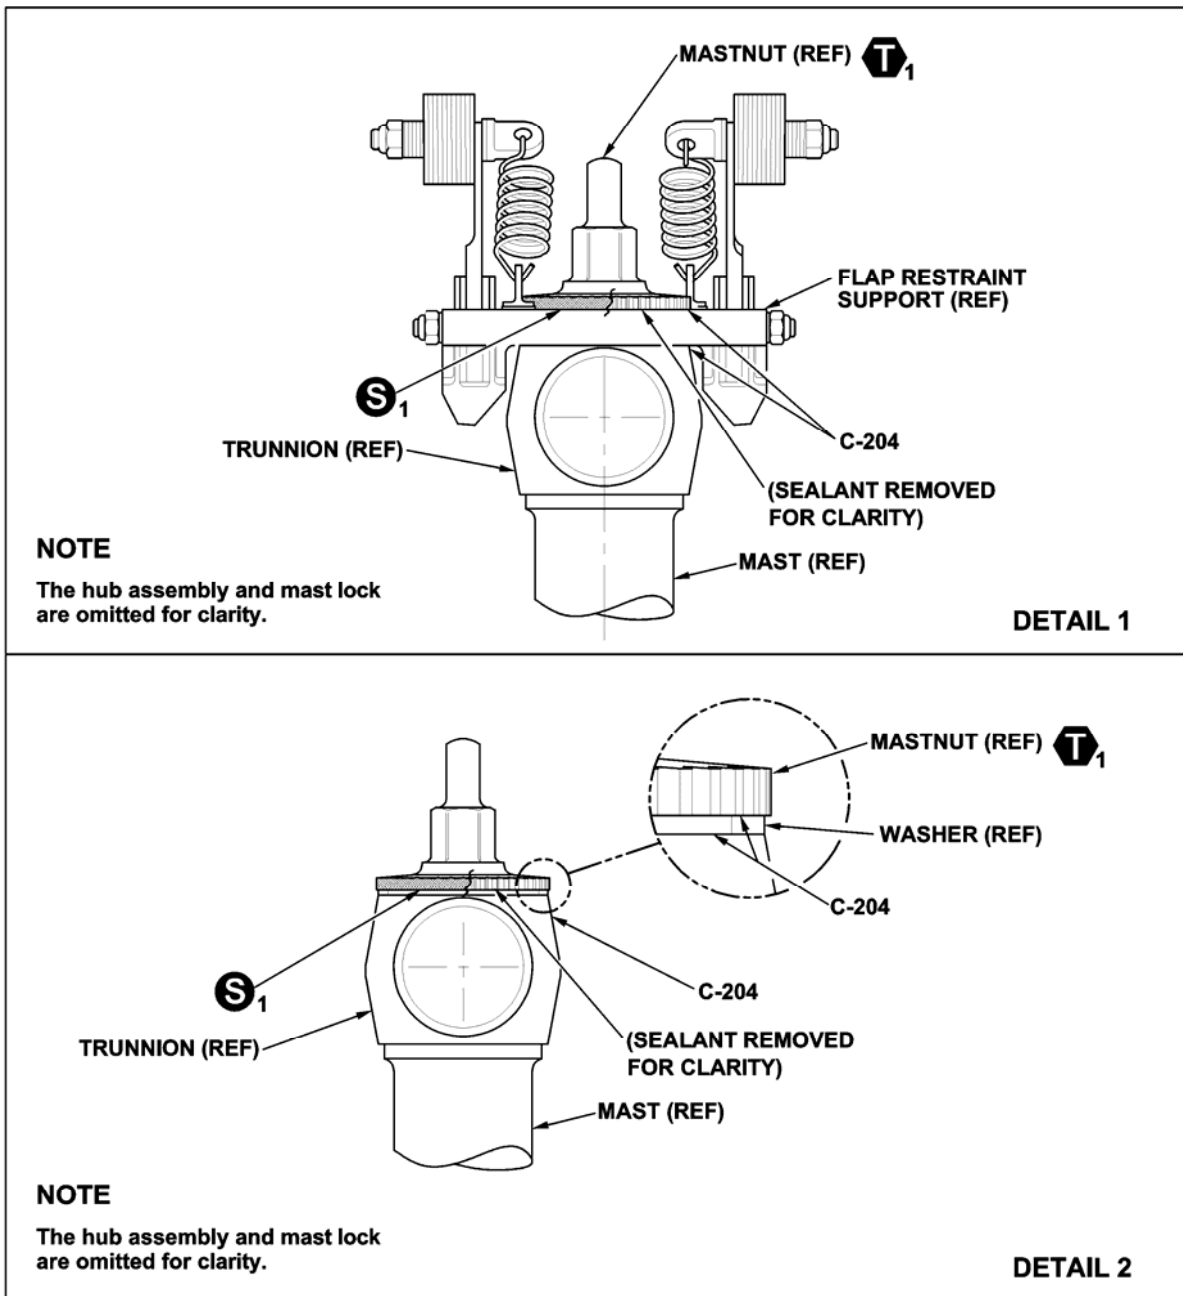
**FIGURE 2: Main Rotor Installed**

**S**<sub>1</sub> MIL-PRF-81733 TYPE II (C-251)

**T**<sub>1</sub> 250 TO 275 FT-LBS  
(339 TO 373 Nm)

- c. Apply a bead of sealant MIL-PRF-81733, Type II (C-251) to the mating edge of the mast nut serrations and the flap restraint support (Refer to Figure 2). Ensure no sealant penetrates the mast nut lock retainer bolt hole. Make sure that the bead of sealant is smoothed out to avoid an area capable of retaining pooled moisture.
5. Install the mast nut lock (Refer to the Maintenance Manual, Chapter 62).
6. Make an entry in the helicopter records to indicate that Part II of this Technical Bulletin has been accomplished.
