**SUBJECT: REVISION A TO TECHNICAL BULLETIN 206-09-195,
SPANNER NUT P/N MS172242, INSP OF.**

TECHNICAL BULLETIN
Bell Helicopter
A Textron Company

No. 206-09-195

SUBJECT: SPANNER NUT P/N MS172242, INSPECTION OF.

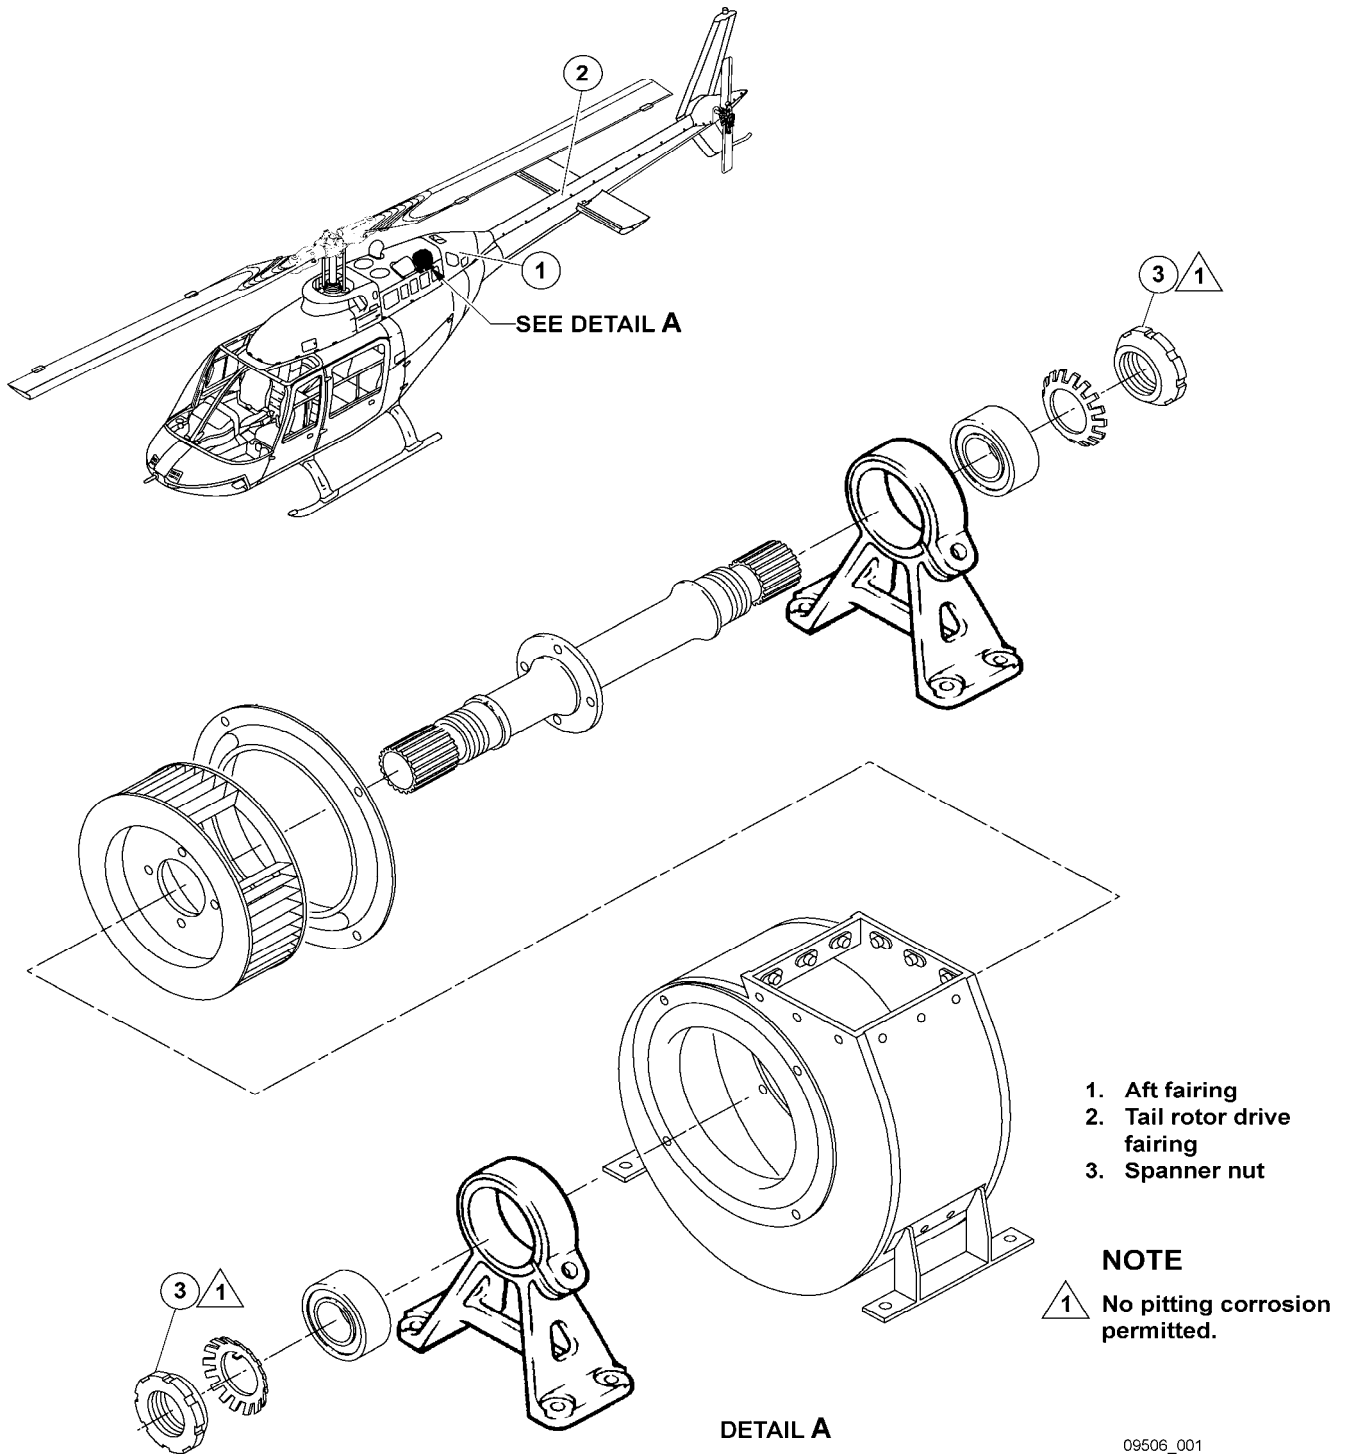
Figure 1. Oil cooler blower assembly

Bell Helicopter has received reports of surface corrosion on spanner nut P/N MS172242. This corrosion has been noticed on installed as well as newly received nuts due to omission of phosphate treatment during the manufacturing process

2. Clean forward and aft nuts (3) using Aliphatic Naphtha (C-305).
3. Examine forward and aft spanner nuts (3) for evidence of corrosion.

1. Gain access to oil cooler blower shaft assembly (Refer to Detail A, Fig 1).

- a. If surface corrosion is found, remove and replace with nut 90-118-2 or phosphate coated nut MS172242 (BHT-206A/B M&O Section IV or BHT-206B3-CR&O Chapter 65). If the nut can not be replaced immediately, apply corrosion preventive compound (C-101). Replace the nut when ever convenient.
- b. If pitting corrosion is found, remove and replace immediately with nut 90-118-2 or phosphate coated nut MS172242 (Refer to applicable model BHT-206A/B M&O Section VI or BHT-206B3-CR&O Chapter 65).
