TECHNICAL BULLETIN

No. 206L-07-223

MODEL AFFECTED: 206L SERIES

SUBJECT: MAIN ROTOR MAST NUT INSTALLATION
PROCEDURE, IMPROVEMENT OF

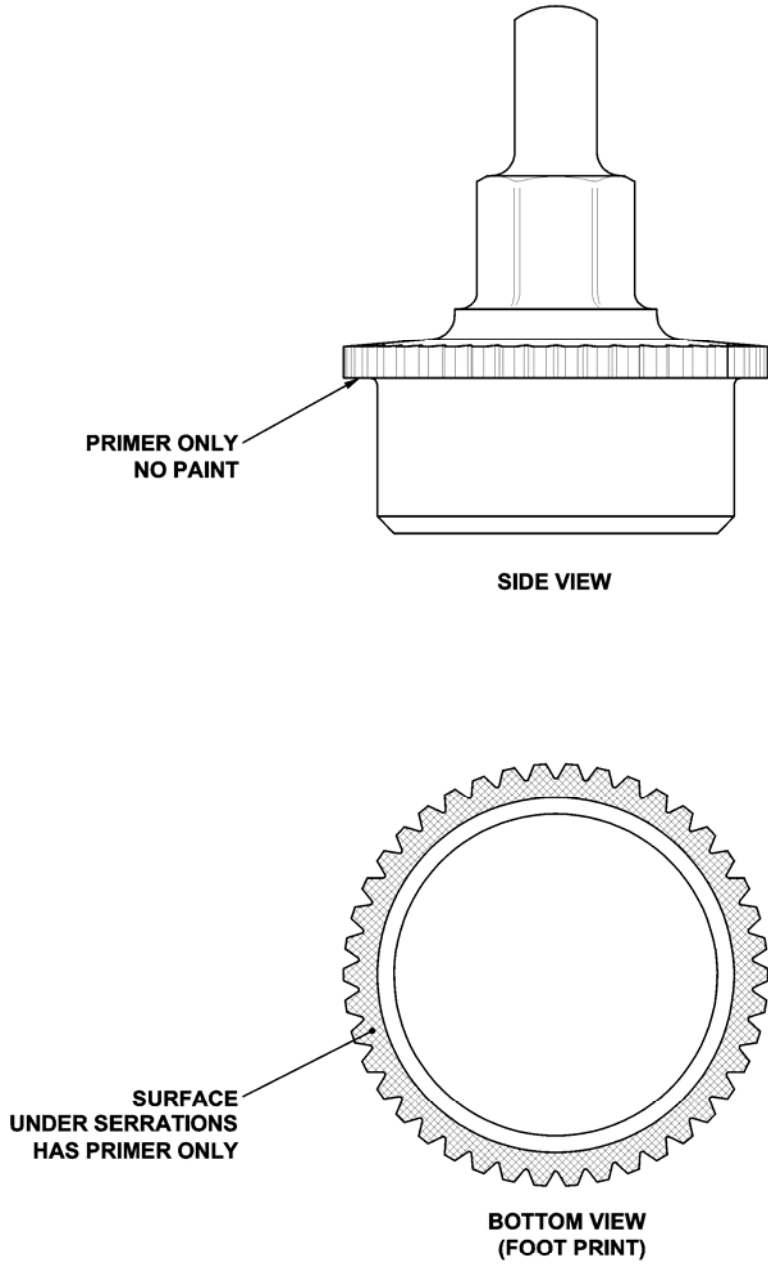
FIGURE 1: Mast Nut Paint Scheme (sheet 1)

Bell Helicopter has received reports from operators indicating difficulties to stabilize the mast nut torque. It has been determined that the mast nut torque instability was due to the paint applied to the mating surfaces of the hub attaching components that peel or compress when the nut is tightened.

1. Ensure that the paint and primer are applied to the flap restraint support P/N 206-010-191, the trunnion P/N 206-011-120 and mast nut P/N 206-011-152 as per new paint scheme (Refer to Figure1, sheet 1, 2, 3). Failure to adhere to the paint scheme requirement may result in difficulties to stabilize the mast nut torque.
2. Install the flap restraint and mast nut as follows:
 - a. Apply a thin coat of unreduced polyamide epoxy primer (C-204) between the faying surfaces of the main rotor trunnion and the flap restraint support (Refer to Figure 2).

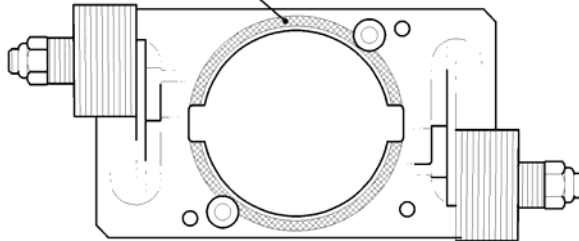
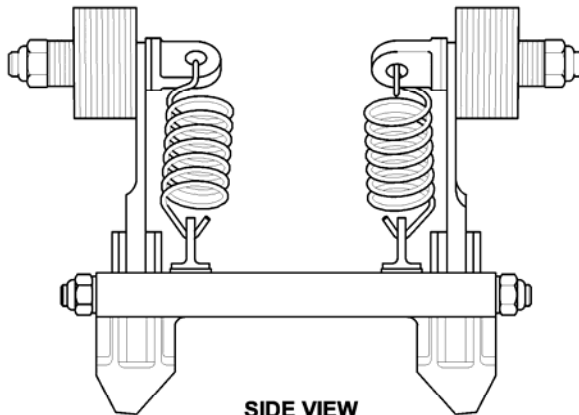
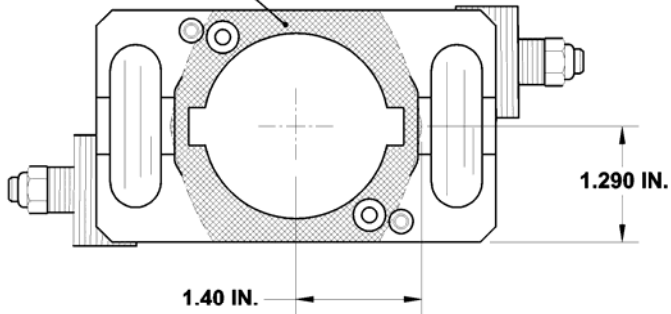
FIGURE 1: Flap Restraint Paint Scheme (sheet 2)

PRIMER ONLY ON SURFACE IN CONTACT
WITH MAST NUT FOOT PRINT

PRIMER ONLY ON SURFACE
IN CONTACT WITH TRUNNION

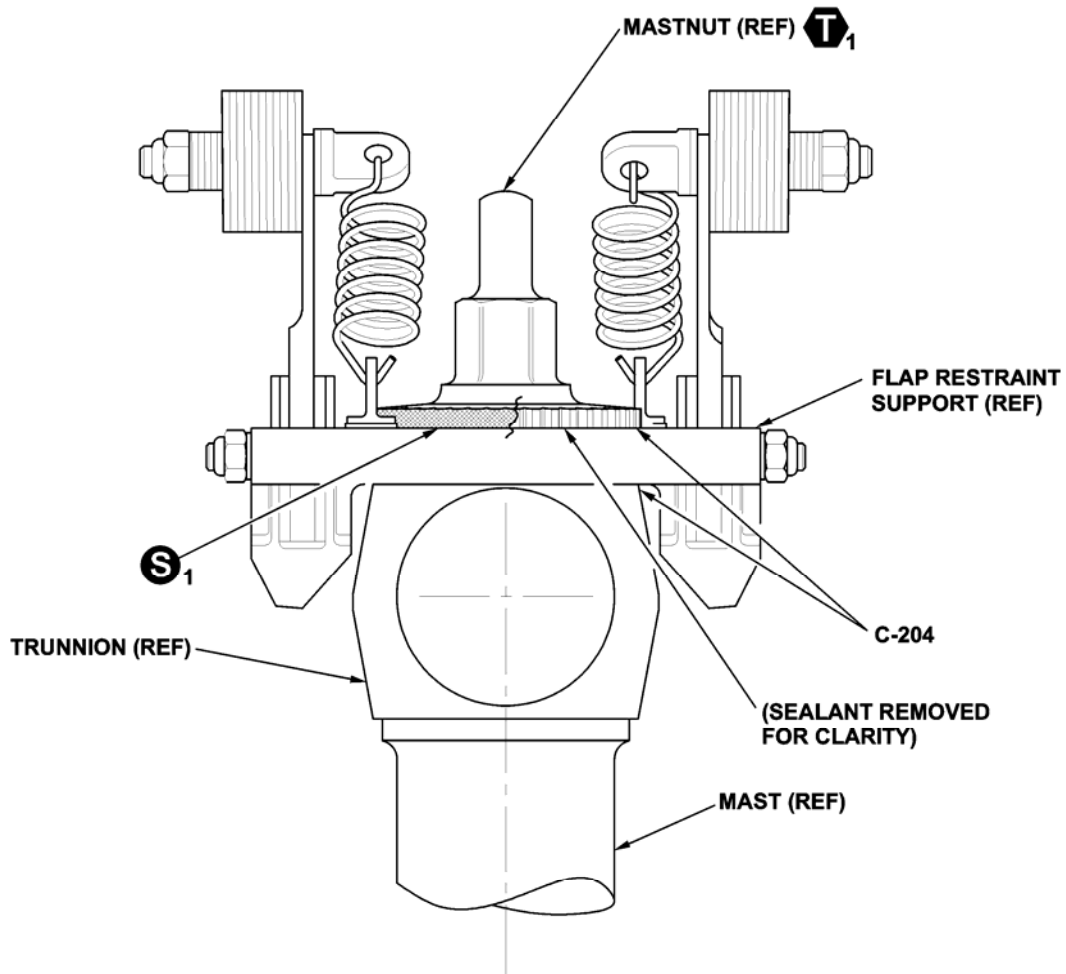
FIGURE 2: Main Rotor Installed

S₁ MIL-PRF-81733 TYPE II (C-251)

T₁ 250 TO 275 FT-LBS
(339 TO 373 Nm)

- c. Apply a bead of sealant MIL-PRF-81733, Type II (C-251) to the mating edge of the mast nut serrations and the flap restraint support (Refer to Figure 2). Ensure no sealant penetrates the mast nut lock retainer bolt hole. Make sure that the bead of sealant is smoothed out to avoid an area capable of retaining pooled moisture.
