TECHNICAL BULLETIN
Bell Helicopter
A Textron Company

No. 206L-09-238

MODEL AFFECTED: 206L

SUBJECT: SPANNER NUT P/N MS172242, INSPECTION OF.

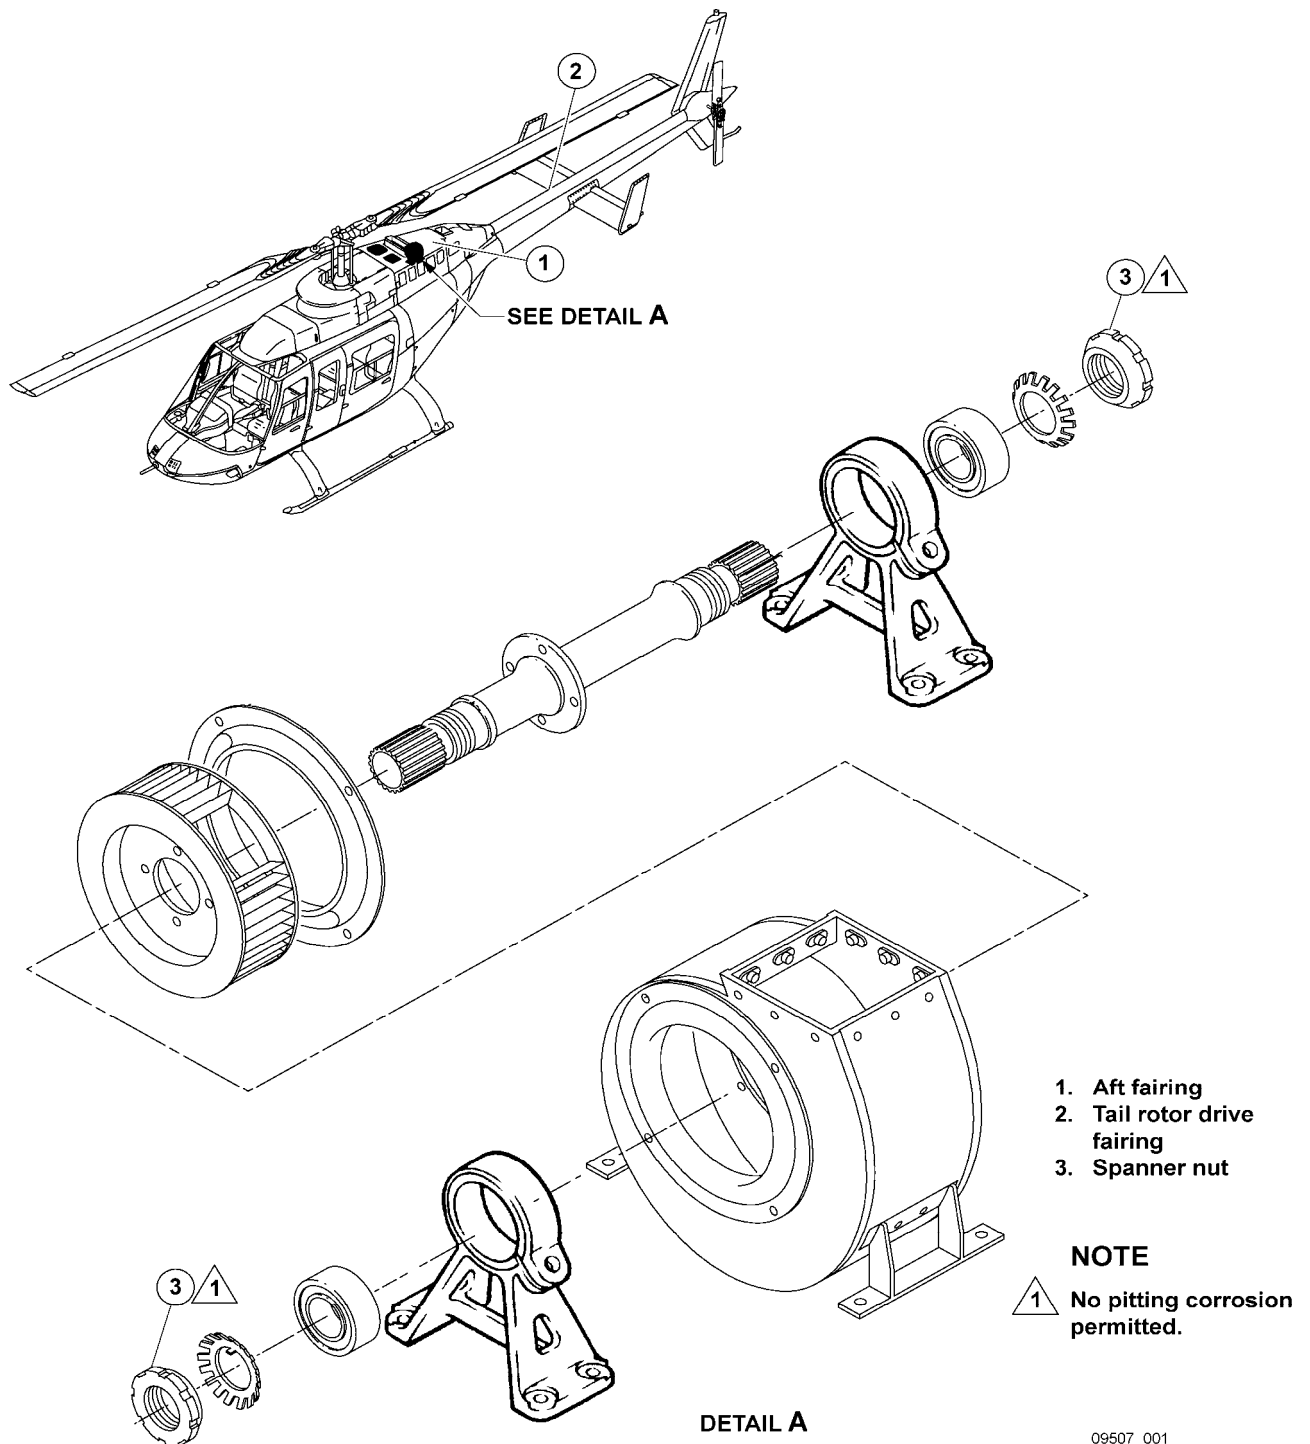
Figure 1. Oil cooler blower assembly

Bell Helicopter has received reports of corrosion on spanner nut MS172242. This corrosion has been noticed on installed as well as newly received nuts due to omission of phosphate treatment during manufacturing process.

1. Gain access to oil cooler blower shaft assembly (Refer to Detail A, Fig 1).

2. Clean forward and aft nuts (3) using Aliphatic Naphtha (C-305).
3. Examine forward and aft spanner nuts (3) for evidence of corrosion.
 - a. If surface corrosion is found, remove and replace with nut 90-118-2 or phosphate coated nut MS172242 (Refer to BHT-206L-CR&O Chapter 65). If the nut can not be replaced immediately, apply corrosion preventive compound (C-101). Replace the nut when ever convenient.
 - b. If pitting corrosion is found, remove and replace immediately with nut 90-118-2 or phosphate coated nut MS172242 (Refer to BHT-206L-CR&O Chapter 65).

PART I of this bulletin introduces spanner nut P/N 90-118-2 as a direct replacement for nut P/N MS172242.
