TECHNICAL BULLETIN
Bell Helicopter **TEXTRON**

No. 212-06-204

MODEL AFFECTED: 212

SUBJECT: VERTICAL FIN COVER HINGE PIN IMPROVED
INSTALLATION

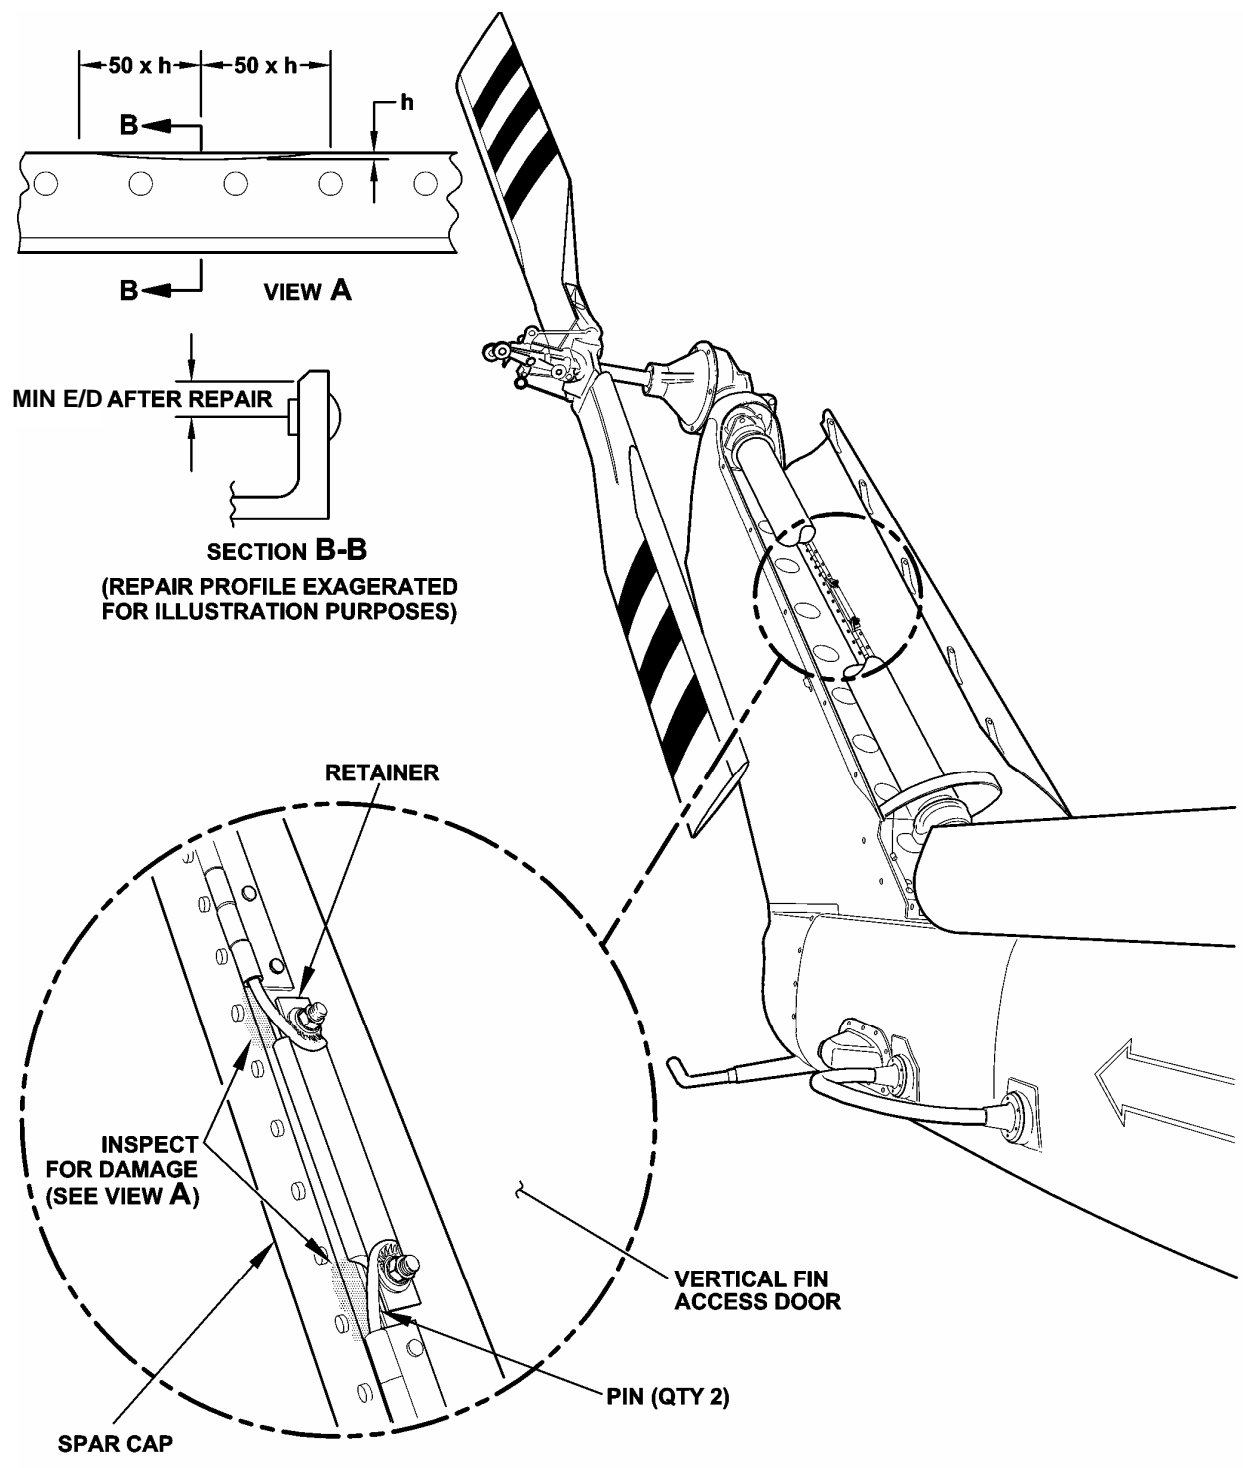
Figure 1
New Hinge Pin Installation

Bell Helicopter has designed a new installation for the vertical fin cover to prevent chaffing damage to the left hand spar cap caused by improperly bent hinge pins. This technical bulletin allows retrofit of the installation on earlier aircraft.

4. Remove door by removing hinge pins. Remove cotter pins at each end of the fixed half of hinge and discard.
5. Inspect spar cap as indicated in Figure 1, View A, for any chafing damage caused by improperly installed hinge pins.

- a. Chafing damage of 0.040 inch-deep or less (up to the full width of the flange) may be blended to a length-to-depth ratio of 50:1 (in each direction from the deepest point) and refinished, provided the distance between the center of the nearest rivet and the repaired area is at least 1.5 time the rivet diameter (min E/D). Remove minimum amount of material and polish repair area using 400-grit sandpaper. Removal of the hinge from the fin may be required.

- c. Report any damage in excess of 0.040 inch-deep to Product Support Engineering.

- b. Perform a Fluorescent Penetrant Inspection per Standard Practices Manual, followed by application of chemical film to the repaired area per Structural Repair Manual Section 3-2-14. Refinish area in accordance with Standard Practices Manual.

6. Reinstall door by inserting Pins P/N 209-031-816-119. Attach pins to door using existing screws, 209-031-816-123 Retainer and MS21042L3 Nuts, as shown on Figure 1. Close door.
7. Make an entry in helicopter historical records indicating compliance with this technical bulletin.
8. Make helicopter safe for flight.
