TECHNICAL BULLETIN  
**Bell Helicopter**  
A Textron Company

No. 212-08-207

**SUBJECT:** UPPER CREW DOOR HINGE STRUCTURE,  
REINFORCEMENT OF.

**HELICOPTERS AFFECTED:** Model 212 helicopters serial number 30502 through 31311, 32101 through 32142 and 35001 through 35103.

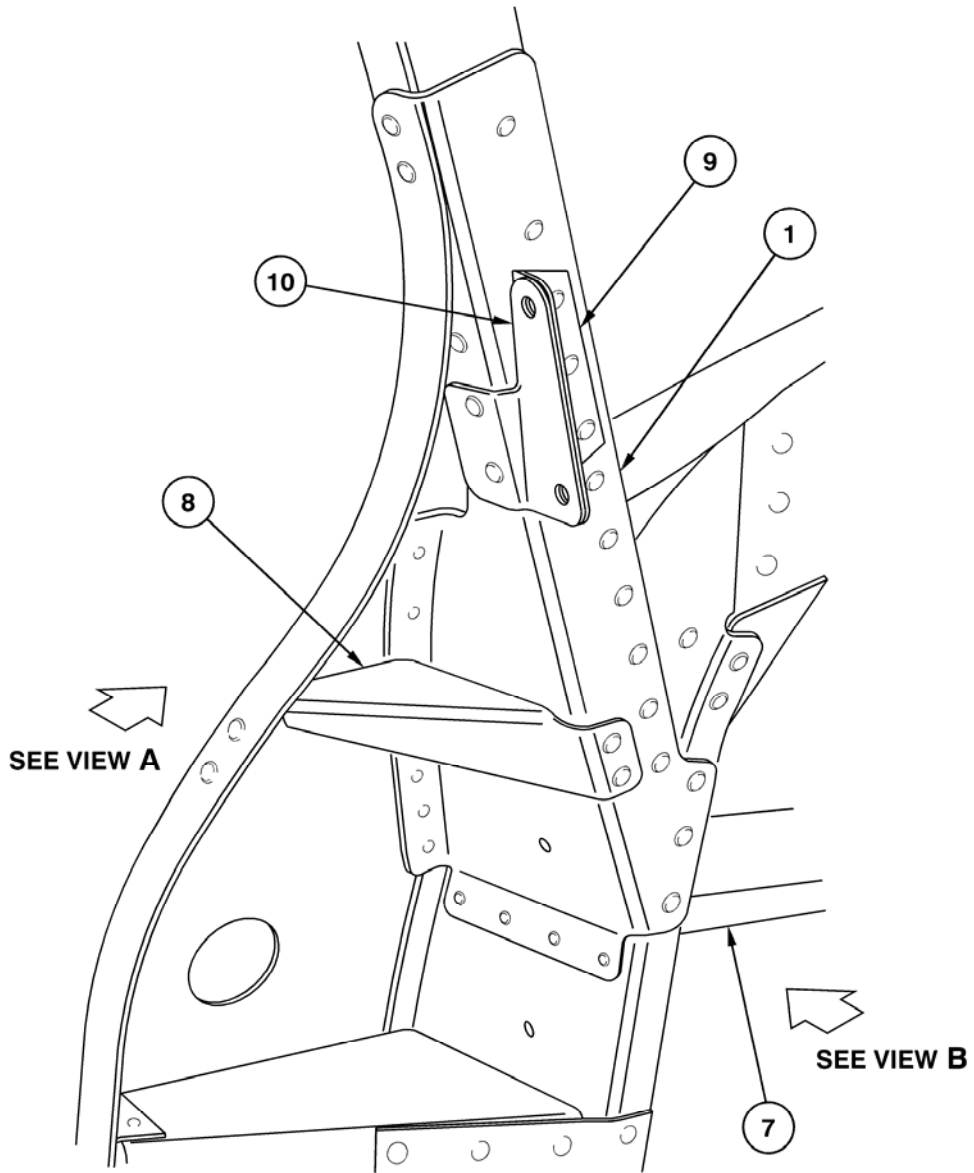
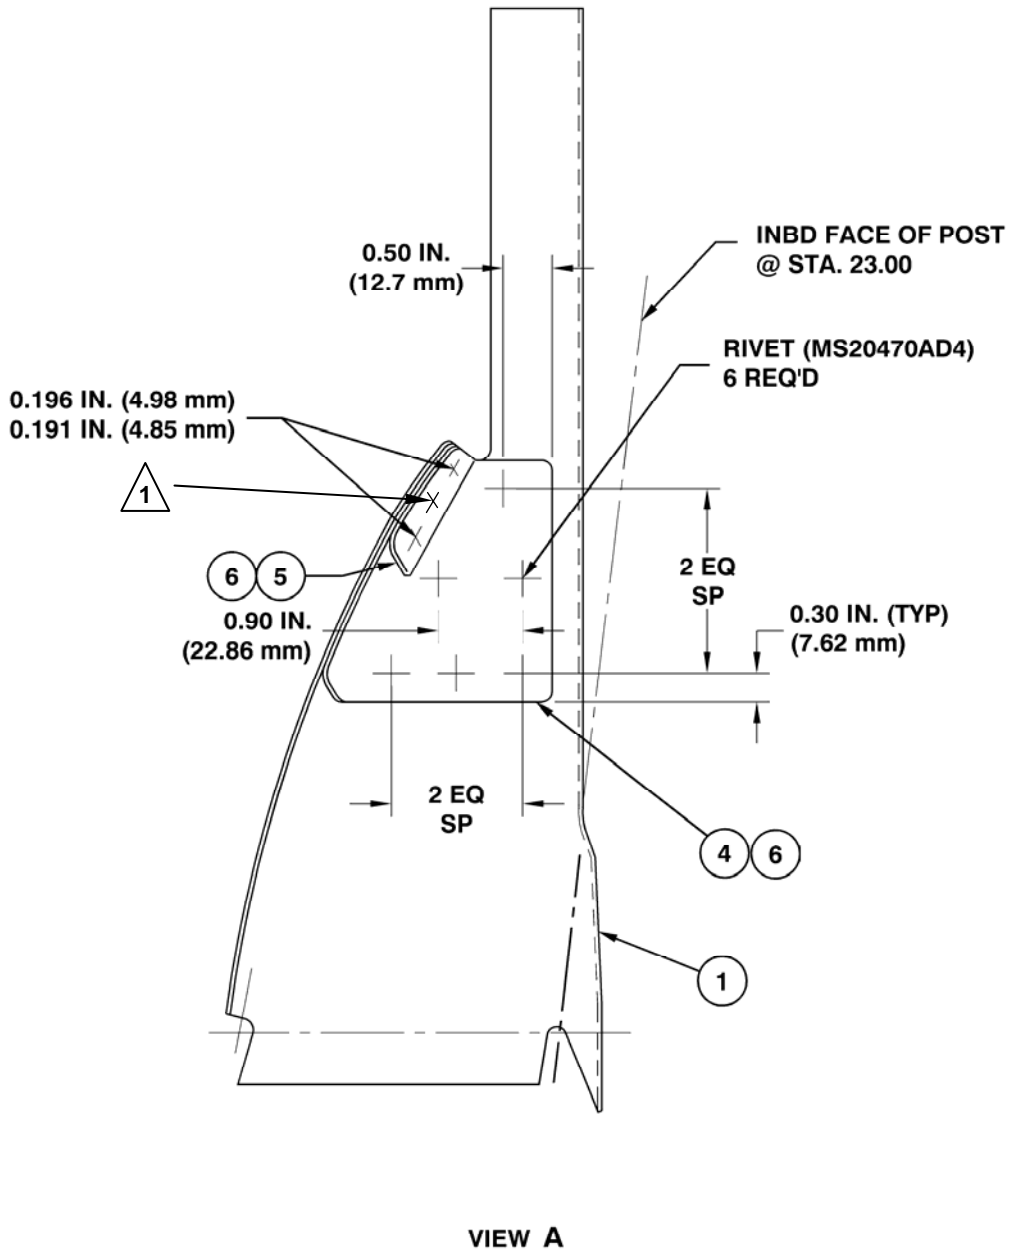
Figure 1 (Sheet 1 of 4)

Bell Helicopter has received some reports of cracking occurring at supports P/N 204-030-662-037 & -038 (or the earlier -025 & -026) caused by the crew doors repeatedly hitting their open stop, especially under windy conditions. This bulletin provides the instructions for a simple reinforcement to the surrounding area.

5. On left side, remove instrument panel support fitting (9).
6. Remove strap (10).
7. Remove support (1) and support (8) as a unit. Remove support (8) from support (1).
8. Fit new support (1). See note 1 in Figure 1. Measure gap between forward leg of support (1) and frame (7), View B and Section C-C. If gap is less than 0.063 inch, peel or grind shim (2), taper or straight, as required to fill gap without stress on support (1) and discard shim (3). If gap is 0.063 inch or more, install shim (3) in addition to shim (2), peeled or ground as required. Secure with Cleco fasteners.

9. Fit doubler (4) and radius block (5); refer to View A. See note 1 in Figure 1. Verify for possible interference with support (8) and trim doubler as required. Trim radius block to follow edge of doubler (4) and support (1). Secure with Cleco fasteners.
