TECHNICAL BULLETIN  
**Bell Helicopter**

No. 212-08-208

**MODEL AFFECTED:** 212

**SUBJECT:** REPLACEMENT OF BLIND RIVETS ON TAILBOOM

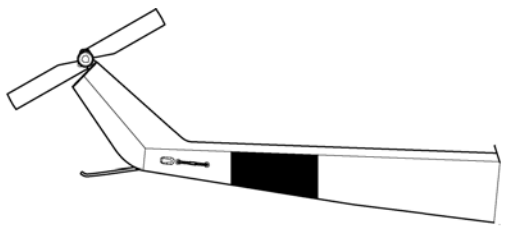
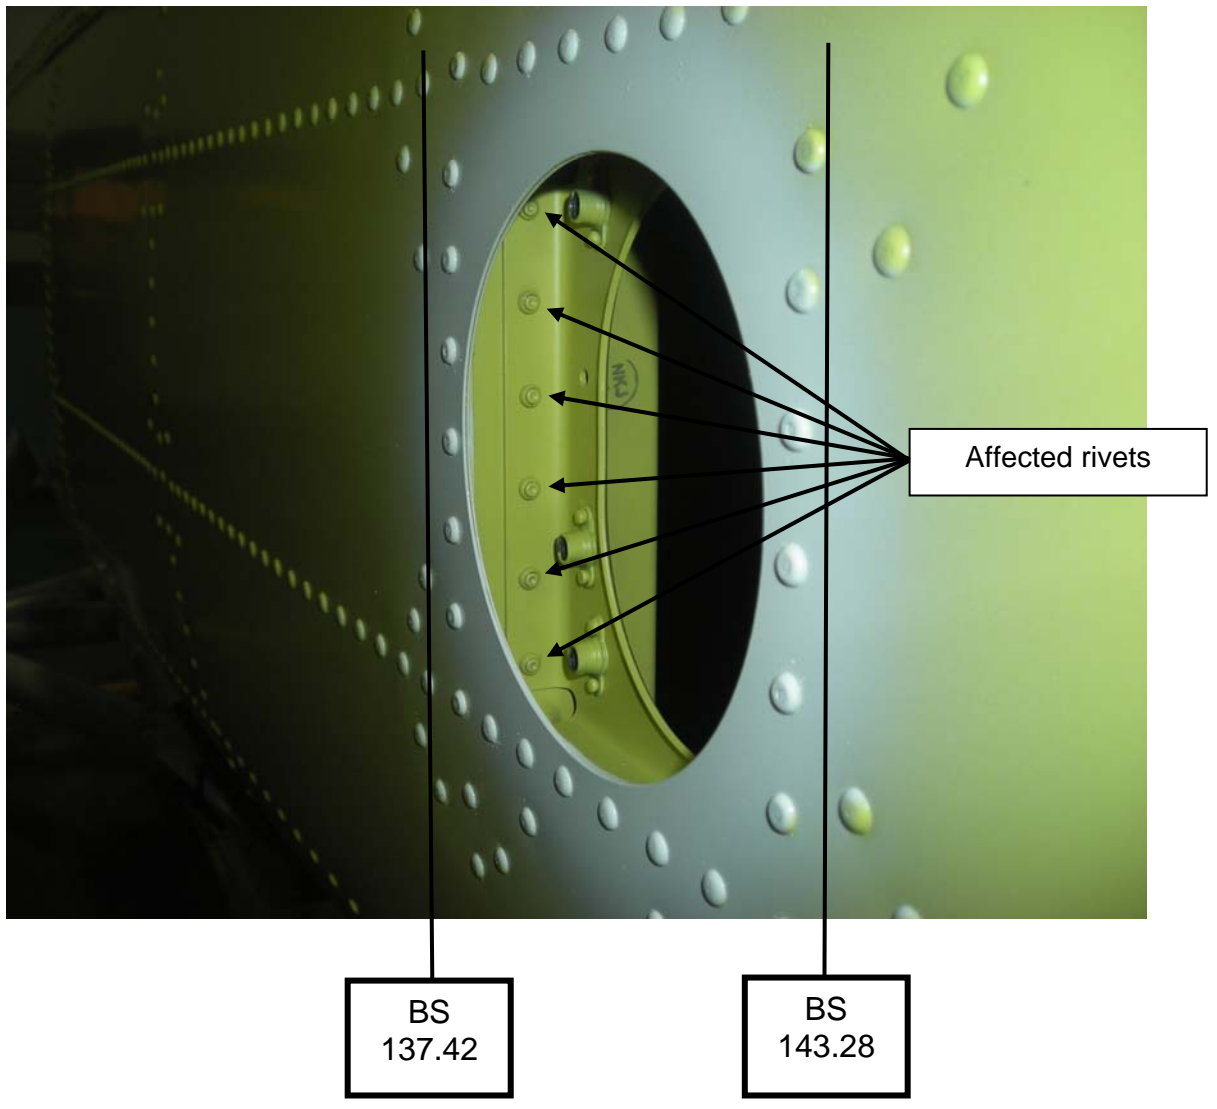
**Figure 1**  
Affected Rivets  
(Looking Forward and Inboard)

It was recently brought to Bell Helicopter's attention that blind rivets used to install Supports P/N 205-030-889-015 & -016 on some tailbooms may be responsible for cracks on the supports and their attaching structure. Future tailbooms will be built with only solid rivets at this location. This technical bulletin shows how to retrofit existing tailbooms by replacing the existing blind oversize rivets with solid oversize rivets. Only tailboom serial numbers with prefix PZ are affected.

1. Make helicopter ready for maintenance.
2. Confirm presence of blind rivets at the affected location (see Figure 1). If solid rivets are present, this technical bulletin is not required.

3. Remove both lower access doors on tailboom belly. Remove both elevators. Remove Elevator Horn. Refer to Maintenance Manual.
4. Replace rivets (vertical rows only) attaching Supports P/N 205-030-889-015 & -016 as follows (refer to Figure 1):

- a. There are four rows of rivets affected. Two on each support, of which one is common to the bulkhead at Boom Station (BS) 143.28 and one is common to the rib at BS 137.42. Remove existing blind rivets from one of the rows. Temporarily attach with Cleco fasteners. Wet-install rivets P/N NAS1242AD5-5 in existing holes using sealant (C-392). Refinish.

- b. Repeat for other three rows (24 rivets total).
5. Reinstall Elevator Horn in accordance with Maintenance Manual.
6. Reinstall both Elevators in accordance with Maintenance Manual.
