**SUBJECT: REVISION "B" TO TECHNICAL BULLETIN 212-78-15:
REPAIR OF ENGINE SERVICE DECK CENTER PANEL P/N 212-
030-009-007 AND -097**

No. 212-78-15

MODEL AFFECTED: 212

SUBJECT: REPAIR OF ENGINE SERVICE DECK CENTER
PANEL P/N 212-030-009-007 AND -097

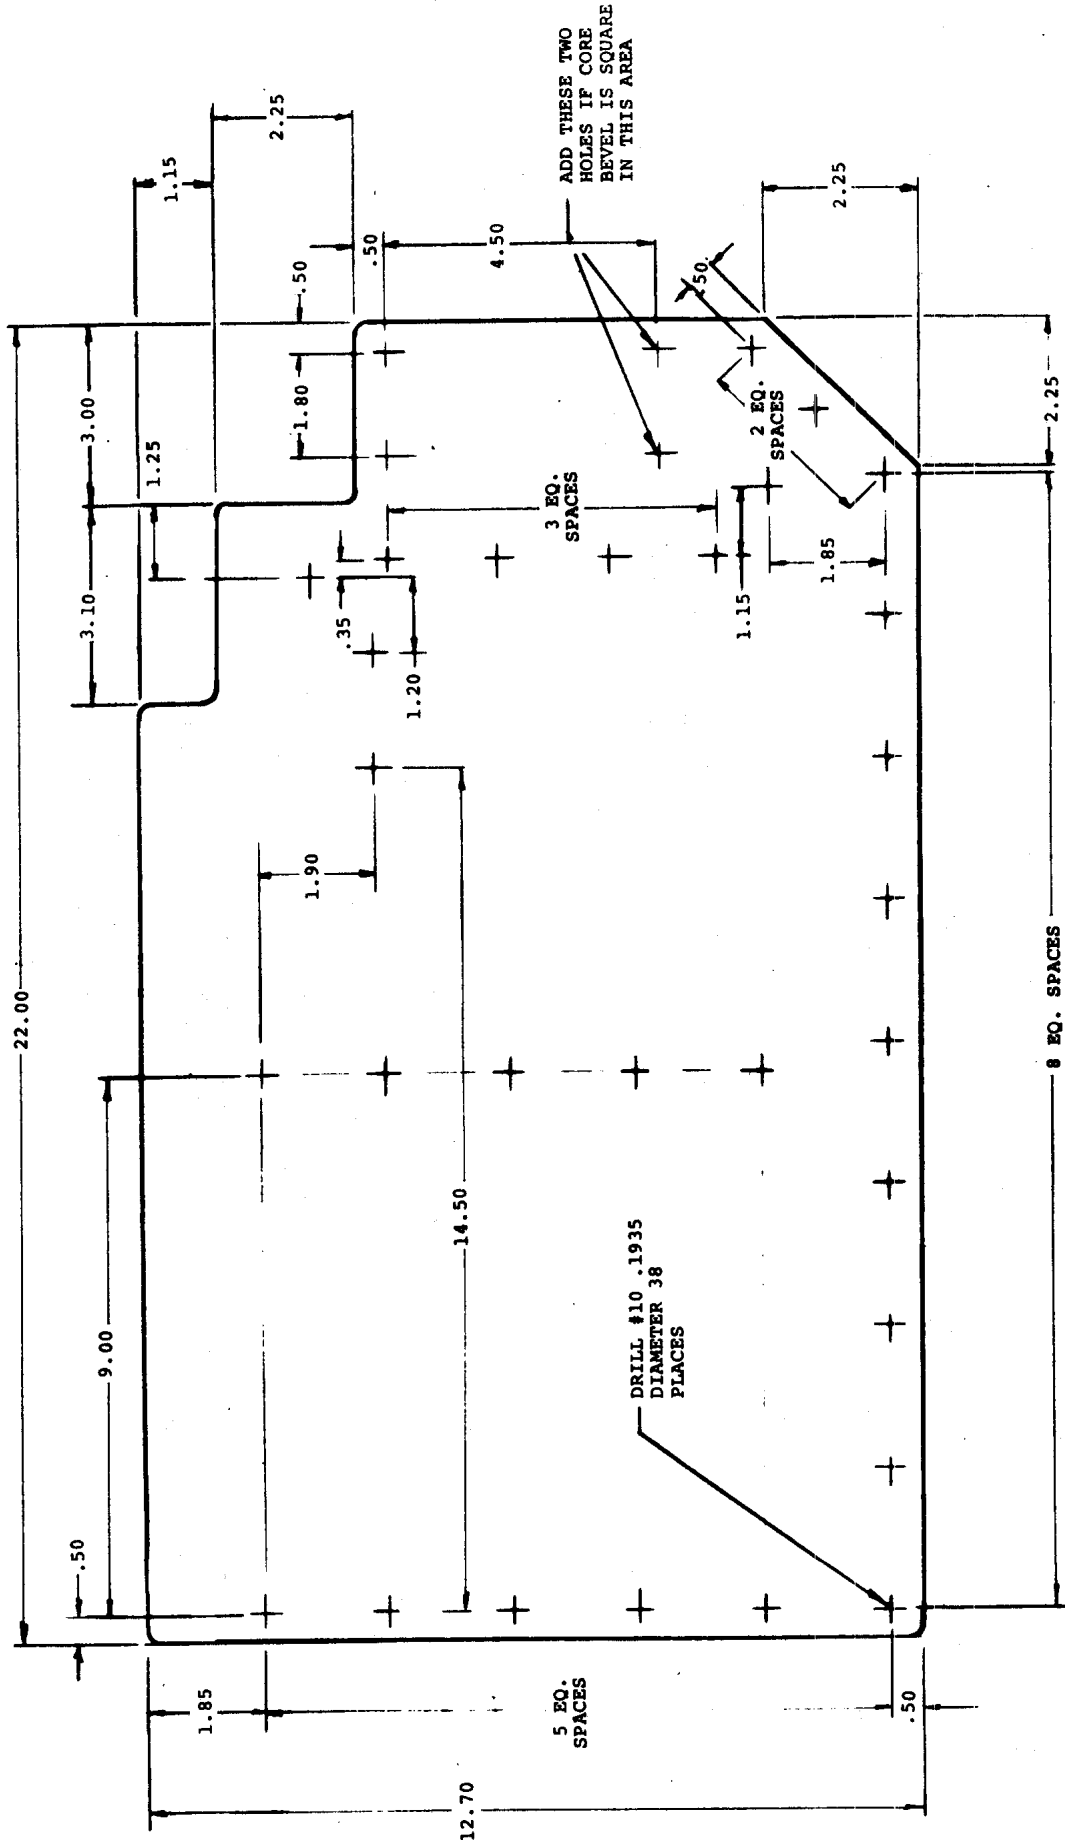
RIGHT SIDE DOUBLER
FIGURE 4

1. MATERIAL 301 1/4 HARD .040 THICK STAINLESS STEEL
2. BREAK SHARP EDGES AND DE-BURR HOLES
3. ALL CORNER RADII .25 R.

3. Refer to Figure 3 and 4. Fabricate the two doublers as detailed from 0.040"-thick 301, ¼ hard stainless steel.
4. Refer to Figure 1 and 2. Locate the doublers and drill holes in the panel from the doublers and pick-up existing holes in the panel into the doublers. Use sharp cobalt drills.

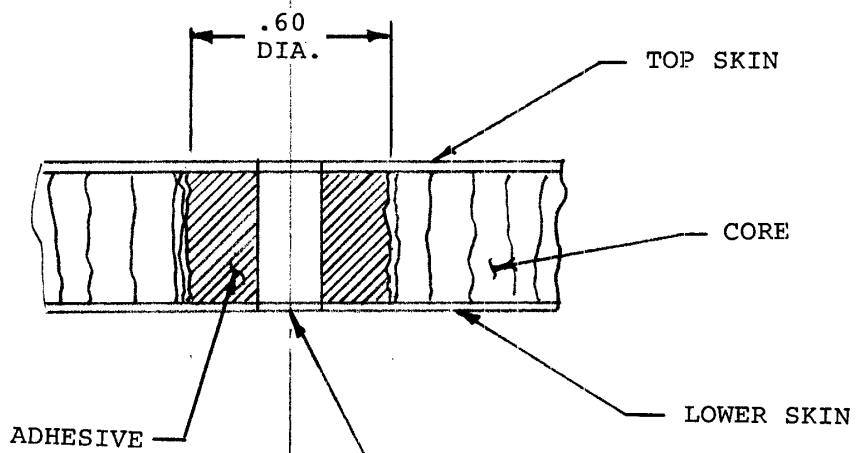
CORE FILL DETAIL
FIGURE 5

DRILL #10 (.1935) HOLE
CRUSH CORE BACK .60 INCH
DIAMETER THEN FILL WITH
299-947-100TY2CL2 ADHESIVE
AFTER ADHESIVE CURES RE-DRILL
#10 (.1935) HOLE

5. Drill #10 (0.1935 inch) holes for the core fill (see Section A-A, Figure 5). Clean the hole of all chips. Tape the hole in the lower skin and fill the hole with adhesive and allow 4 hours to cure.
