**TECHNICAL BULLETIN**  
**Bell Helicopter** **TEXTRON**

No. 407-05-72

**SUBJECT:** Bearing Support 407-030-009-103,  
407-030-010-101, 407-030-831-105 and  
407-030-832-101, Primer- Application of

**HELICOPTERS AFFECTED:** Model 407 helicopters serial number 53555 through 53640.

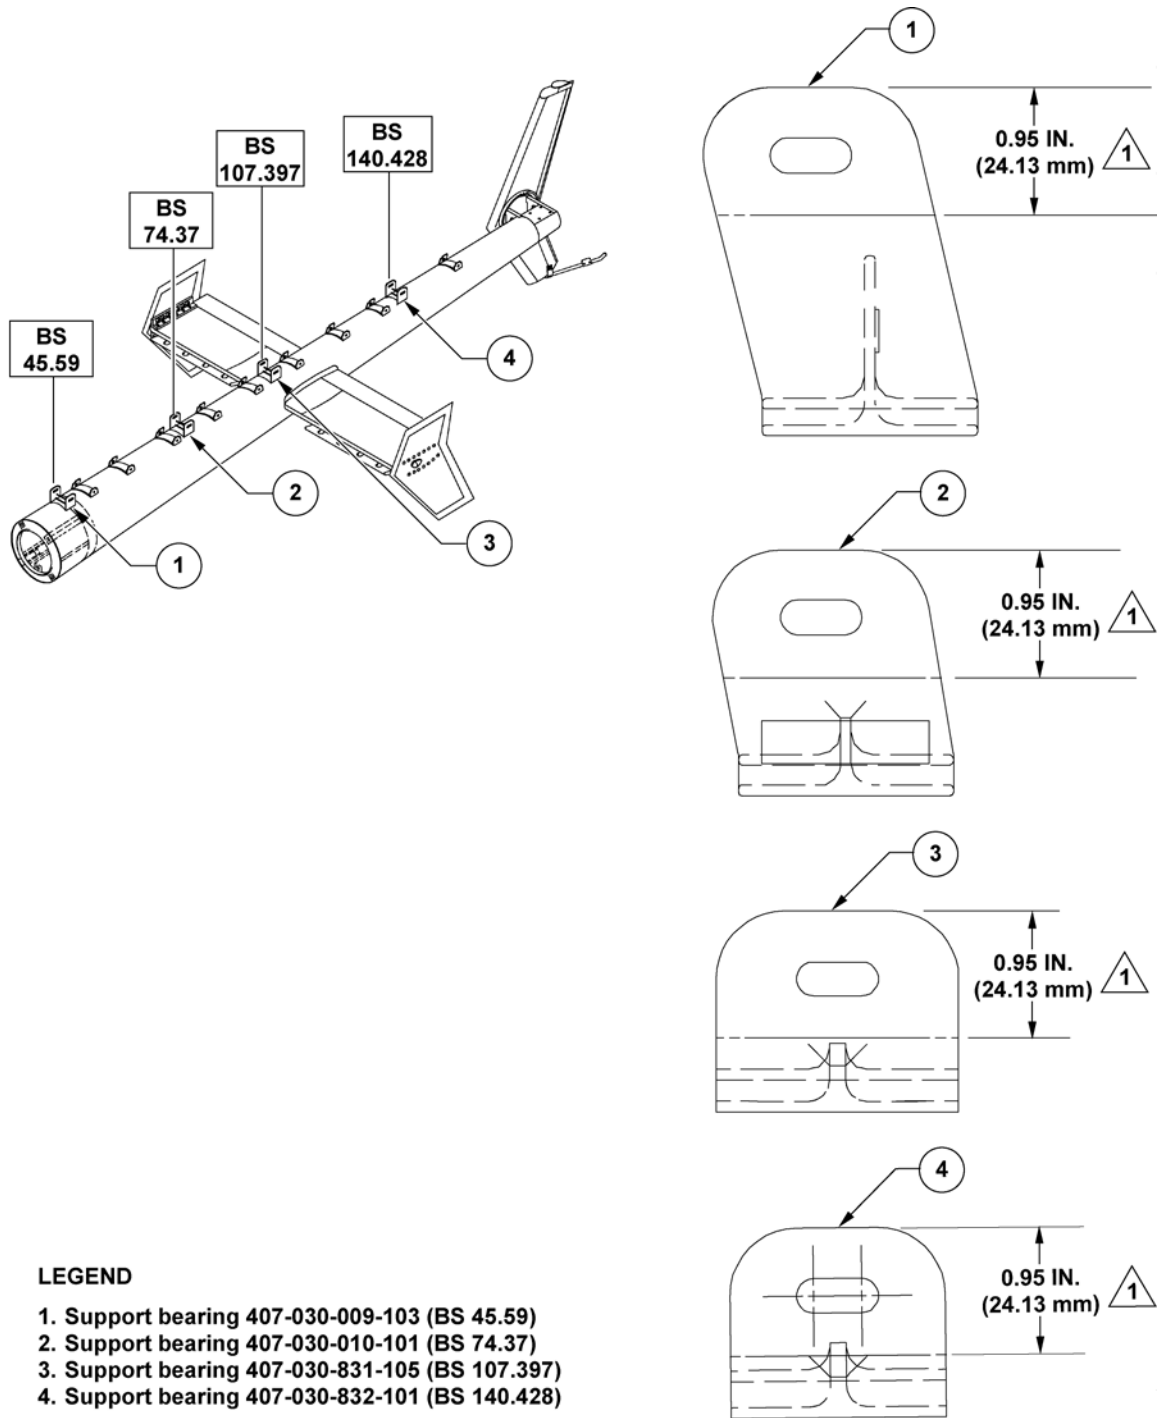
**Figure 1 Area on bearing support where the primer is to be removed  
 (sheet 1 of 1)**

It has been determined that primer applied on bearing supports 407-030-009-103, 407-030-010-101, 407-030-831-105 and 407-030-832-101, could affect the bearing 407-340-339-107 alignment procedure.

This bulletin gives instructions to remove only the primer that is in contact with the bearing hangers 407-040-322-103.

3. Remove primer at specific location only on bearing supports (1,2,3,4, figure 1). Refer to BHT-ALL-SPM, Chapter 3, Plastic Media Blasting or Chapter 4, Paint Remover and Strippers.
4. Install the Aft Short Shaft Assembly and the Tail Rotor Drive Shaft Segmented Assemblies. Refer to BHT-407-MM-7, Chapter 65.
5. Install the Aft Engine Fairing Assembly, the Tail Rotor Drive Shaft Assemblies and the Tail Rotor Gearbox Fairing Assemblies. Refer to with BHT-407-MM-5, Chapter 53.
6. Annotate the aircraft technical records to indicate that this Technical Bulletin has been accomplished.

Remove organic finish as indicated, both sides of flanges and slots over entire area, 2 places.
