TECHNICAL BULLETIN
Bell Helicopter **TEXTRON**

No. 407-06-74

MODEL AFFECTED 407

SUBJECT: **BAGGAGE FLOOR PANEL, IMPROVED
CORROSION RESISTANCE OF,**

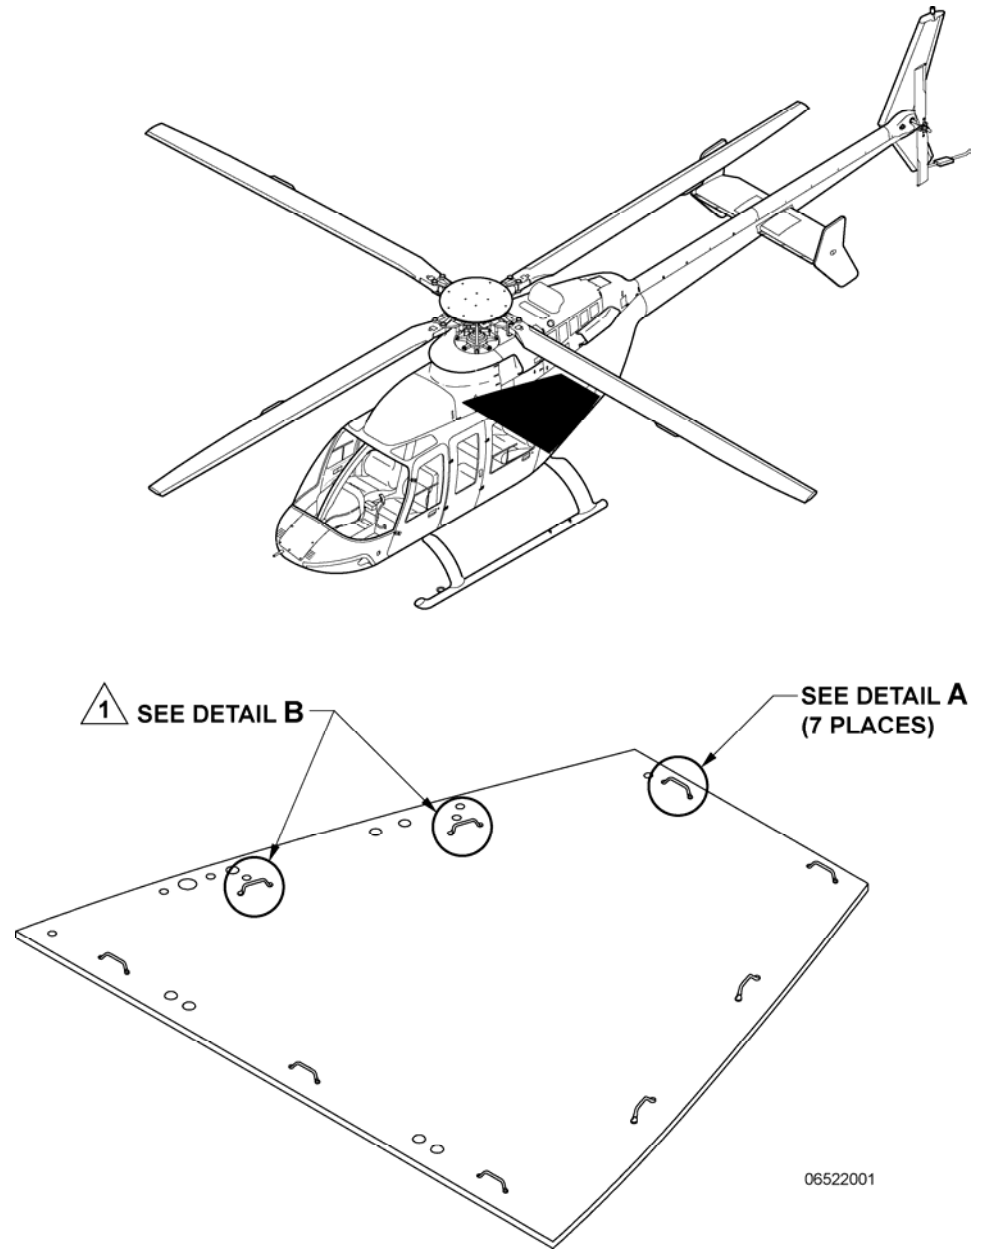
**Figure 1: Baggage Floor Panel (sheet 1 of 2)
407 Helicopters**

This bulletin introduces the addition of washers and sealant to provide improved corrosion protection to the baggage floor panel at the footman loop locations.

1. Gain access to the baggage floor panel.
2. Remove all nine footman loops (1, Figure 1) from floor panel.
3. Inspect footman loops (1), inserts (3) and screws (5) for evidence of corrosion. Replace unserviceable screws (5) and footman loops (1). Replace damaged or corroded inserts (refer to BHT-206-SRM-1). Remove corrosion on inserts as per Standard Practices Manual, Chapter 3.
4. Inspect baggage floor panel for damage or corrosion around insert location. If required, repair baggage floor panel in accordance with BHT-206-SRM Chapter 3.
5. Prime any bare metal surfaces with epoxy primer (C-204).
6. Prior to installing the footman loops (1) apply corrosion inhibiting compound (C-104) on screw shank
7. Apply sealant (C-251) per figure 1 DETAIL C and D. Reinstall the footman loops (1). Contour sealant as shown in DETAIL C, D and E.
