TECHNICAL BULLETIN
Bell Helicopter

No. 407-07-80

MODEL AFFECTED: 407

SUBJECT: PITCH HORN 407-010-103-113, REPAIR OF.

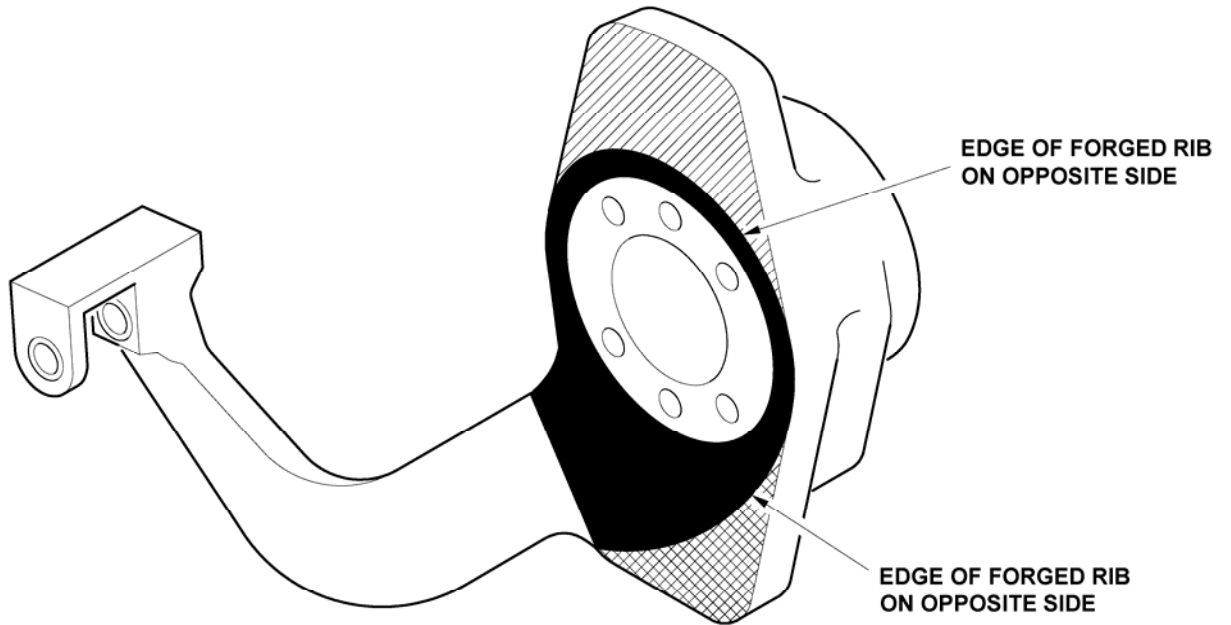
Figure 1. Pitch horn assembly repair limits

Bell Helicopter has received reports of corrosion on the 407-010-103-113 main rotor pitch horn surface where the Tungsten Carbide coating is applied. The corrosion may cause the Tungsten Carbide coating to bulge, crack and eventually flake.

MAXIMUM REPAIR DEPTH			
CORROSION	0.015 inch (0.381 mm)	0.040 inch (1.016 mm)	NO CORROSION DAMAGE ALLOWED

NUMBER OF REPAIRS	FOUR	TEN	NO CORROSION DAMAGE ALLOWED

There must be a minimum of 0.150 inch (3.81 mm) space between the edges of adjacent repair circles.
-

Measure the depth from the tungsten carbide surface.
-

Limits are for corrosion removal prior to Part 1, step 3d.

1. Refer to Figure 1 and evaluate if the repair provided herein can be accomplished.
2. If the corrosion damage does not exceed the repair limits given on Figure 1, proceed with step 3. If the corrosion damage exceeds the limit given on Figure 1, proceed with Part III.
3. Remove the 407-010-103-113 pitch horns from the main rotor hub assembly. Refer to BHT-407-CR&O, Chapter 62.

- c. Measure the depth from the tungsten carbide surface to the bottom of the cut after removing the corrosion from the aluminum. If the depth exceeds the repair limits given on Figure 1, proceed with Part III.

- j. Repeat steps 3.a. through 3.i. for other areas indicating corrosion. Quantity of repairs is limited as shown in Figure 1. There must be also a minimum of 0.150 inch space between the edges of adjacent repair circles.
