TECHNICAL BULLETIN
Bell Helicopter
A Textron Company

No. 407-09-86
Date MAY 26, 2009
Page 1 of 5

MODEL AFFECTED: 407

SUBJECT: HYDRO MECHANICAL UNIT BRACKET
ASSEMBLY 206-063-719, BEARING
REPLACEMENT OF.

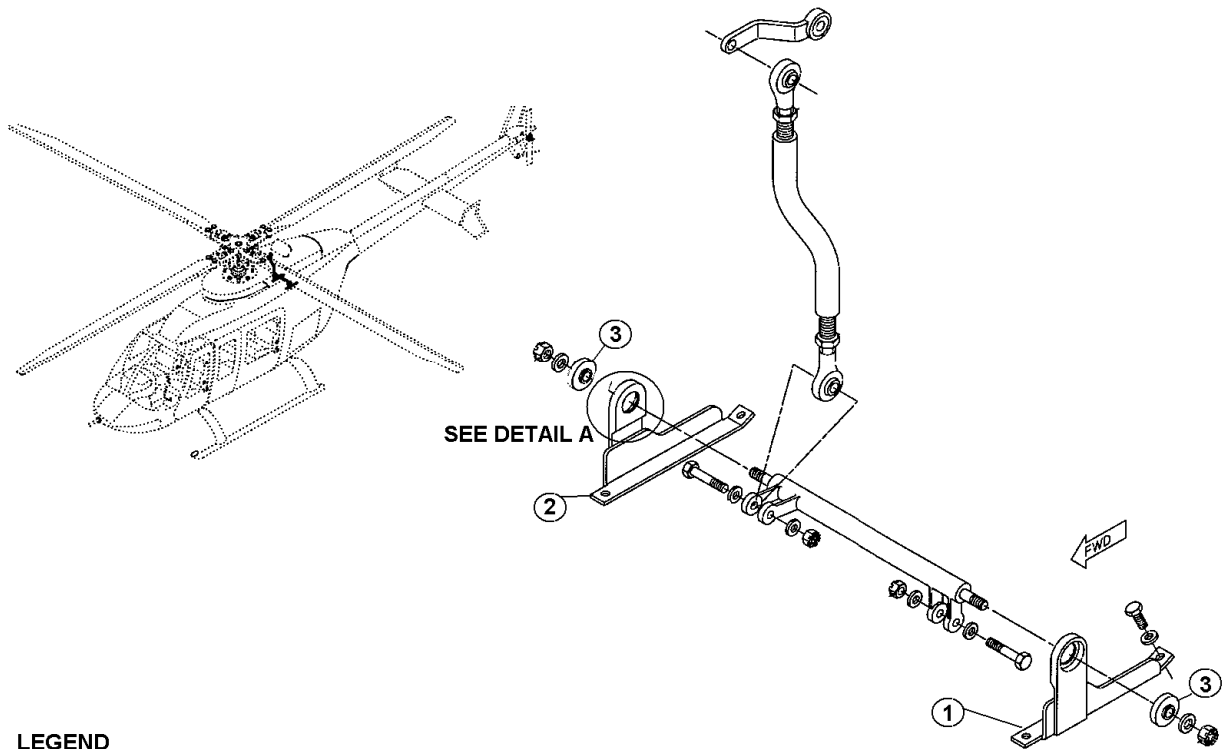
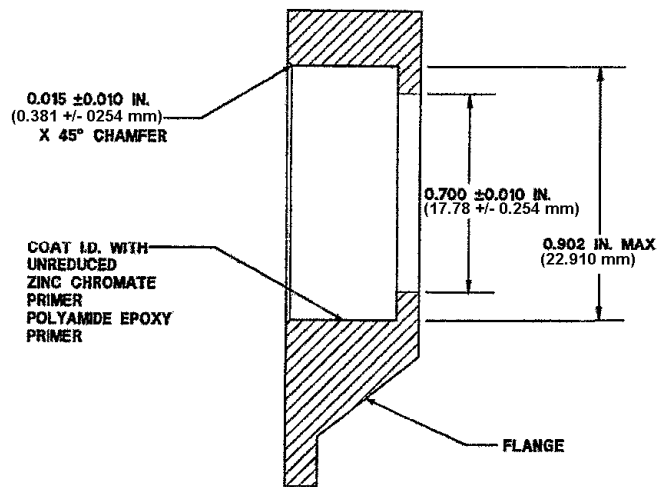
Figure 1. Repair limitations

IF THE FLANGE BORE CANNOT BE REWORK PER
FIGURE 1 OF THIS BULLETIN, DISCARD THE BRACKET
ASSEMBLY.

1. Remove bracket assemblies (1 and 2, Figure 1) (BHT-407-MM, chapter 76).
2. Press bearing (3) out of bracket flange and discard bearing.

As an alternate method, it is also acceptable to rework the flange bore edge with abrasive cloth (C-406) to a maximum of 0.015 +/- 0.010 inch (0.381 +/- 0.254 mm) X 45 degrees and fine polish with abrasive cloth (C-423) (DETAIL A, Figure 1).

- a. Machine a chamfer of 0.015 +/- 0.010 inch X 45 degrees in flange bore edge to eliminate any scratches and marks created by removal of parent metal staking material (DETAIL A, Figure1).
- b. Scratches and marks in flange bore may be polished with abrasive cloth (C-406) to a maximum I.D. of 0.902 inch (22.910 mm).
