**MODEL AFFECTED:** 407

**SUBJECT:** SPANNER NUT P/N MS172244, INSPECTION OF

**HELICOPTERS AFFECTED:** 407 Helicopters serial number 53000 through 53900 and 53911 through 53994.

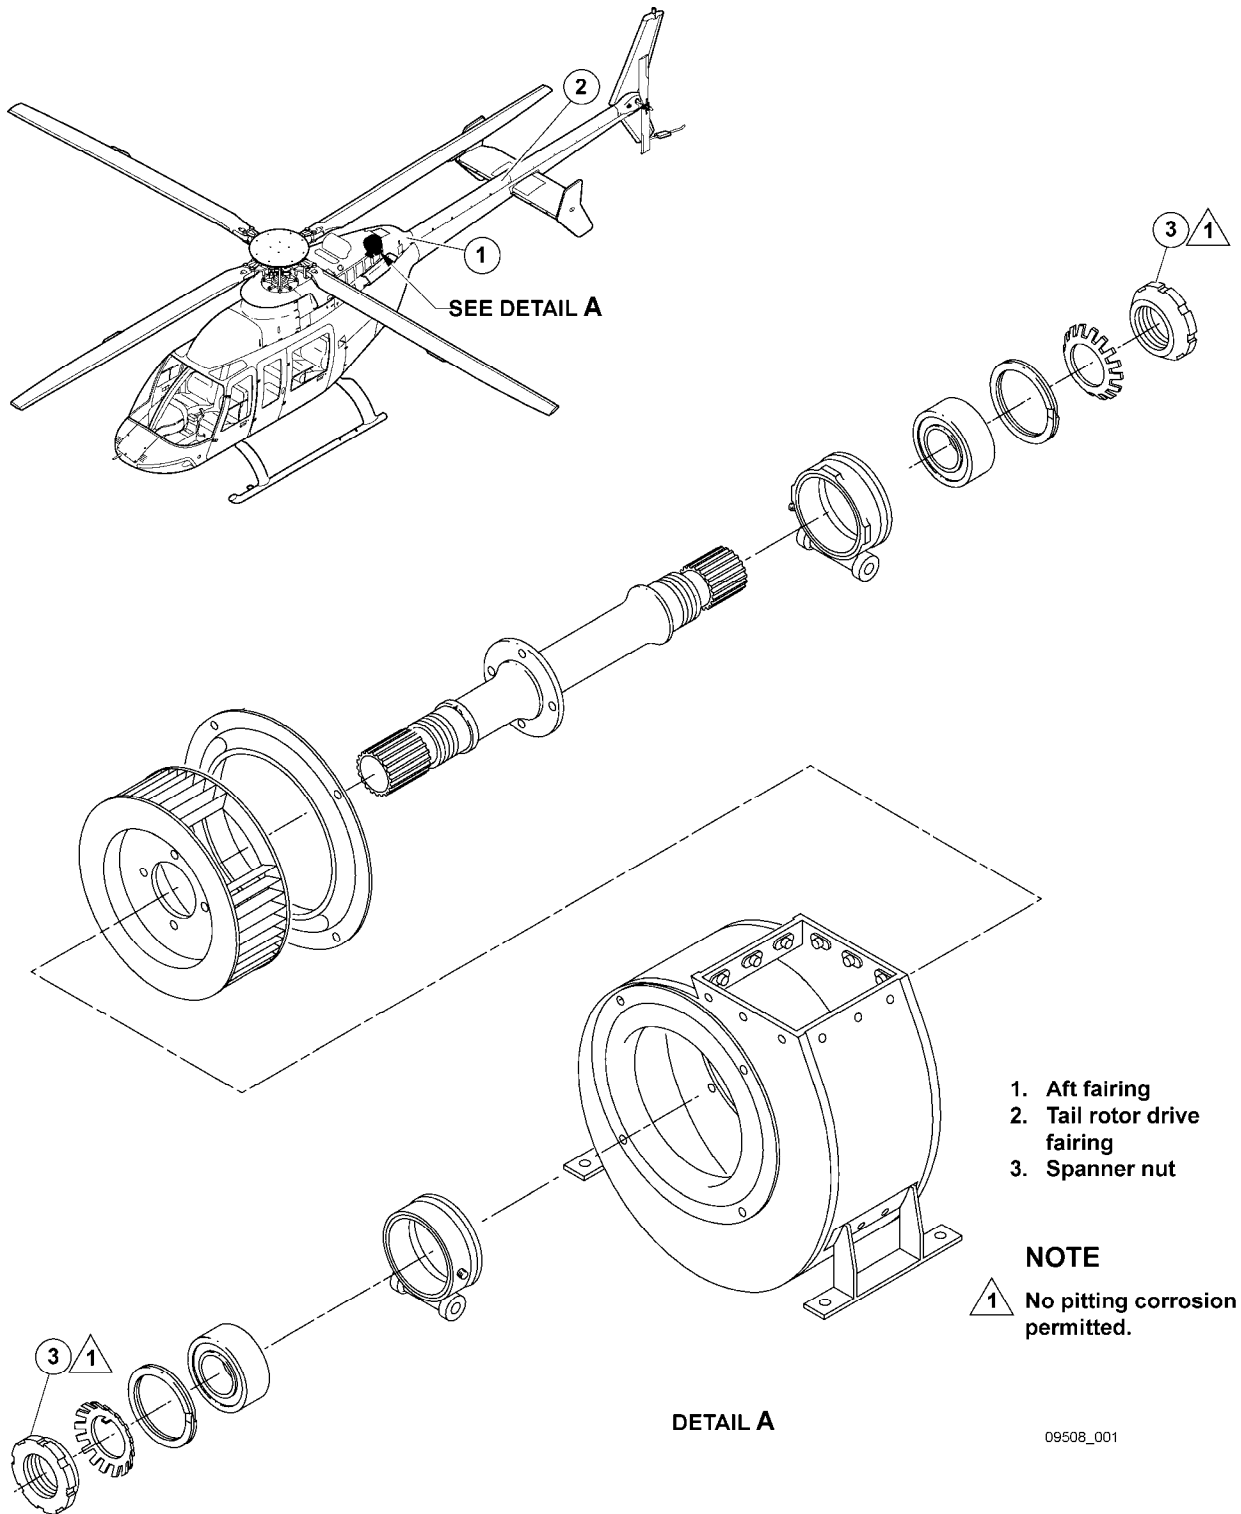
Figure 1. Oil cooler blower assembly

Bell Helicopter has received reports of corrosion on spanner nut MS172244. This corrosion has been noticed on installed as well as newly received nuts due to omission of phosphate treatment during manufacturing process.

1. Gain access to oil cooler blower shaft assembly (Refer to Detail A, Fig 1).

2. Clean forward and aft nuts (3) using Aliphatic Naphtha (C-305).
3. Visually inspect forward and aft spanner nuts (3) for evidence of corrosion.
  - a. If surface corrosion is found, remove and replace with nut 90-118-4 or phosphate coated nut MS172244 (Refer to BHT-407-MM-7 Chapter 65). If the nut can not be replaced immediately, apply corrosion preventive compound (C-101). Replace the nut when ever convenient.
  - b. If pitting corrosion is found, remove and replace immediately with nut 90-118-4 or phosphate coated nut MS172244 (Refer to BHT-407-MM-7 Chapter 65).
