TECHNICAL BULLETIN  
**Bell Helicopter**  
A Textron Company

No. 407-10-90  
Date May 28, 2010  
Page 1 of 3

**MODEL AFFECTED:** 407

**SUBJECT:** BAGGAGE DOOR 206-031-312-119/-123 SEAL  
MODIFICATION INTRODUCTION OF

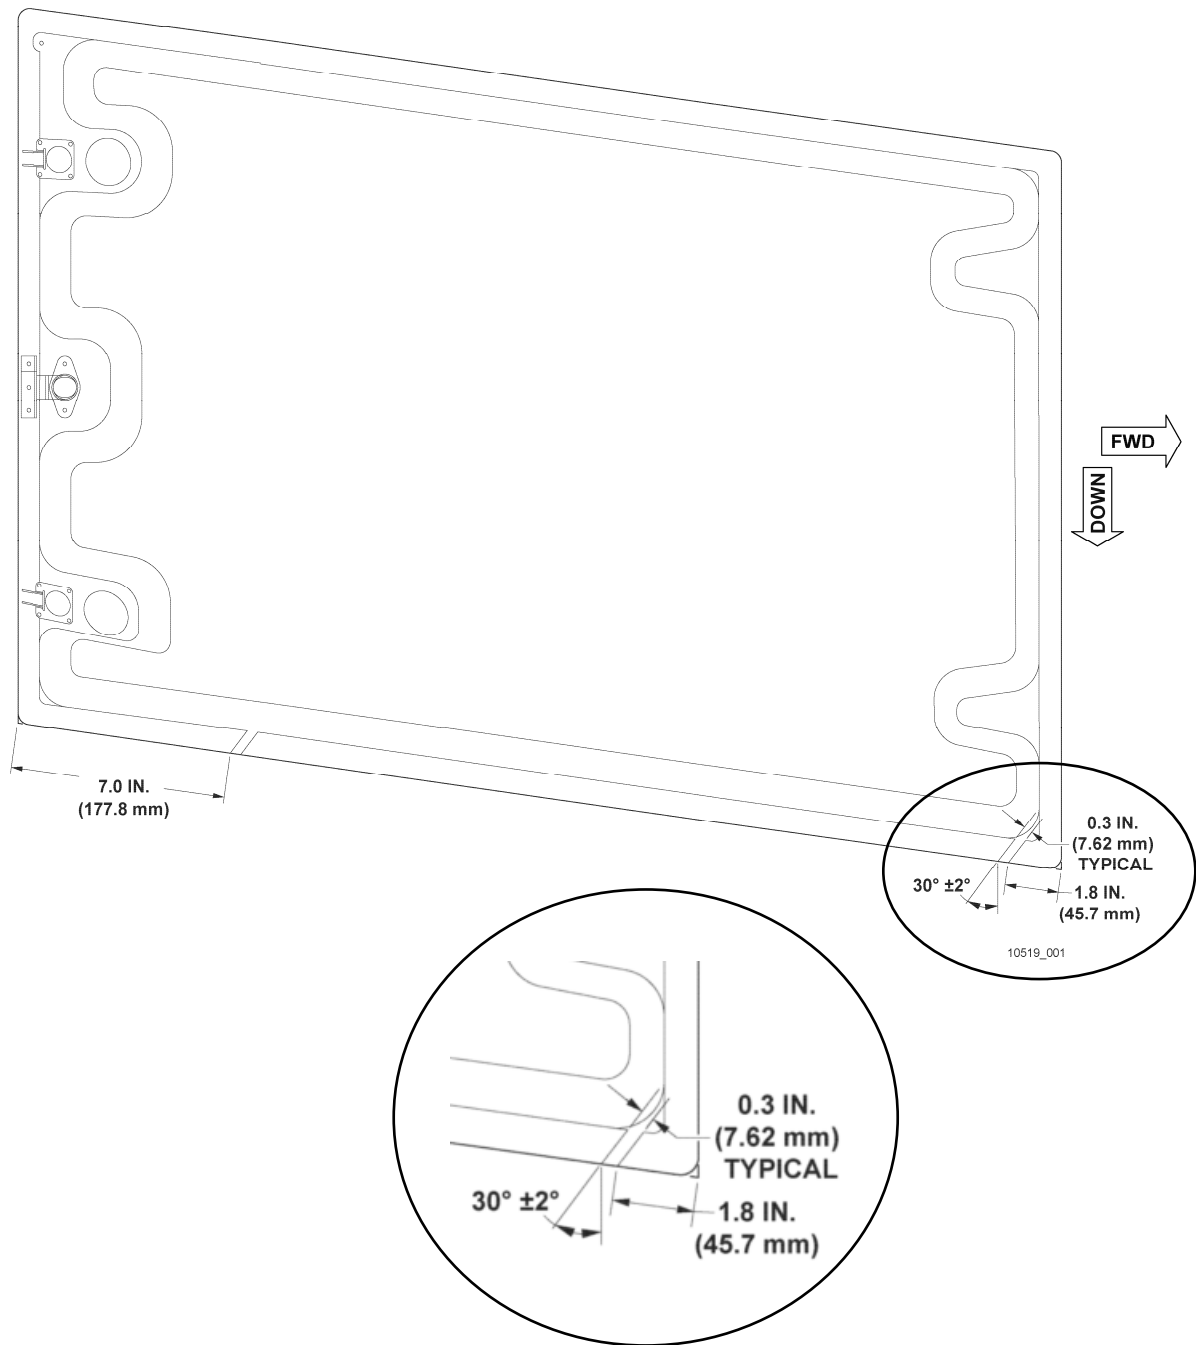
Figure 1. Baggage door seal modification.

Bell has received reports of moisture being trapped within the baggage compartment. To allow moisture to drain from this area the baggage door may be modified by cutting two channels in the form-in-place baggage compartment seal. This procedure is applicable to baggage doors P/N 206-031-312-119 as installed on S/N 53000 through 53288, and P/N 206-031-312-123 as installed on S/N 53289 and subsequent.

1. Refer to Figure 1. Using a putty knife or an equivalent tool, make the two channels to the baggage door seal.
2. Make an entry in the helicopter historical records to indicate that of this Technical Bulletin as been accomplished.
