## **ALERT SERVICE BULLETIN**

**212-24-169**

**MODEL AFFECTED:** 212

**SUBJECT:** INSPECTION OF CAP ANGLE, P/N 212-030-191-001, INTRODUCTION, OF.

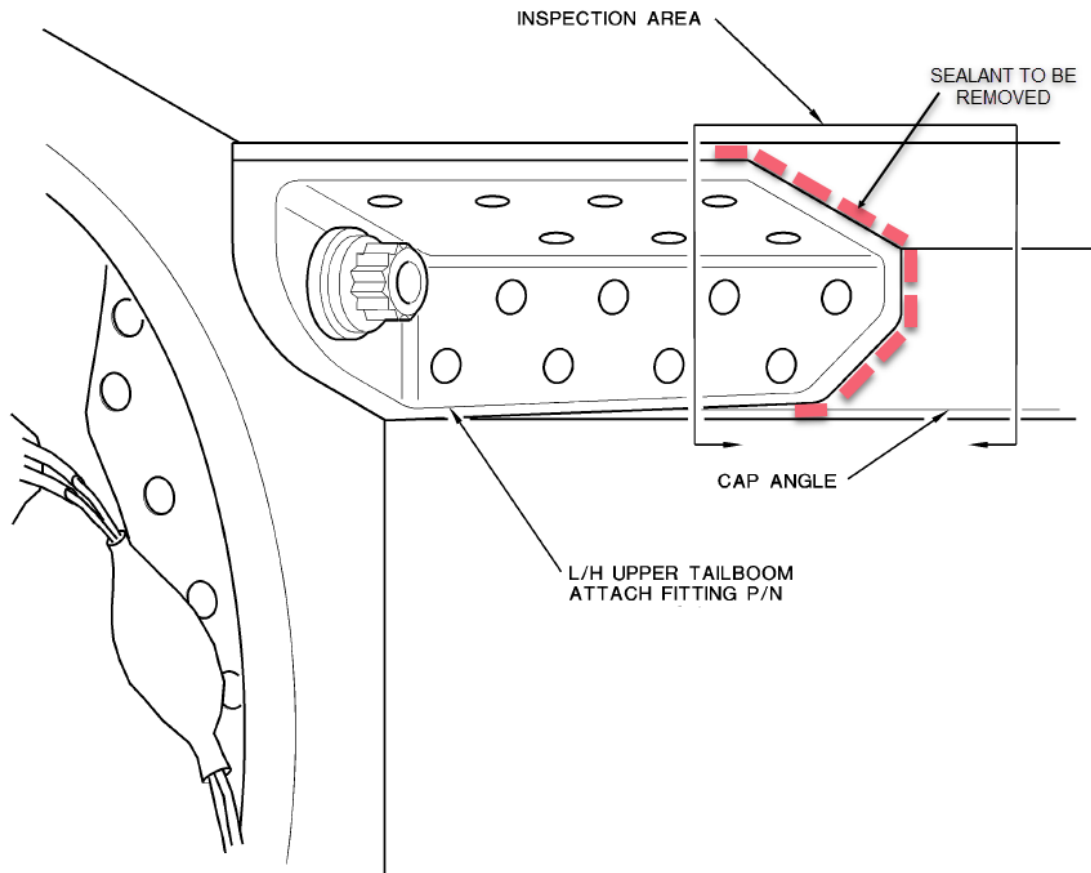
**Figure1. Fuselage Tailboom Attachment Inspection.**

Bell has investigated reports of fractured 212-030-191-001 cap angles. Some were found during routine inspection and some during the scheduled 100 Hours Tailboom Attachment Inspection. The investigation indicates that the model 412/412EP 100 flight hour Special Inspection interval established in 2000, introduced by the ASB 412-00-100 and the FAA AD 2000-18-09, is not adequate to detect all cracks before complete fracture of the cap angle. Back in 2000, no ASB was released to mandate the tailboom attachment Special Inspection on the Model 212. Since the risk of cracking/fracture exists on the 212-030-191-001 cap angle also used on the model 212, this ASB introduces a recurring 25 flight hours tailboom attachment inspection. The Maintenance Manual Chapter 5 Special Inspections section will be revised to include this 25 Hours Tailboom Attachment Inspection.

2. If sealant is present, remove sealant from edge of fitting (Figure 1).
3. Inspect the cap angle area shown with a 10x magnifying glass and bright light.
4. If a crack is found, replace the cap angle before further flight. If the helicopter is at a location where the cap angle cannot be replaced, contact Product Support Engineering.
5. Touch up primer if damaged during sealant removal. Paint touch up is optional. Do not reapply sealant.
6. If no cracks are found, the helicopter can be returned to service.
7. Make an entry in the helicopter logbook and historical service records indicating findings and compliance with this Alert Service Bulletin.
