## ALERT SERVICE BULLETIN

**412CF-00-11**

**MODEL AFFECTED:** 412CF

**SUBJECT:** CAP ANGLE, P/N 212-030-191-001, INITIAL INSPECTION

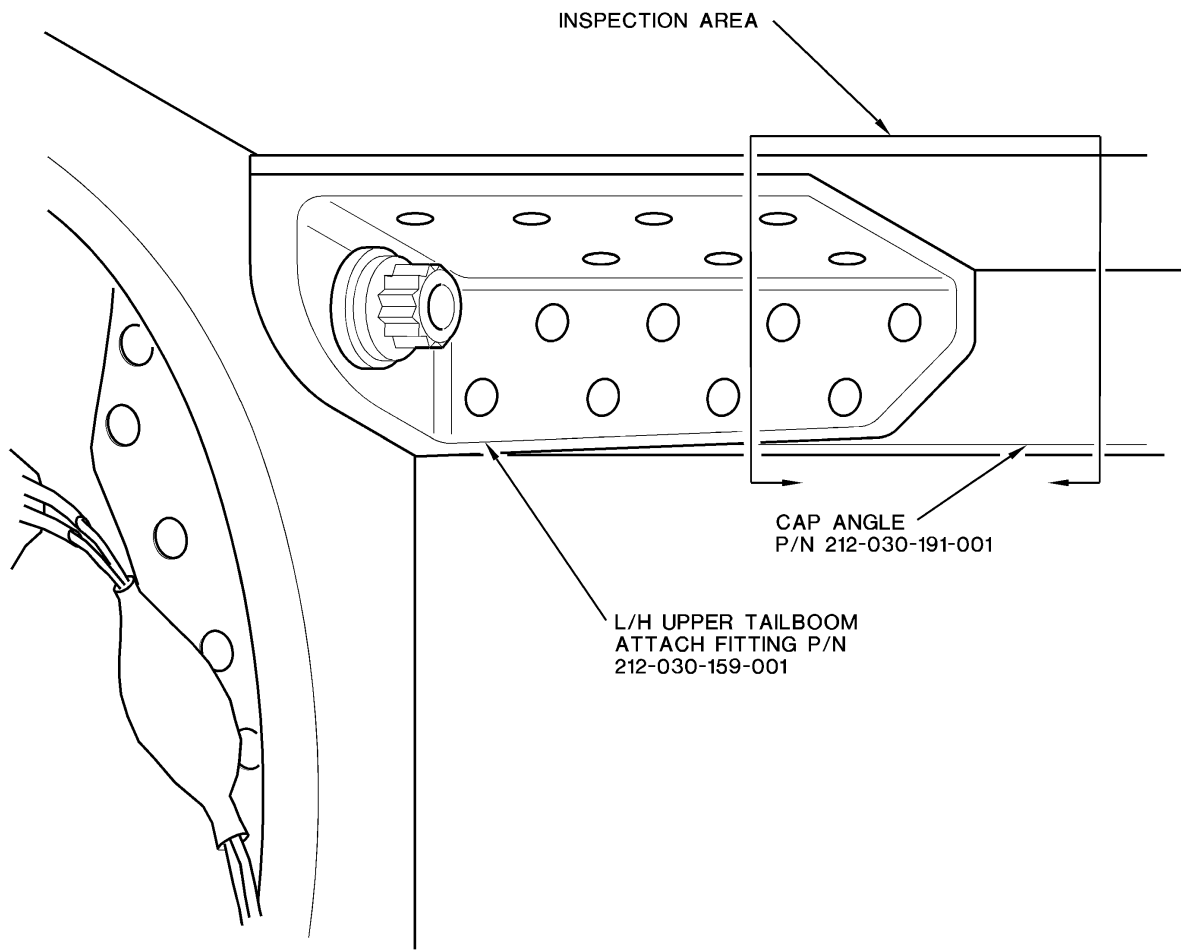
This Alert Service Bulletin (ASB) has been superseded and replaced by **ASB 412CF-24-77**. Bell Helicopter has recently completed an investigation of a fractured Upper Left Fuselage Tailboom Attachment Cap Angle, P/N 212-030-191-001. The fracture was the result of a fatigue crack, which originated from metal chips left between the bottom side of the cap and the upper side of the fittings, or between the cap angle and the adjacent structure. This has been determined to be the result of improper de-burring and cleaning during manufacture.

1. Gain access to the cap angle in the tail rotor servo compartment through the R/H aft fuselage door.
2. Inspect area noted on [figure 1](#) of cap angle, P/N 212-030-191-001, with 10x magnifying glass.
3. If no cracks are found, return the aircraft to service.
4. Revise C-12-146-000/MY-001 CH146 Maintenance Manual Scheduled 100 hour Inspection to include the following statement and copy of the figure 1: **“Inspect fuselage Tailboom attachment components and hardware for cracks with a 10X magnifying glass, pay particular attention to the interface between the end of the Tailboom attachment fitting and cap angle. Refer to figure 1.”**

5. If a crack is found, contact Product Support Engineering before further flight:
