ALERT SERVICE BULLETIN

204-96-49

MODEL AFFECTED: **204B**

SUBJECT: **MAIN ROTOR BLADE 204-011-250-001, -005, -009, -113 AND, -117, INTRODUCTION OF DAILY WIPE-DOWN INSPECTION AND SPECIAL 25-HOUR INSPECTION.**

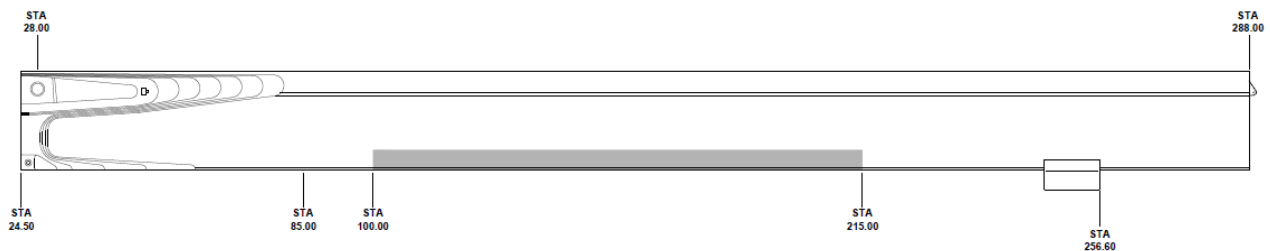
Figure 1 – 204-011-250 Series Main Rotor Blade

1. Prepare the helicopter for maintenance.
2. Inspect the upper and lower skin surfaces of the main rotor blades as follows:
 - a. Wipe the last 4 inches of the trailing edge between blade station 100 and 215 (shaded area) with an alcohol-soaked cloth (C-385) and wipe dry with a clean cloth. (Figure 1)

- b. Using a strong light source at an oblique angle, check for evidence of a dark line. A dark line represents excess alcohol bleeding out of possible cracks or edge voids. (If no defects are found during the inspection, proceed to step 2.f).

- c. Any crack in the surface finish must be investigated further by removing paint in the affected area. Remove paint by hand sanding the affected area in a spanwise direction only, with an abrasive cloth or paper (C-406) 220 grit or smoother to determine if the crack is in the skin. (Any crack in the surface finish may be indicative of a skin crack).
 - d. The main rotor blade must be removed from service if any skin cracks are detected. Contact Bell Product Support if any skin cracks are found during the inspection.
 - e. If no skin cracks are found, touch-up and refinish the affected area. (BHT-204B-M&O, Section II).
 - f. Carry out main rotor blade preventive maintenance. (BHT-204B-M&O, Section II).
3. Make an entry in the helicopter logbook and historical service records indicating findings and compliance with Part II of this Alert Service Bulletin.
