ALERT SERVICE BULLETIN

204B-17-72
11 January 2017

MODEL AFFECTED: 204B

SUBJECT: MAIN ROTOR BLADE 204-011-250-001, -005, -009, -113 AND -117, INSPECTION OF.

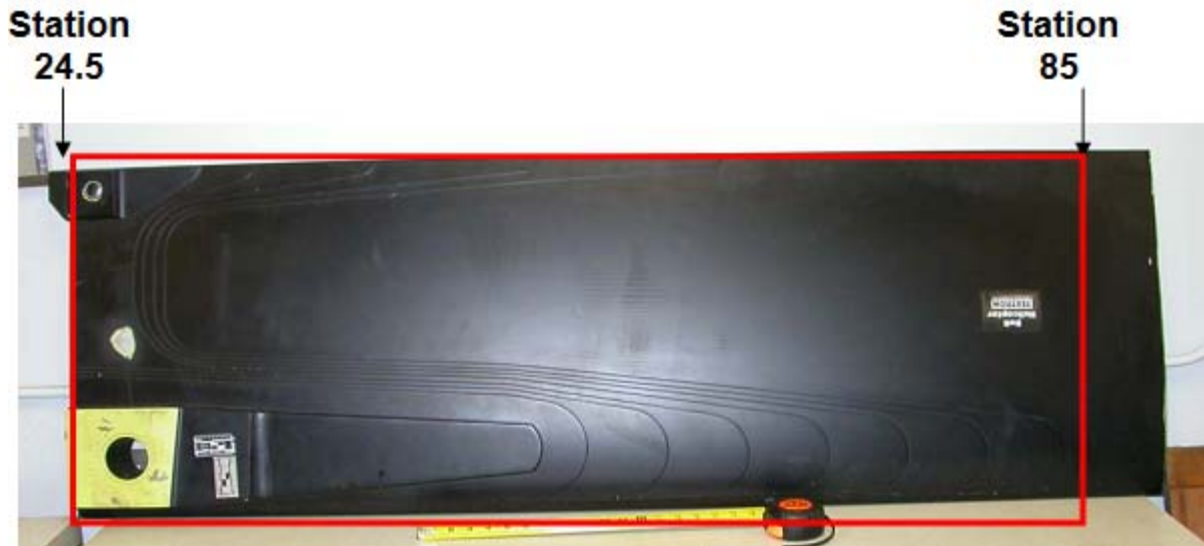
4. Carry out a detailed visual inspection of the top and bottom inspection areas of the blade with a 3X power magnifying glass and a strong light source. Refer to Figure 1. Check for evidence of a dark line between the doublers, grip plates, and skin with excess alcohol bleeding out of possible edge voids. Any cracks in the finish must be investigated further by removing the paint in the affected areas. Sand the affected area in a spanwise direction with an abrasive cloth or paper (C-406) 180 to 220 grit to determine if the grip plate/doublers are cracked or voided. Any crack in the paint finish, which follows the grip plate/doublers outline, may indicate a possible edge void.

Figure 1 - Area to be inspected with 3X Power Magnifying Glass (Upper and Lower Surfaces)

6. If cracks in the grip plate/doublers are found, the affected blade must be immediately removed from service. If no cracks are detected, continue with step 7.
7. If edge voids between the grip plate/doublers/skin are found, determine the depth and length with a 0.0015 inch (0.038 mm) feeler gauge. If edge voids are suspected near the outboard tip of the grip plate/doublers, carry out a tap test of the affected area. Refer to the BHT-204B-M&O, Section 2, Para 2-13 for void repair limits and inspection/repair instructions. If no voids are detected, continue with step 8.
8. Touch-up / refinish the sanded area as per the BHT-204B-M&O, Section 2.
9. Following the inspection, apply a light coat of preservative oil (C-125) to all surfaces of blade.
10. Make an entry in the helicopter logbook and historical service records indicating findings and compliance with this Alert Service Bulletin.

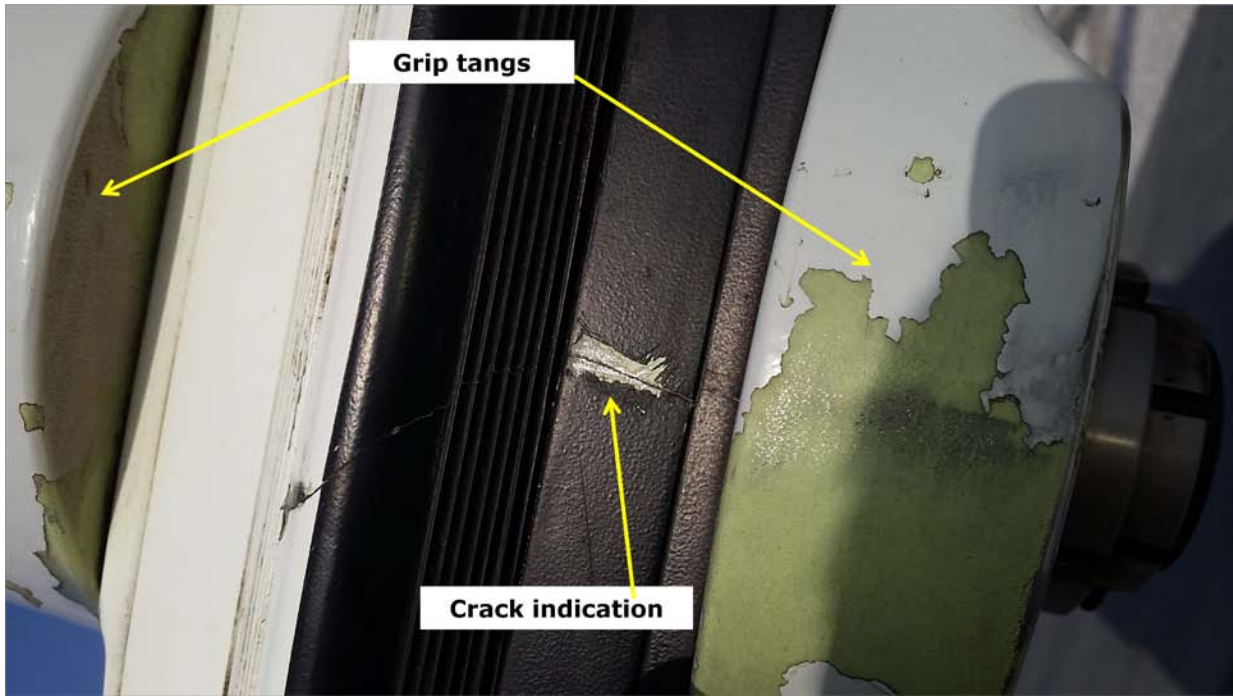
Figure 3 - Crack indication
