ALERT SERVICE BULLETIN

205-17-114
11 January 2017

MODEL AFFECTED: 205A/205A-1

SUBJECT: MAIN ROTOR BLADE 204-011-250-001, -005, -009, -113 AND -117, INSPECTION OF.

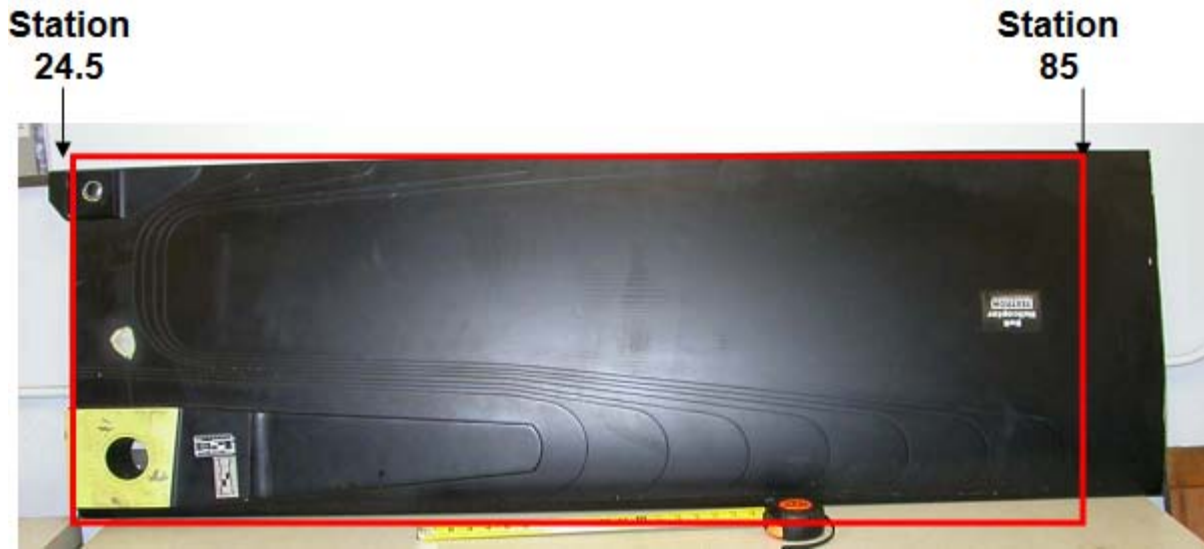
4. Carry out a detailed visual inspection of the top and bottom inspection areas of the blade with a 3X power magnifying glass and a strong light source. Refer to Figure 1. Check for evidence of a dark line between the doublers, grip plates, and skin with excess alcohol bleeding out of possible edge voids. Any cracks in the finish must be investigated further by removing the paint in the affected areas. Sand the affected area in a spanwise direction with an abrasive cloth or paper (C-406) 180 to 220 grit to determine if the grip plate/doublers are cracked or voided. Any crack in the paint finish, which follows the grip plate/doublers outline, may indicate a possible edge void.

Figure 1 - Area to be inspected with 3X Power Magnifying Glass (Upper and Lower Surfaces)

6. If cracks in the grip plate/doublers are found, the affected blade must be immediately removed from service. If no cracks are detected, continue with step 7.
7. If edge voids between the grip plate/doublers/skin are found, determine the depth and length with a 0.0015 inch (0.038 mm) feeler gauge. If edge voids are suspected near the outboard tip of the grip plate/doublers, carry out a tap test of the affected area. Refer to the BHT-205A1-MM, Para 65-25 for void repair limits and inspection/repair instructions. If no voids are detected, continue with step 8.
8. Touch-up / refinish the sanded area as per the BHT-205A1-MM, Para 65-29.
9. Following the inspection, apply a light coat of preservative oil (C-125) to all surfaces of blade.
10. Make an entry in the helicopter logbook and historical service records indicating findings and compliance with this Alert Service Bulletin.

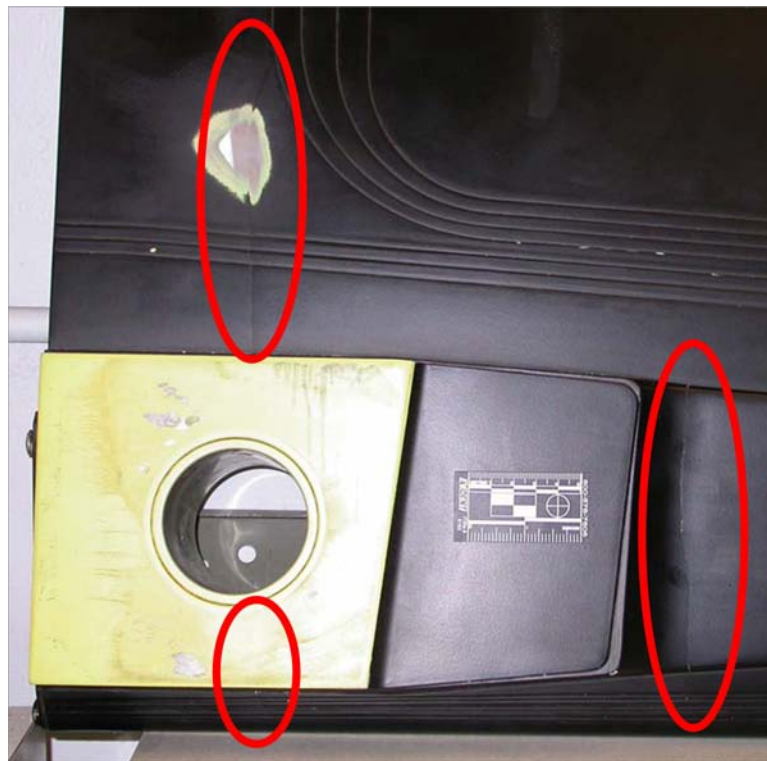
Figure 2 - Crack indications

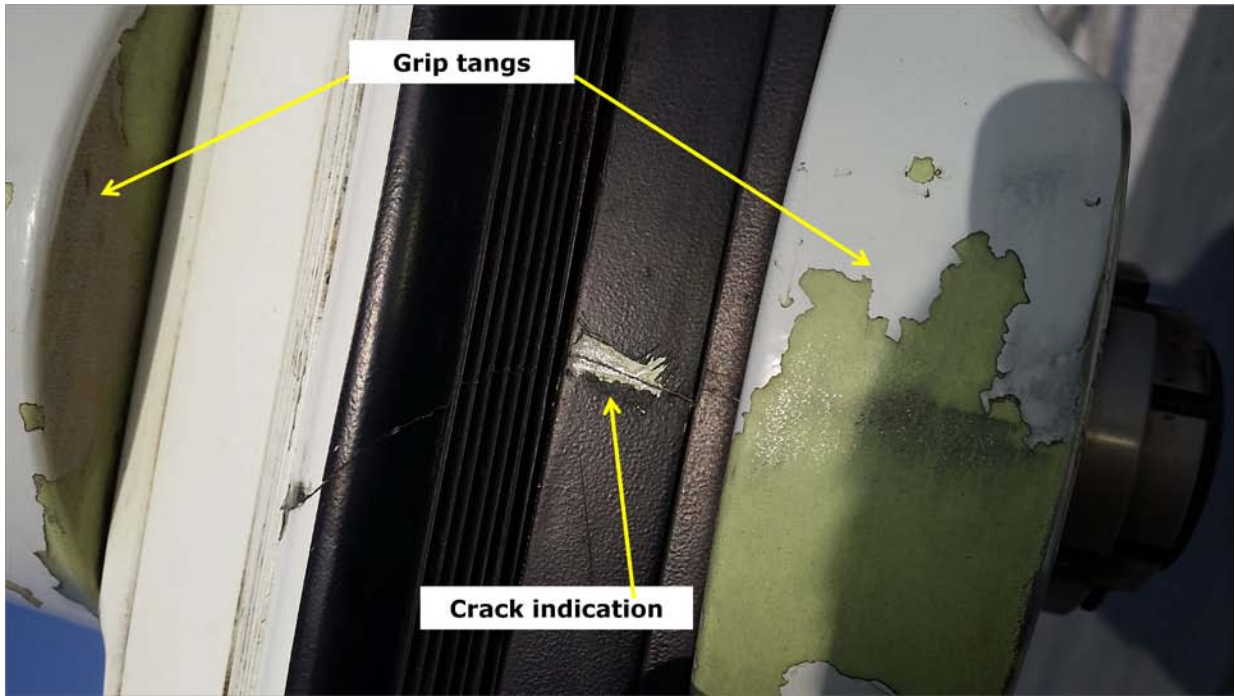
Figure 3 - Crack indication

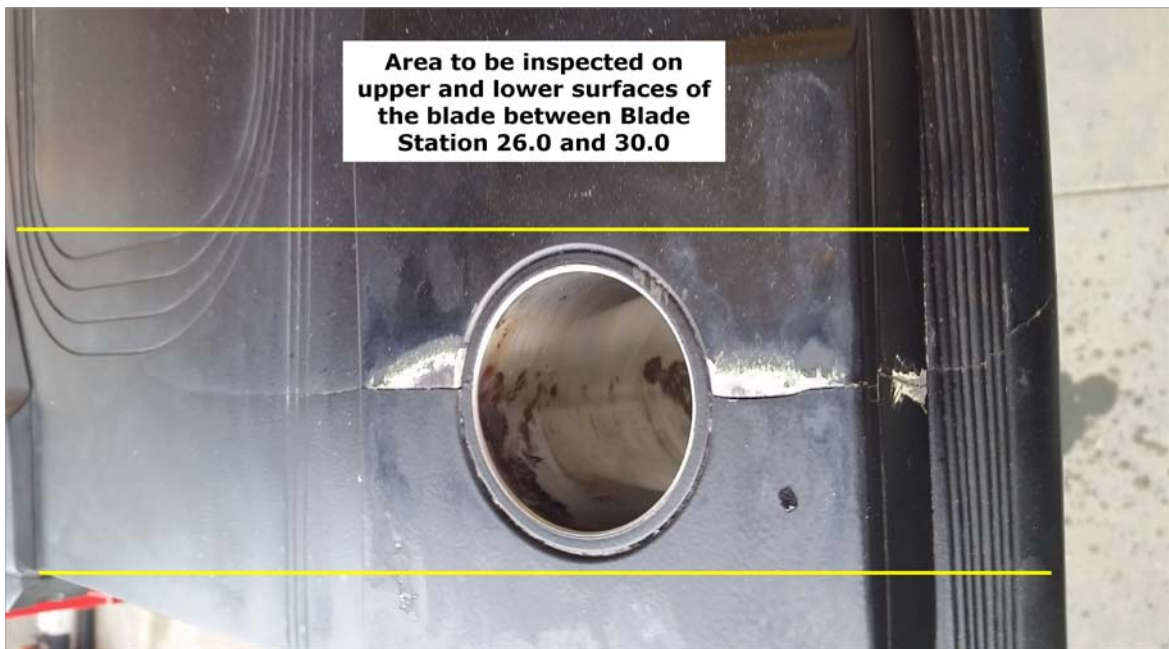
5. Carry out a detailed visual inspection of the top and bottom inspection areas in the blade bolt area with a 10X power magnifying glass and a strong light source (Figure 4). Inspect the leading edge and trailing edge sides of the blade at the blade bolt span station for evidence of cracks or dark lines in the grip plates going across the doublers (Figure 3). Any cracks in the finish must be investigated further by removing paint in the affected areas. Sand the affected area in a spanwise direction using an abrasive cloth or paper (C-406) 180 to 220 grit to determine if the grip plate/doublers are cracked or voided.

Figure 4 - Area to be Inspected with a 10X Power Magnifying Glass (Upper and Lower Surfaces)

Note: It is not required to remove the blade for inspection. The areas under the grip tangs will not be visible.
