## **ALERT SERVICE BULLETIN**

**205-96-67**

**MODEL AFFECTED:** 205A/205A-1

**SUBJECT:** MAIN ROTOR BLADE 204-011-250-001, -005, -009, -113 AND, -117, INTRODUCTION OF DAILY WIPE-DOWN INSPECTION AND SPECIAL 25-HOUR INSPECTION.

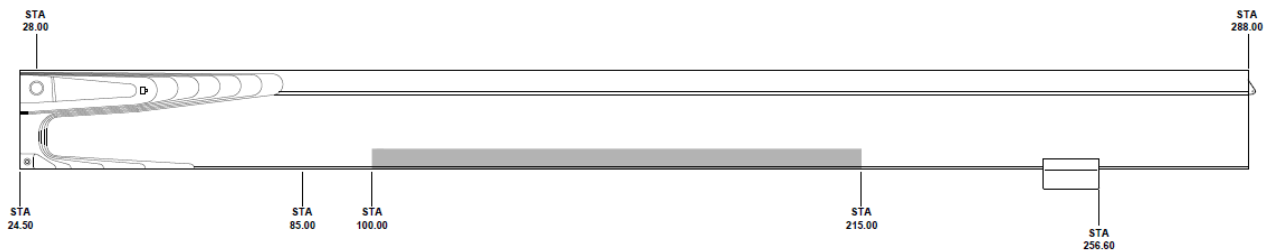
Figure 1 – 204-011-250 Series Main Rotor Blade

1. Prepare the helicopter for maintenance.
2. Inspect the upper and lower skin surfaces of the main rotor blades as follows:
  - a. Wipe the last 4 inches of the trailing edge between blade station 100 and 215 (shaded area) with an alcohol-soaked cloth (C-385) and wipe dry with a clean cloth. (Figure 1)

- b. Using a strong light source at an oblique angle, check for evidence of a dark line. A dark line represents excess alcohol bleeding out of possible cracks or edge voids. (If no defects are found during the inspection, proceed to step 2.f).

- c. Any crack in the surface finish must be investigated further by removing paint in the affected area. Remove paint by hand sanding the affected area in a spanwise direction only, with an abrasive cloth or paper (C-406) 220 grit or smoother to determine if the crack is in the skin. (Any crack in the surface finish may be indicative of a skin crack).
  - d. The main rotor blade must be removed from service if any skin cracks are detected. Contact Bell Product Support if any skin cracks are found during the inspection.
  - e. If no skin cracks are found, touch-up and refinish the affected area. (BHT-205A1-MM, Chapter 65).
  - f. Carry out main rotor blade preventive maintenance. (BHT-205-MM, Para 65-22).
3. Make an entry in the helicopter logbook and historical service records indicating findings and compliance with Part II of this Alert Service Bulletin.
