## **ALERT SERVICE BULLETIN**

**407-23-133**

**MODEL AFFECTED:** 407

**SUBJECT:** HORIZONTAL STABILIZER AND CARGO HOOK  
FITTINGS – SELF LOCKING INSERTS,  
INSPECTION OF

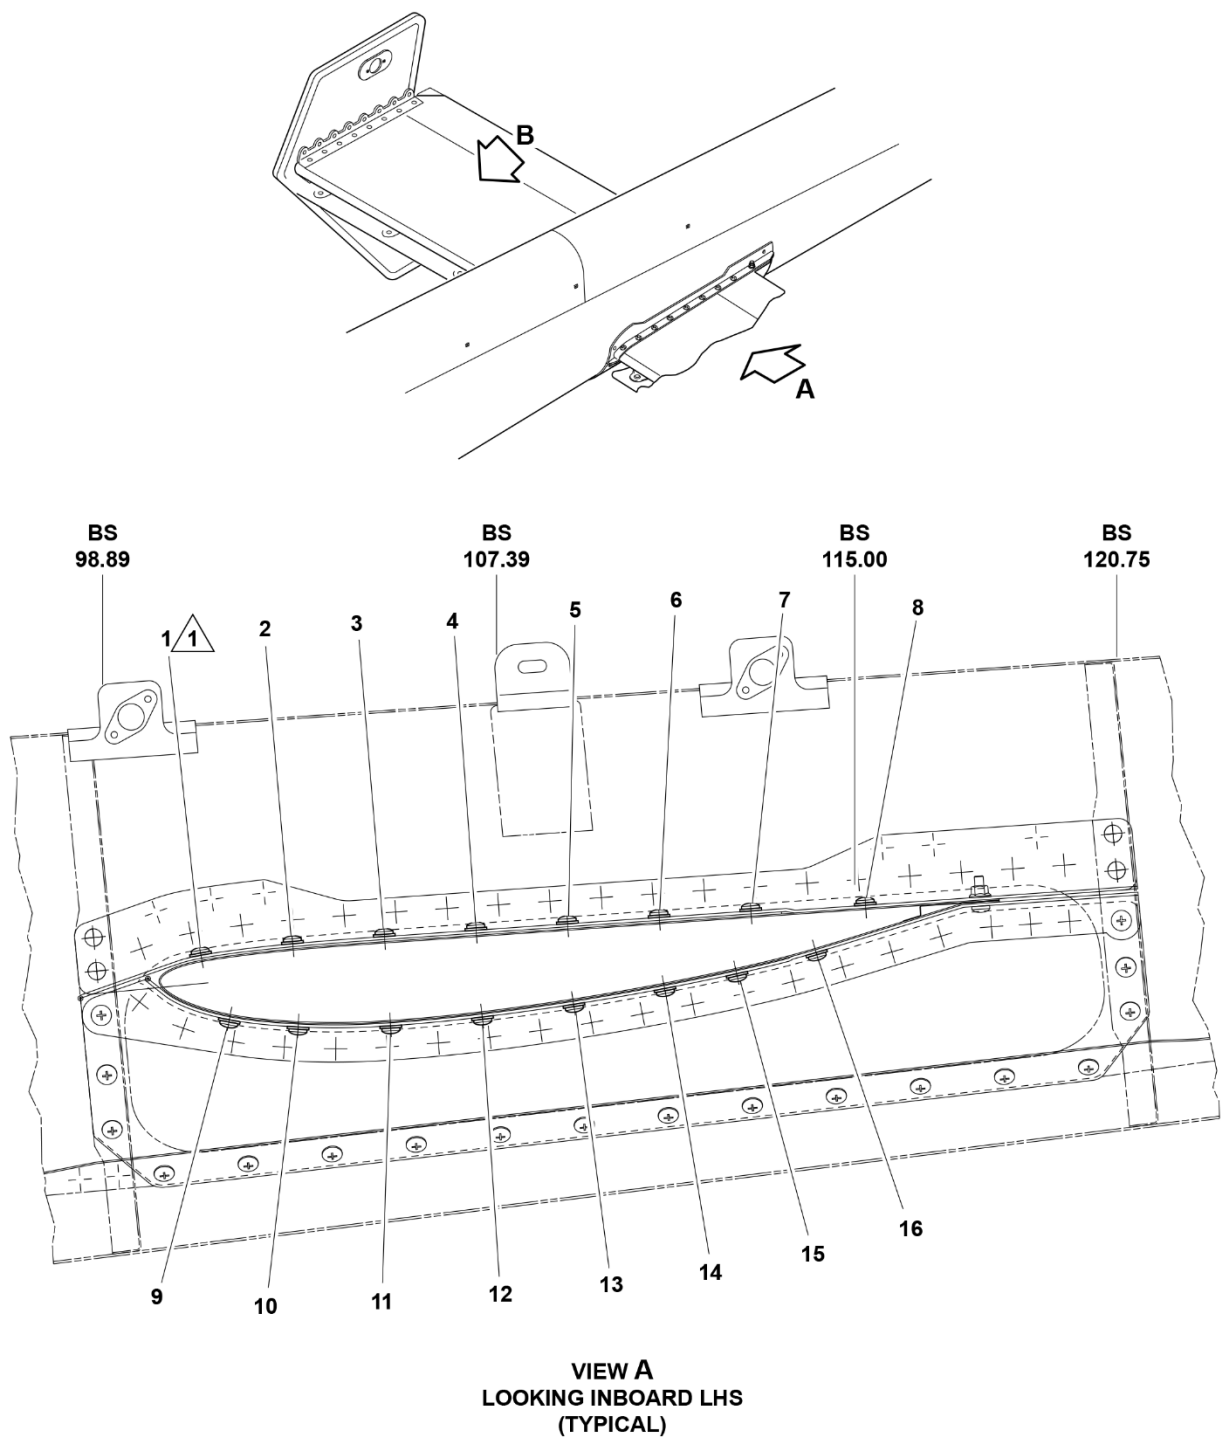
**Figure 1 (Sheet 1 of 2) – Horizontal Stabilizer Inspection**

A gap under the screw head, cracks in the paint around the screw head, loose washer, or black fretting dust could indicate fastener looseness.

- a. Fasteners (Qty 32) attaching the horizontal stabilizer to the tailboom (Figure 1, Sheet 1).
  - b. Fasteners (Qty 16) attaching the slats to the horizontal stabilizer (Figure 1, Sheet 2).

7. If there are no signs of fasteners loosening, proceed to step 10.
  8. If any sign of fastener loosening is detected, perform the following for every suspected insert:

- a. Remove the fastener and measure the tare torque of the insert (BHT-ALL-SPM Chapter 2, Section 2). The minimum tare torque of the inserts shall be 2.0 inch-pounds (0.23 Nm).

- (4) If the tare torque is not sufficient, apply a drop of low strength threadlocker Loctite 080 (C-320) on the threads of the new fastener, install the fastener ([DMC-407-A-53-02-00-00A-720A-A](#) and/or [DMC-407-A-53-02-00-01A-720A-A](#)) and apply a stripe of torque seal lacquer (C-049) on the affected fastener.

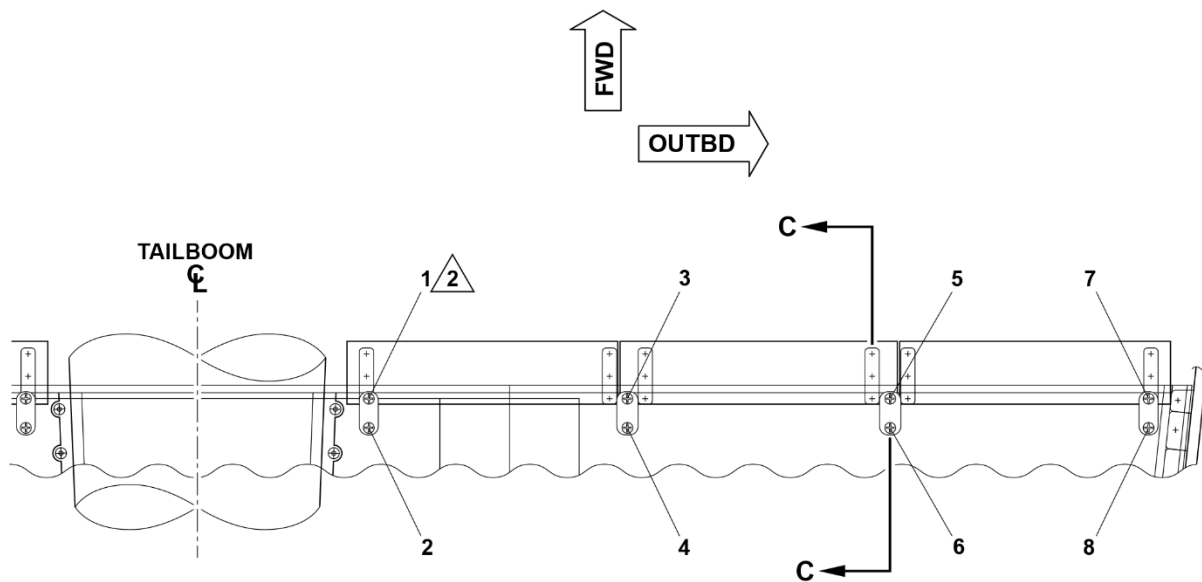
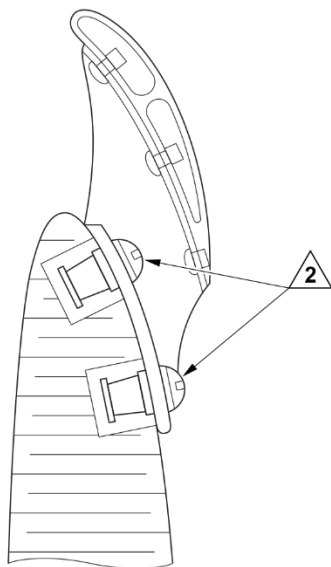
**Figure 1 (Sheet 2 of 2) – Horizontal Stabilizer Inspection**

Inspect at 16 locations on LHS and RHS
-

Inspect at 8 locations on LHS and RHS

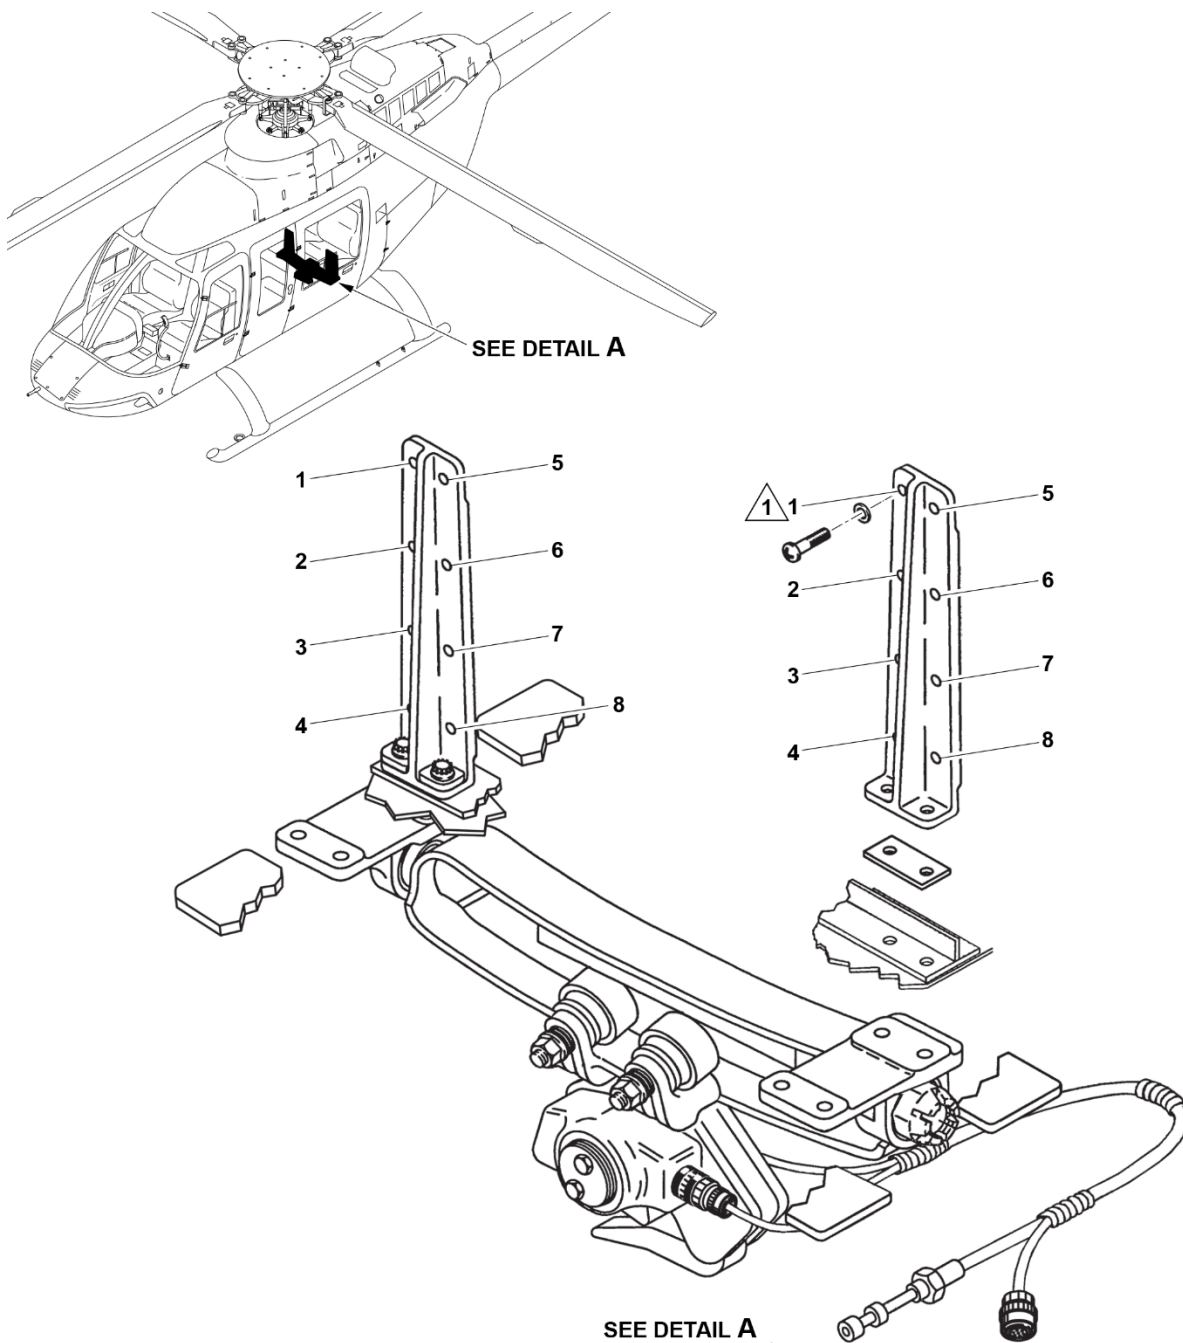
**Figure 2 – Cargo Hook Fittings Inspection**

5. Verify the tare torque on the attaching fasteners (Qty 16) of the cargo hook fittings on the passenger seat bulkhead (Figure 2) as follow. Verify one fastener at a time.
  - a. Measure the tare torque of the insert (BHT-ALL-SPM Chapter 2, Section 2).
  - b. The minimum tare torque of the inserts shall be 2.0 inch-pounds (0.23 Nm).
6. If the tare torque of a specific insert does not meet the minimum value, do the following for each discrepant insert:
  - a. Remove and discard the screw installed in the discrepant insert. Retain washer if it is serviceable.
  - b. Remove and discard a screw installed in a vertically adjacent insert. Retain washer if it is serviceable.

1 Measure tare torque at 8 locations on LHS and RHS fittings.

- c. Install new bolts NAS6603H4 with two washers NAS1149D0316J at the locations where the original screws were discarded.

- d. Torque the bolts to 20 to 25 inch-pounds (2.3-2.8 Nm) plus tare torque.
  - e. Safety the new bolts together using (C-405) safety wire (BHT-ALL-SPM, Chapter 8).
- 7. Torque all other disturbed fasteners to 20 to 25 inch-pounds (2.3 to 2.8 Nm) plus tare torque.
  - 8. If inserts with tare torque below the minimum requirement are found, report the results to Product Support Engineering at [productsupport@bellflight.com](mailto:productsupport@bellflight.com).
  - 9. Make an entry in the helicopter logbook and historical service records indicating compliance with **PART II** of this Alert Service Bulletin.
