## **ALERT SERVICE BULLETIN**

**412CF-24-77**

**MODEL AFFECTED:** 412CF

**SUBJECT:** CAP ANGLE, P/N 212-030-191-001, INSPECTION INTERVAL, REDUCTION OF.

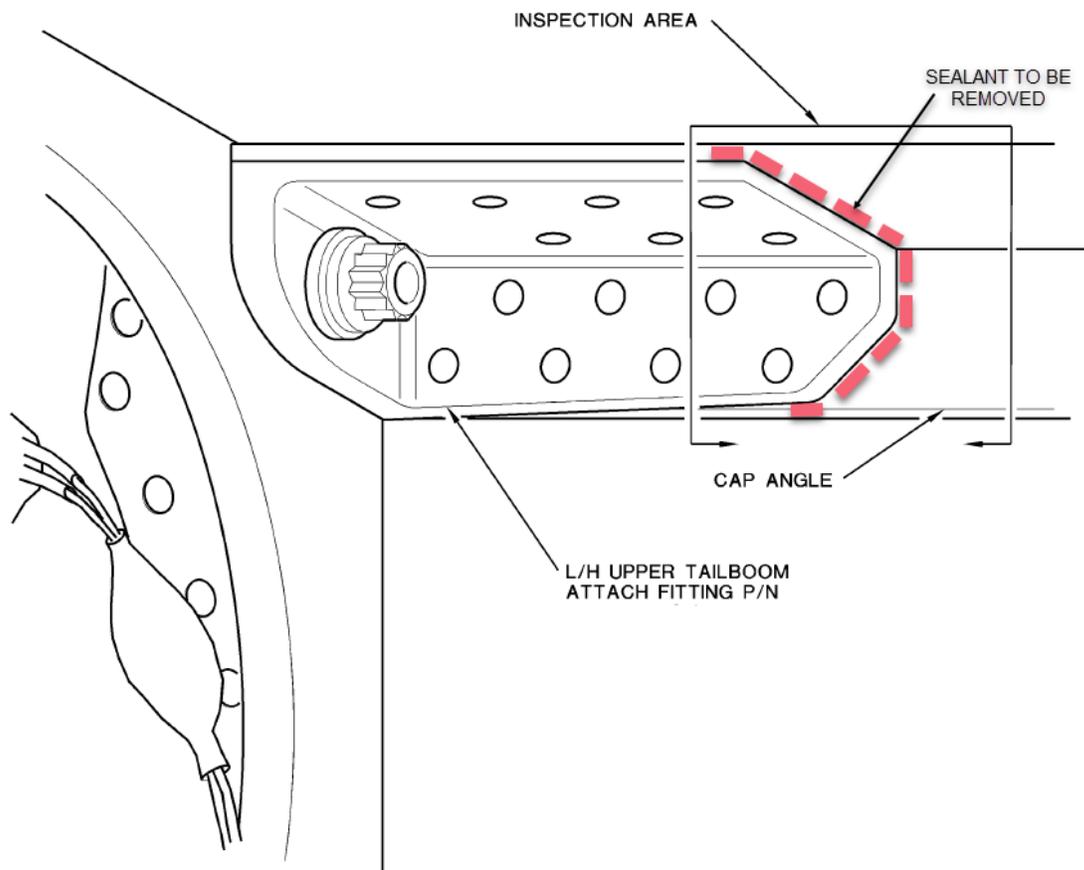
**Figure1. Fuselage Tailboom Attachment Inspection.**

Bell has investigated reports of fractured 212-030-191-001 cap angles. Some were found during routine inspection and some during the scheduled 100 Hour Tailboom Attachment Inspection. The investigation indicates that the 100 flight hour inspection interval established in 2000, introduced by the ASB 412CF-00-11 and the FAA AD 2000-18-09, is not adequate to detect all cracks before complete fracture of the cap angle. This ASB reduces the 100 Hours tailboom attachment inspection interval from 100 flight hours to 25 flight hours and supersedes ASB 412CF-00-11. The Maintenance Manual Chapter 5 will be revised to incorporate this change.

2. If sealant is present, remove sealant from edge of fitting (Figure 1).
3. Inspect the cap angle area shown with a 10x magnifying glass and bright light.
4. If a crack is found, replace the cap angle before further flight. If the helicopter is at a location where the cap angle cannot be replaced, contact Product Support Engineering.
5. Touch up primer if damaged during sealant removal. Paint touch up is optional. Do not reapply sealant.
6. If no cracks are found, the helicopter can be returned to service.
7. Make an entry in the helicopter logbook and historical service records indicating findings and compliance with this Alert Service Bulletin.
