ALERT SERVICE BULLETIN

205B-24-77

MODEL AFFECTED: 205B

SUBJECT: INSPECTION OF CAP ANGLE, P/N 205-030-207-005, INTRODUCTION, OF.

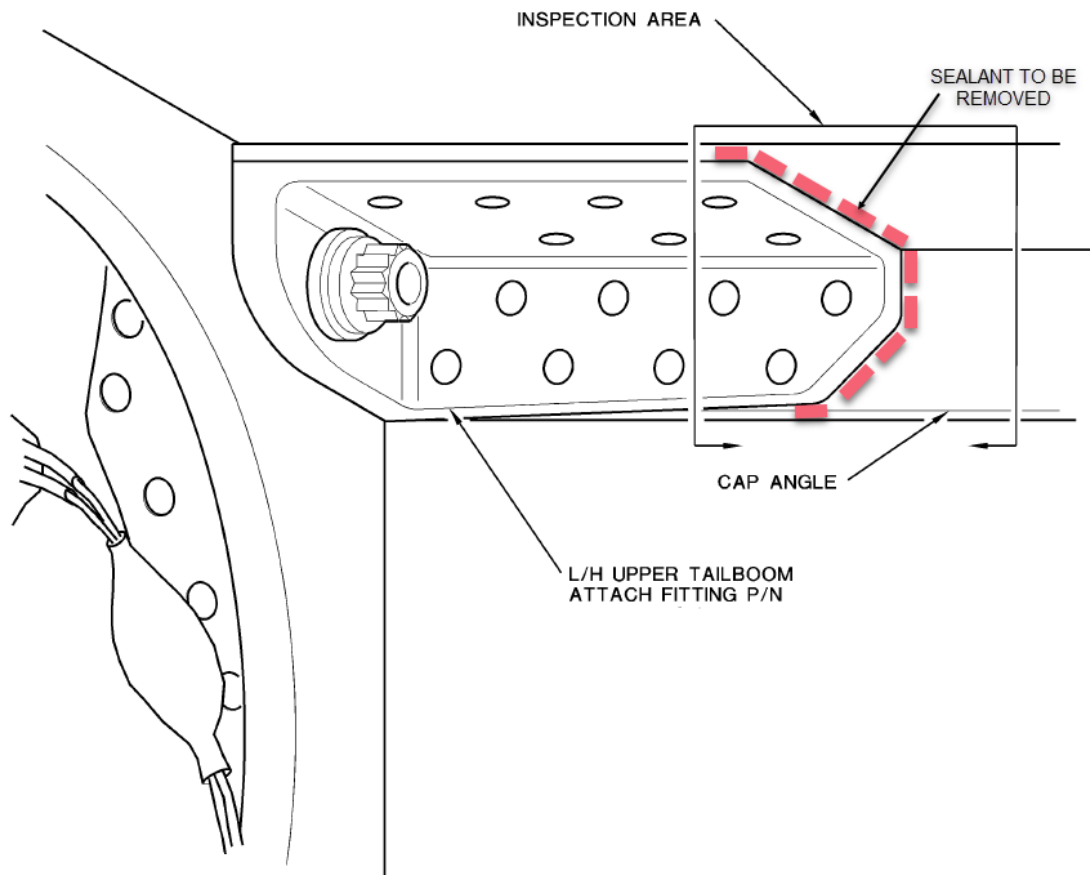
Figure1. Fuselage Tailboom Attachment Inspection.

Bell has investigated reports of fractured 212-030-191-001 cap angles. Some were found during routine inspection and some during the scheduled 100 Hours Tailboom Attachment Inspection. The investigation indicates that the model 412/412EP 100 flight hour Special Inspection interval established in 2000, introduced by the ASB 412-00-100 and the FAA AD 2000-18-09, is not adequate to detect all cracks before complete fracture of the cap angle. Back in 2000, no ASB was released to mandate the tailboom attachment Special Inspection on the Model 205B. Since the risk of cracking/fracture exists on the 205-030-207-005 cap angle used on the model 205B, this ASB introduces a recurring 25 flight hours tailboom attachment inspection. The Maintenance Manual Chapter 5 Special Inspections section will be revised to include this 25 Hours Tailboom Attachment Inspection.

2. If sealant is present, remove sealant from edge of fitting (Figure 1).
3. Inspect the cap angle area shown with a 10x magnifying glass and bright light.
4. If a crack is found, replace the cap angle before further flight. If the helicopter is at a location where the cap angle cannot be replaced, contact Product Support Engineering.
5. Touch up primer if damaged during sealant removal. Paint touch up is optional. Do not reapply sealant.
6. If no cracks are found, the helicopter can be returned to service.
7. Make an entry in the helicopter logbook and historical service records indicating findings and compliance with this Alert Service Bulletin.
