ALERT SERVICE BULLETIN

212-18-159
13 September 2018

MODEL AFFECTED: 212

SUBJECT: FUEL FITTING P/N 50-040-1 AND 50-040-3, VERIFICATION OF.

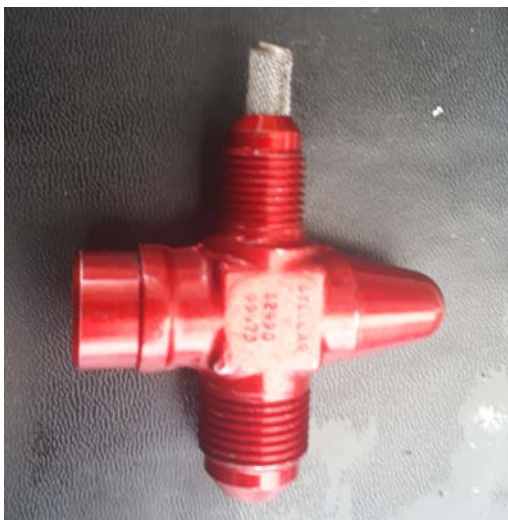
Due to an error that occurred in BHT-212-IPB Revision 9 (30 Mar 2012), an operator inadvertently installed fuel fitting P/N 50-040-1 with screen. BHT-212-IPB Figures 28-4 and 28-5 should have shown the (blue) fitting P/N 50-040-3 (without screen) as the replacement for the fitting S2490.

**50-040-1
(with screen)**

9. If the (red) fuel fitting has a screen, remove it and re-install fuel fitting and fuel sump assembly. (BHT-212-MM, Para 28-33, Figure 28-7)
10. Make an entry in the helicopter logbook and historical service records indicating compliance with this Alert Service Bulletin.

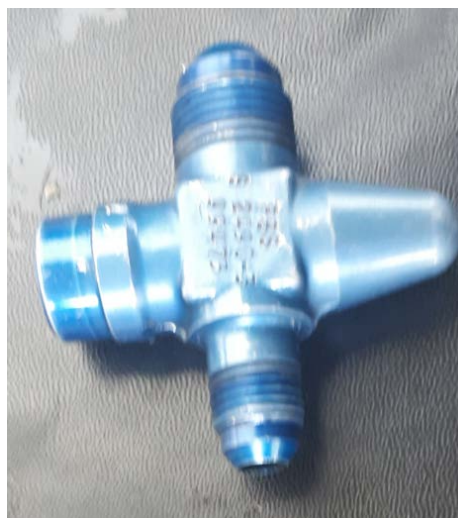
**50-040-3
(without screen)**

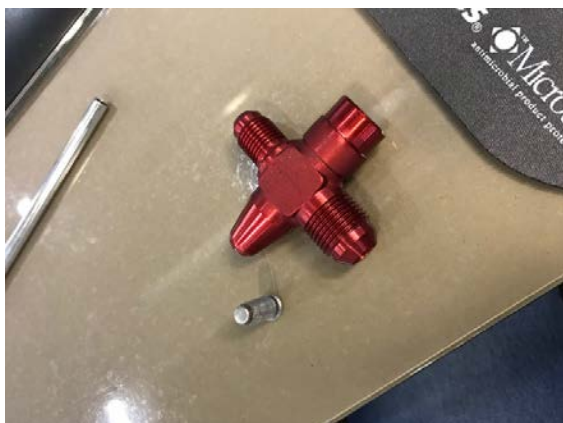
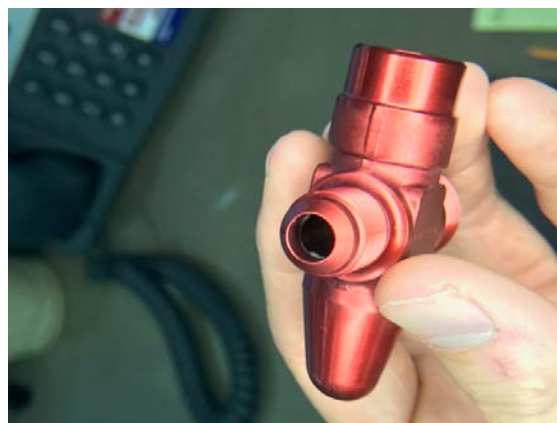
Figure 1

Fuel Fitting P/N S2490 is identical to 50-040-1. The screen in S2490 or 50-040-1 pump outlet is to be removed prior to installing Fuel Fitting on pump.

**S2490 or 50-040-1
Fuel Fitting with
Screen Removed**
