ALERT SERVICE BULLETIN

222-17-114
3 March 2017

MODEL AFFECTED: 222/222B

SUBJECT: **MAGNETIC BRAKE ASSEMBLY 204-001-376-105 AND 204-001-376-107, INSPECTION AND REPAIR OF.**

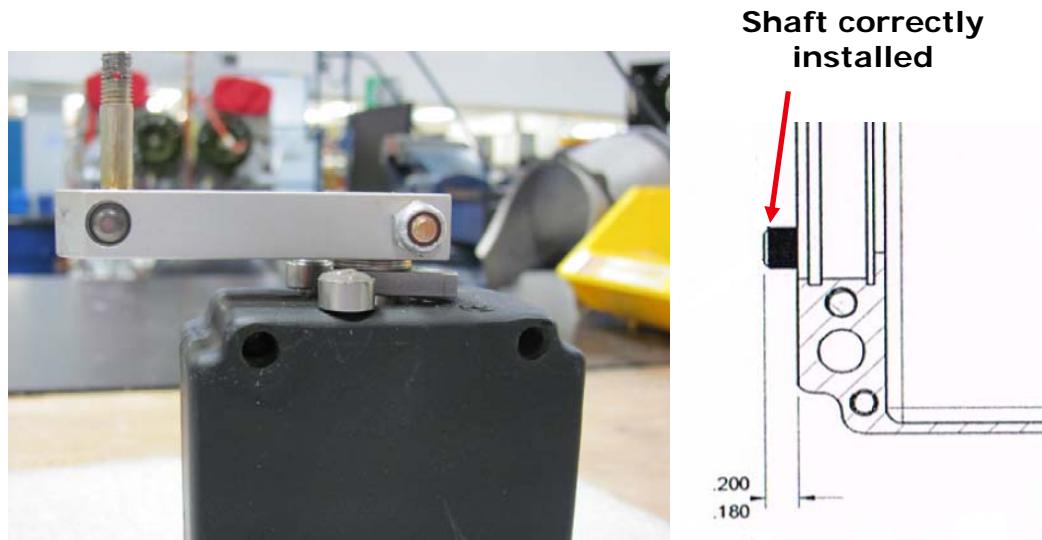
Figure 2. Magnetic brake assembly with stops properly installed.

8. The shaft should protrude from the housing surface between 0.180 inch (4.57 mm) and 0.200 inch (5.08 mm). (Figure 2).
9. Allow sufficient time for the adhesive to cure 24 hours at 70 to 95°F (21° to 35°C) and return the magnetic brake assembly to service. Verify/adjust stop limits to achieve the arm assembly shaft travel. (Figure 5).

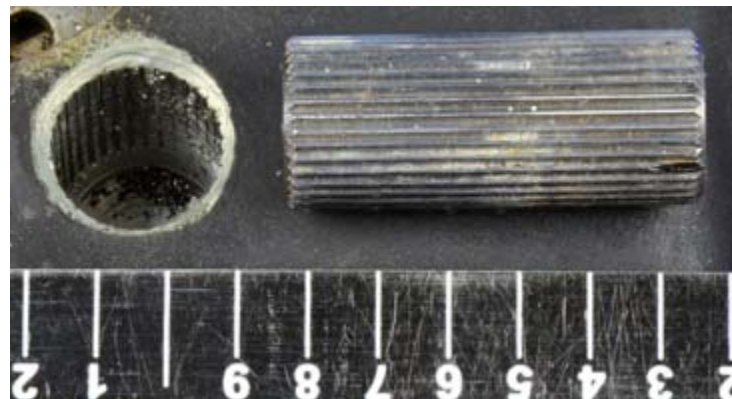
Figure 4. Shaft removed from housing.

5. Thoroughly clean adhesive residue from the shaft and the housing bore (BHT-ALL-SPM). If the splined stop requires removal from the shaft, index mark the stop, the shaft and the housing to ensure installation at the same location. If the screw is removed from the shaft, reinstall with Loctite (C-320) and torque to 5 to 10 inch-pounds (0.56 to 1.13 Newton-meters).

6. Apply adhesive (C-317) to the mating surfaces of the housing and the shaft.
7. Install the stop assembly in the housing bore and remove excess of adhesive.
