ALERT SERVICE BULLETIN

429-16-29

MODEL AFFECTED: 429

SUBJECT: FWD CENTER FIREWALL WELDED ASSEMBLY 429-069-501-101/-109/-113 AND AFT CENTER FIREWALL WELDED ASSEMBLY 429-069-504-101/-103/-105/-107, INSPECTION AND REPAIR OF

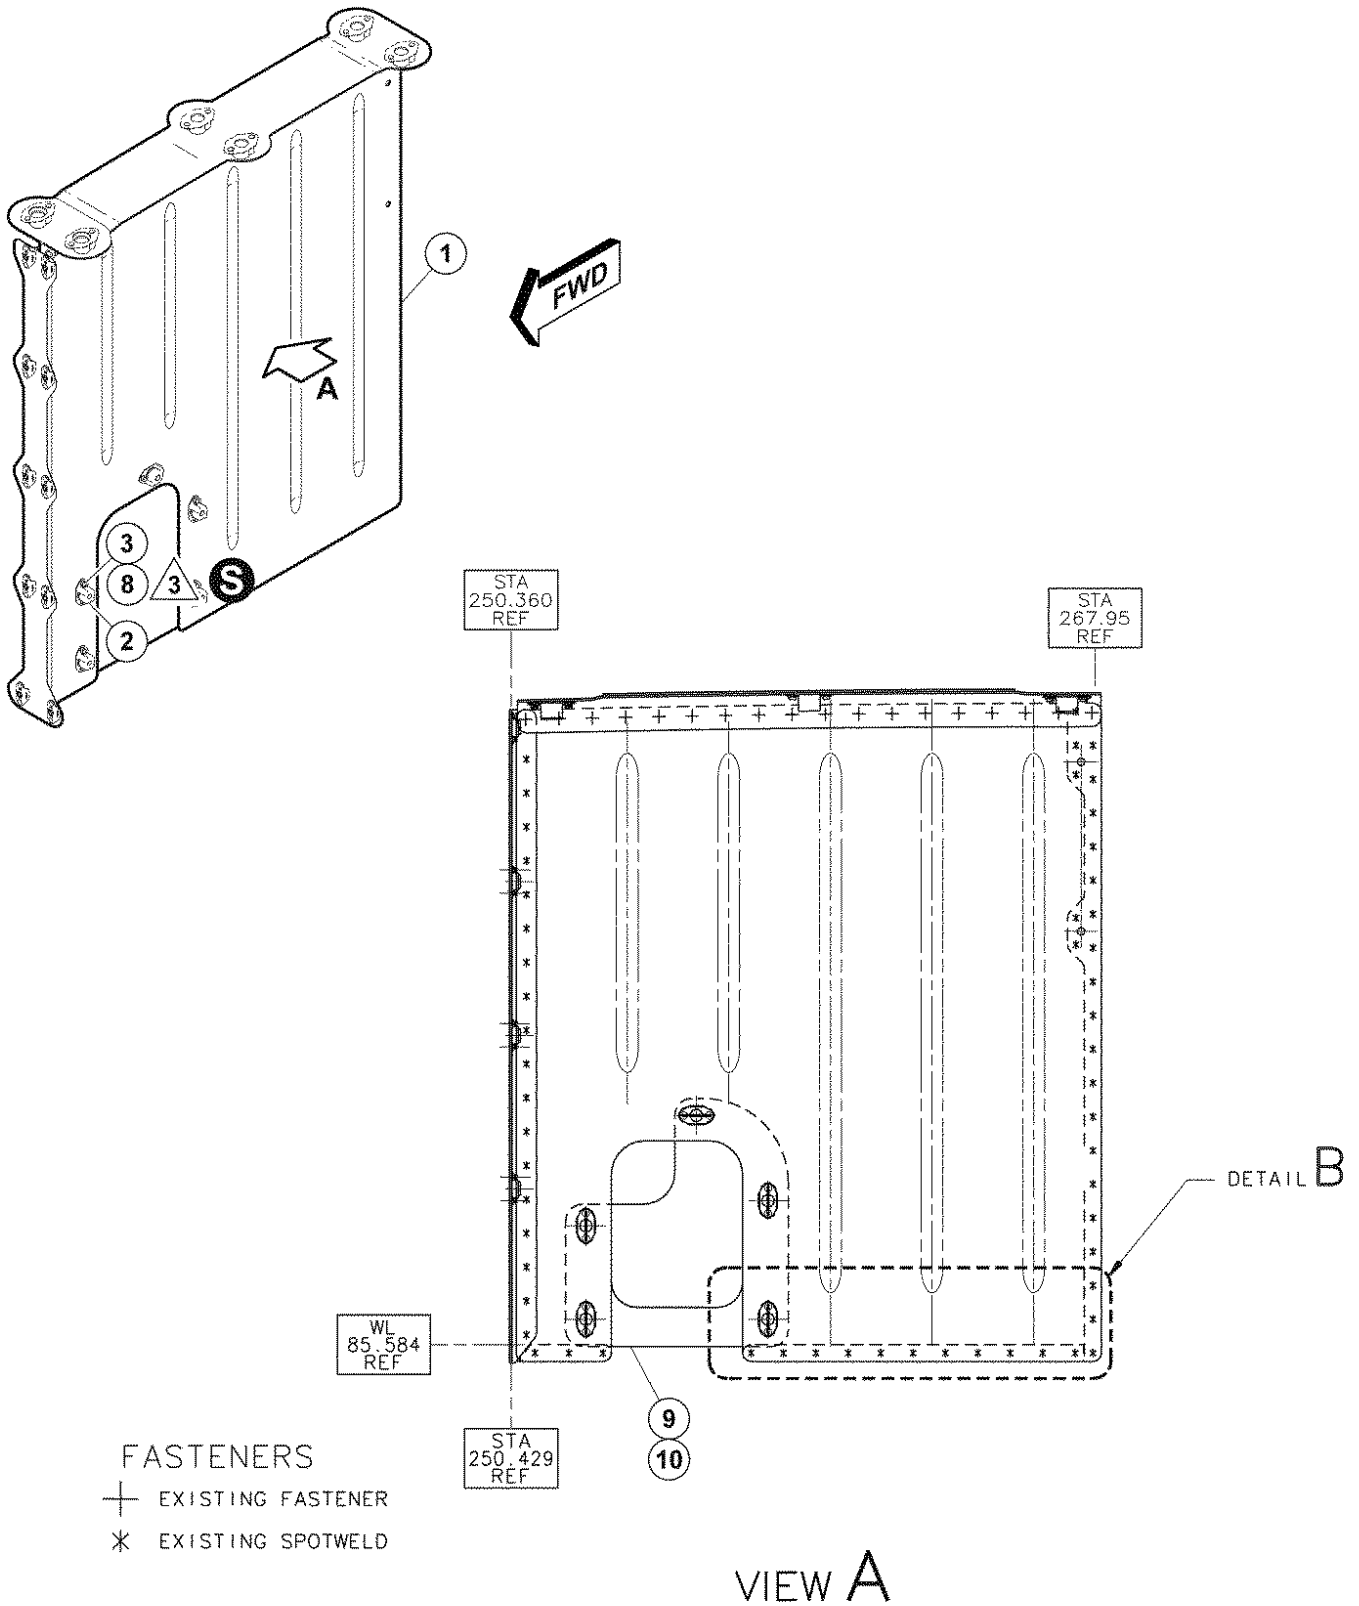
Figure 2 – Part II - A (Sheet 1 of 5)

- b. If cracks are detected on the FWD center firewall welded assembly 429-069-501-101/-109, comply with **Part II - A** (Figure 2), if not previously accomplished.
 - (1) If **Part II - A** has previously been accomplished, or a Bell Helicopter approved structural repair has previously been accomplished, remove and replace the cracked FWD center firewall.
- c. If cracks are detected on the FWD center firewall welded assembly 429-069-501-113, comply with **Part II - B** (Figure 3), if not previously accomplished.
 - (1) If **Part II - B** has previously been accomplished, or a Bell Helicopter approved structural repair has previously been accomplished, remove and replace the cracked FWD center firewall.

1. Remove the FWD center firewall welded assembly (1) from the helicopter (Figure 2) ([DMC-429-A-71-30-00-03A-520A-A](#)).
2. Remove and retain the receptacles (2) from the FWD center firewall welded assembly (1). Discard and replace if any are damaged.

3. Cut out and remove the damaged portion of the FWD center firewall welded assembly (1) and doublers. Cutout to be as per dimensions shown in Detail B.

4. Inspect the exposed areas of the FWD center firewall welded assembly (1) and the surrounding structure for corrosion, cracks, chafing, or damage. Make sure the spot welds adjacent to the cutline are intact (Detail B). If any such damage exists, submit to PSE with details describing the extent of the damage.

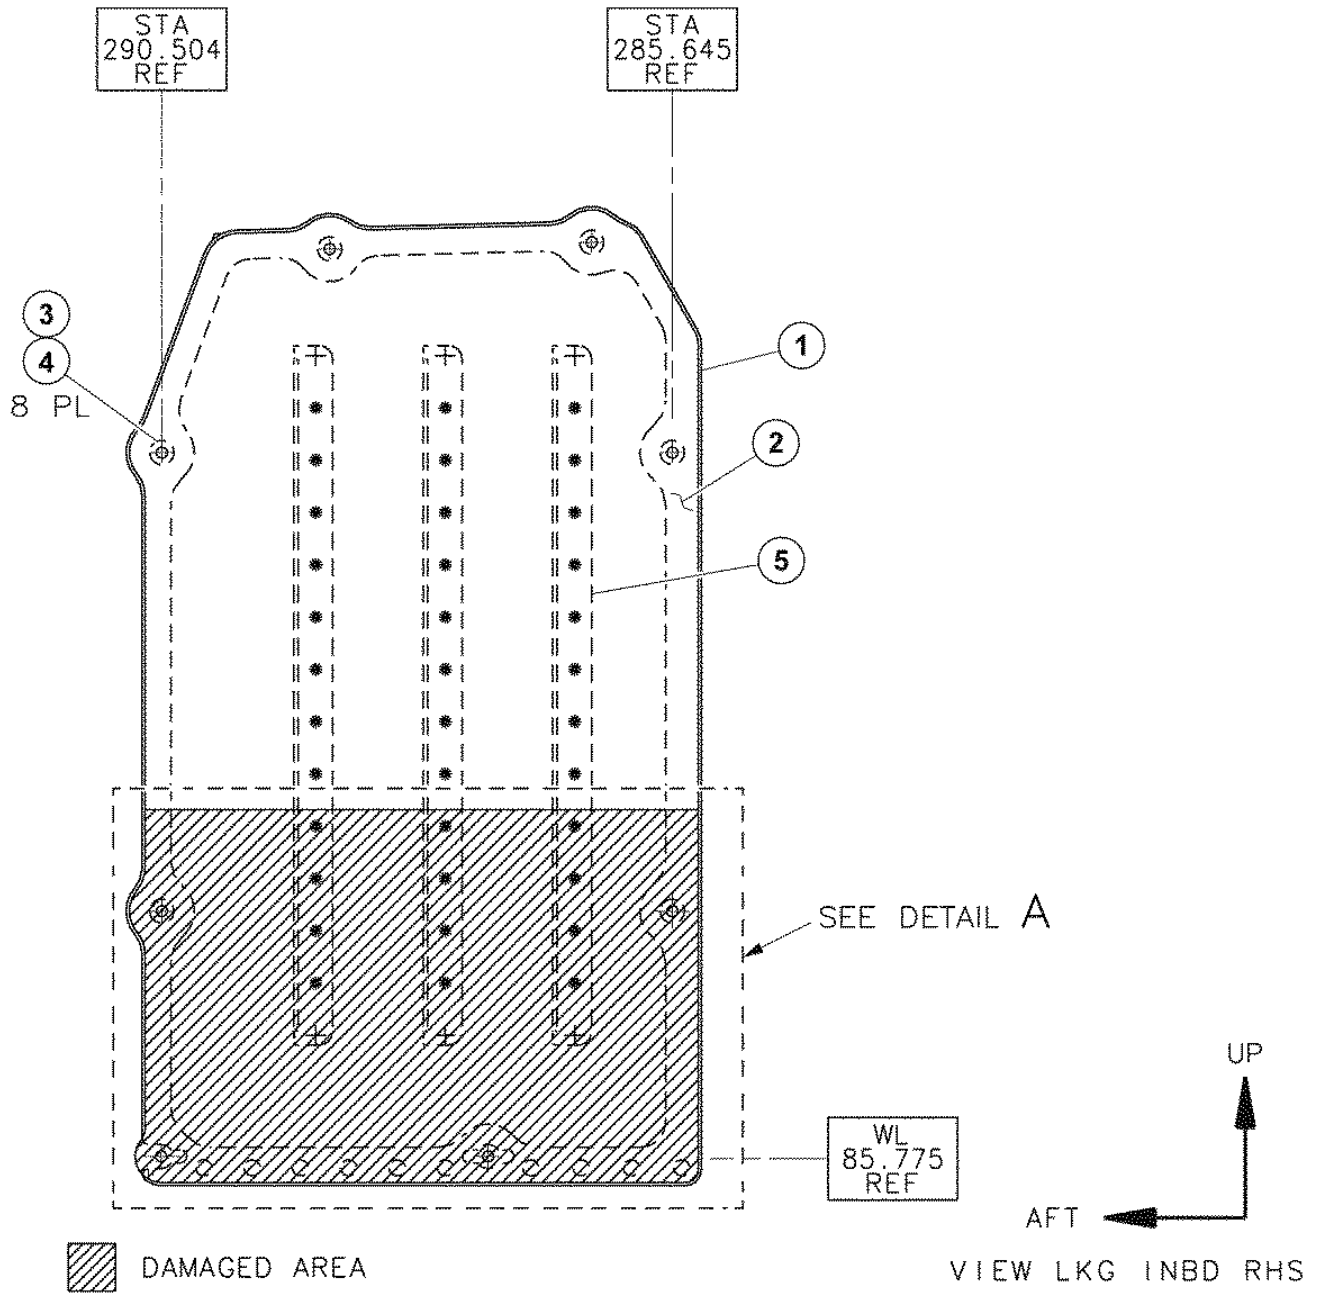
Figure 4 – Part II - C (Sheet 1 of 5)

- e. If cracks are detected on the AFT center firewall welded assembly 429-069-504-105, comply with **Part II - C** (Figure 4), if not previously accomplished.

Do not remove more material than required. Only remove the damaged portion of the web while respecting the dimensions shown in Detail A.

5. Cut out and remove the damaged portion of the AFT center firewall welded assembly (1). Cutout to be as per the dimensions shown in Detail A.
6. Inspect the exposed area of the AFT center firewall welded assembly (1) and the surrounding structure for corrosion, chafing, cracks, or damage. Make sure the spot welds adjacent to the cutlines are intact (Detail A). If any such damage exists, submit to PSE with details describing the extent of the damage.

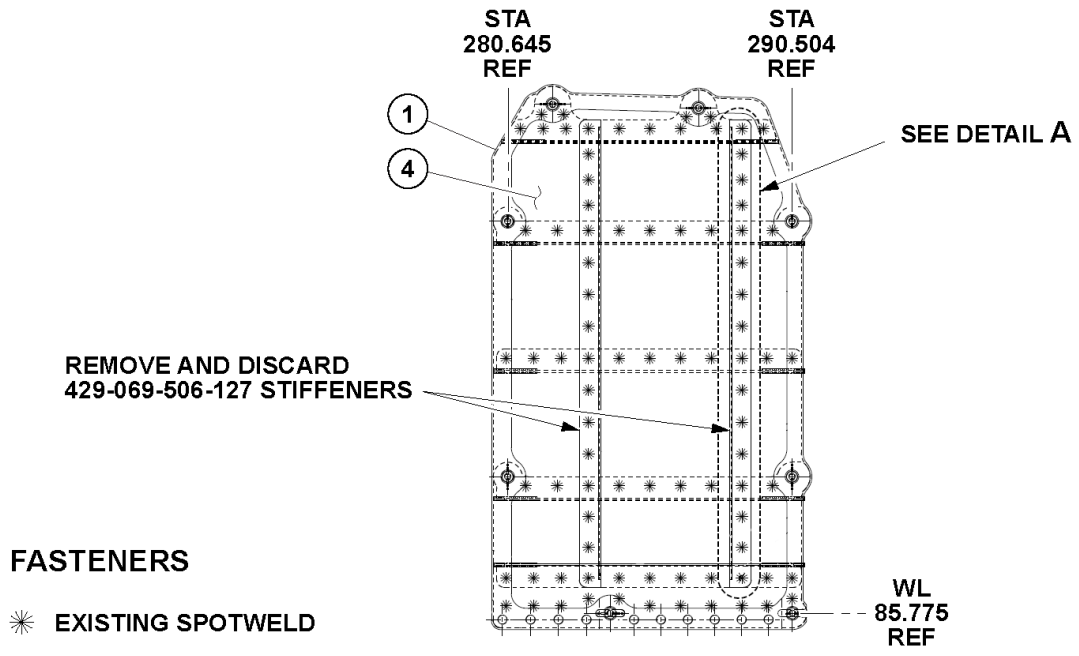
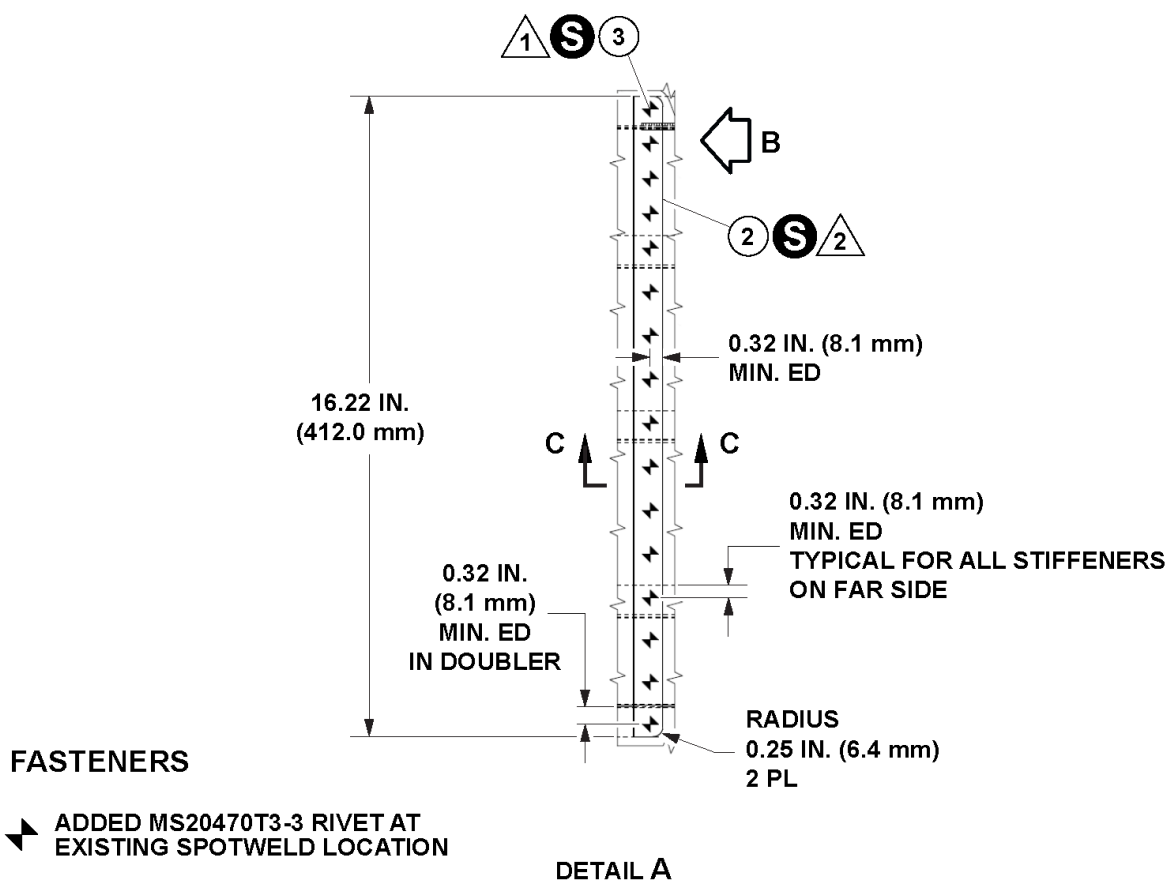
Figure 5 – Part II - D (Sheet 1 of 2)

Revision B of this bulletin addresses the 429-069-501-147 FWD Center Firewall and the 429-069-504-107 AFT Center Firewall which were introduced at helicopter serial numbers 57340 and subsequent. While the 429-069-501-147 FWD Center Firewall has proven to be reliable, the 429-069-504-107 Aft Center Firewall continues to see cracking at the extremities of the vertical stiffeners.

- f. If cracks are detected on the AFT center firewall welded assembly 429-069-504-107, comply with **Part II - D** (Figure 5).
5. Reinstall the transmission cowl assemblies 600EL and 600ER ([DMC-429-A-53-00-00-44A-720A-A](#)) and the aft engine cowl assemblies ([DMC-429-A-53-00-00-47A-720A-A](#)).

When removing the stiffeners (2), be careful not to damage the web (4). Drill through the spotwelds using a #40 drill bit to detach the stiffeners from the web and doubler. It may be necessary to carefully grind what remains of the spotwelds on the stiffeners (2) after drilling to successfully remove them.

3. Inspect the exposed areas of the welded assembly (1) for corrosion, cracks, or damage. If the welded assembly (1) is damaged, submit a structural repair request to productsupport@bellflight.com ([IL GEN-22-154](#)).
4. Fabricate two stiffeners (2) as shown in Detail A, View B and Section C-C, using repair material 150-021-35C1-2. Make sure to maintain a 0.06 inch (1.52 mm) minimum bend radius.
5. Position the two stiffeners (2) on the welded assembly (1). Locate and drill holes using the drilled-out spotweld holes in the welded assembly. Maintain proper edge distance and spacing. Refer to [Table 3-28 of ALL-SRM](#) for the appropriate fastener hole size.

7. Locate and secure the stiffeners (2) using fasteners (3), as shown in Detail A.
8. Seal all edges of both stiffeners (2) on the AFT firewall welded assembly (1) with firewall sealant (C-353). Make sure the AFT center firewall welded assembly (1) and the web (4) are sealed and that the rivet heads and the shop heads are overcoated with firewall sealant (Detail A).
9. Install the repaired Aft center firewall welded assembly (1) on the helicopter ([DMC-429-A-71-30-00-03A-720A-A](#)).
10. Make an entry in the helicopter logbook and historical service records indicating compliance with **Part II – D** of this ASB.

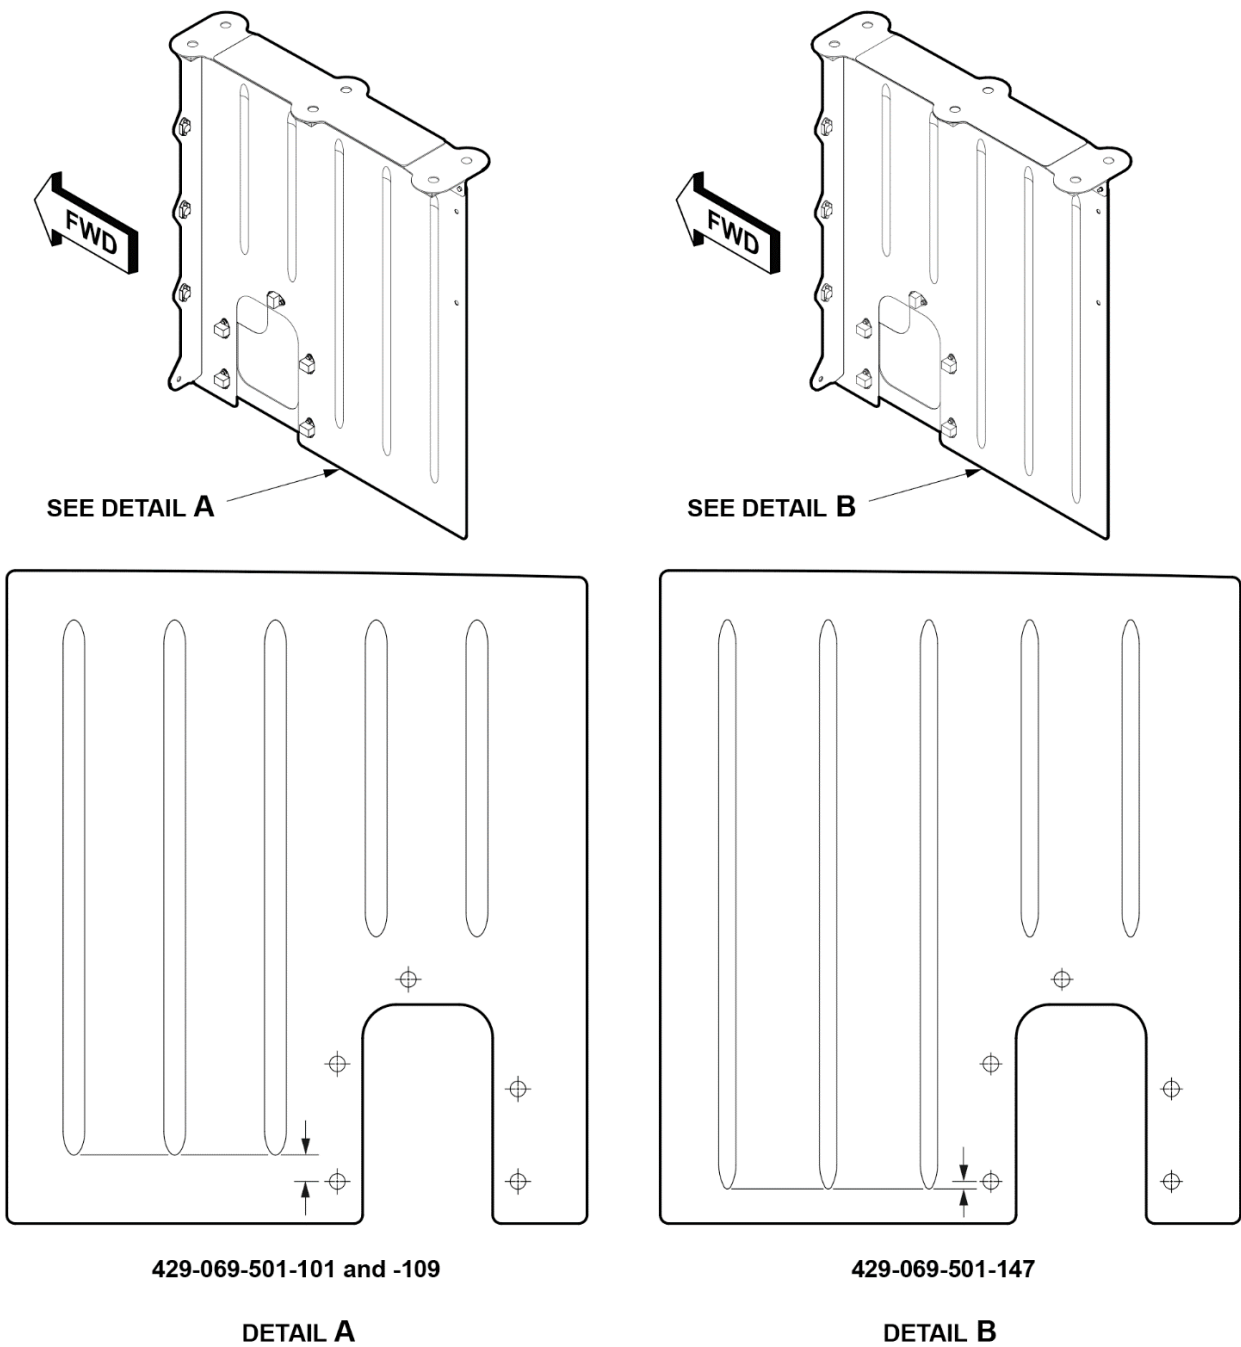
Figure 6 – FWD Center Firewall Part Number Identification

1. The 429-069-501-147 FWD Center Firewall can be differentiated from the 429-069-501-101 and -109 by the length of the beads as shown above.
2. The 429-069-501-113 FWD Center Firewall has stiffeners instead of beads.
