ALERT SERVICE BULLETIN

505-22-29

MODEL AFFECTED: 505

SUBJECT: ENGINE FUEL DRAIN TUBE AND COMPRESSOR WASH TUBE CLAMPING, INTRODUCTION OF.

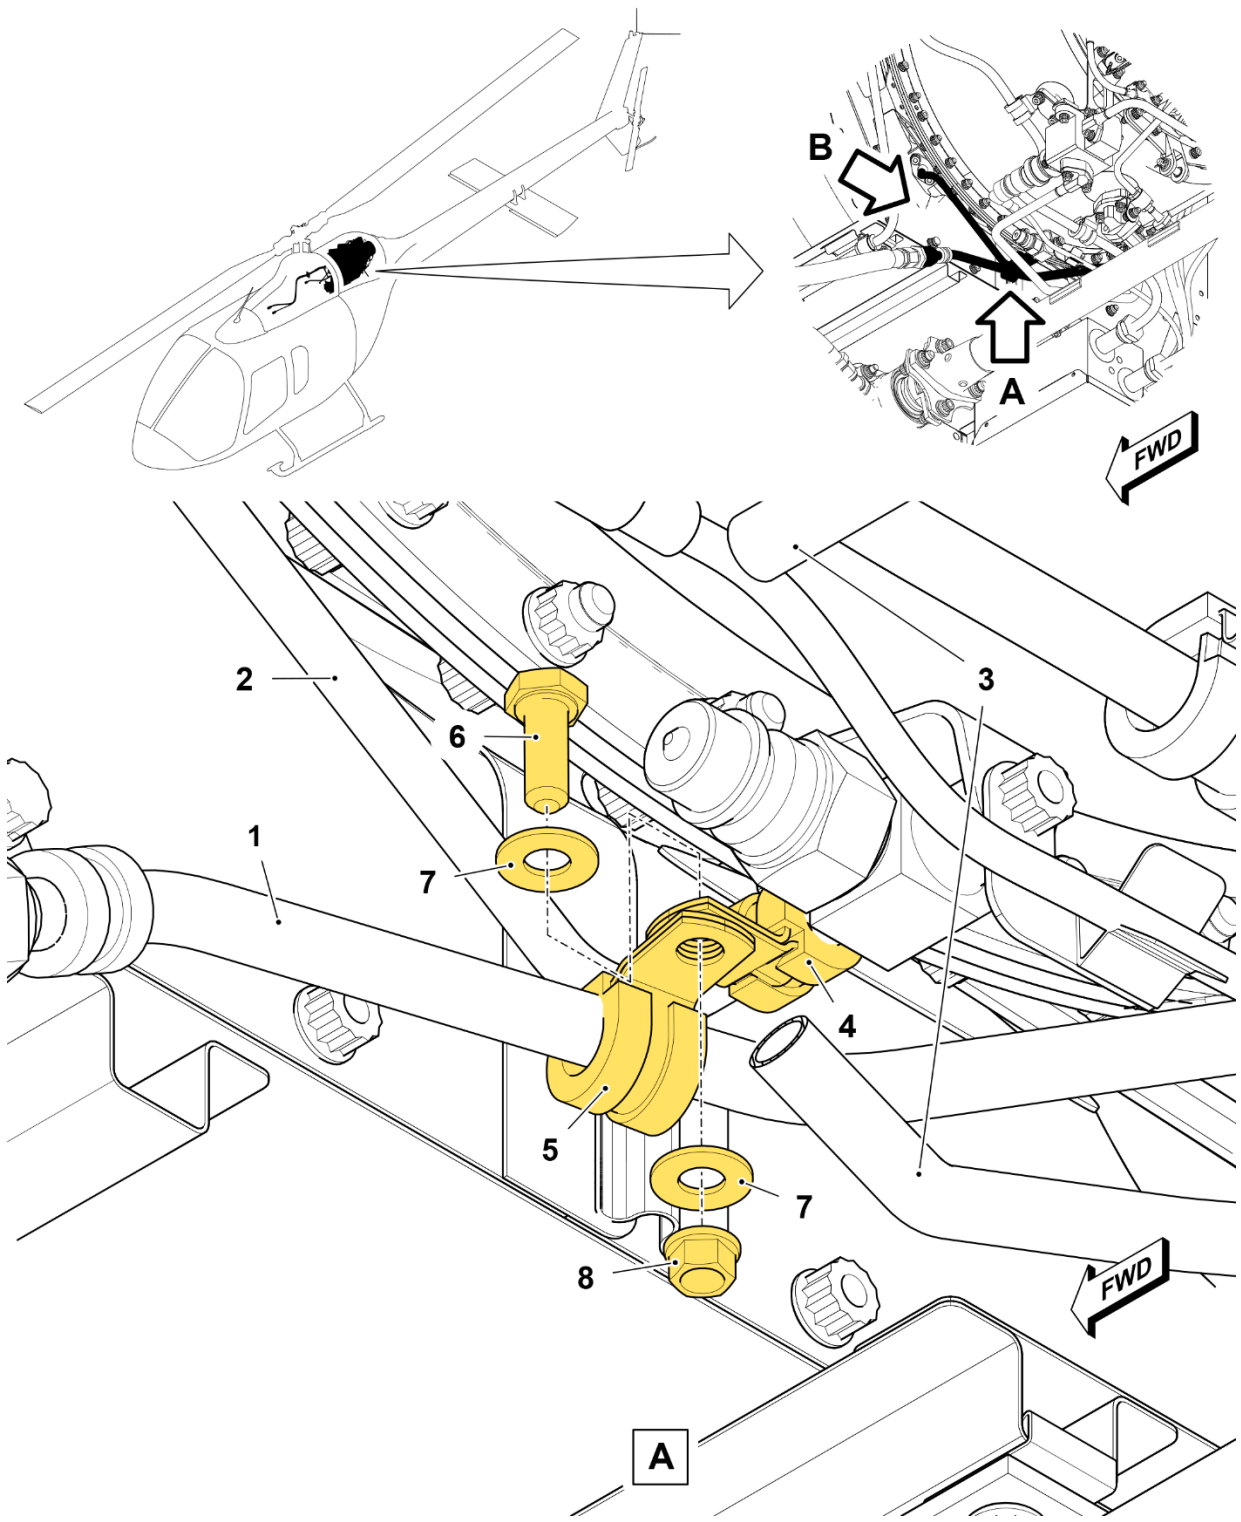
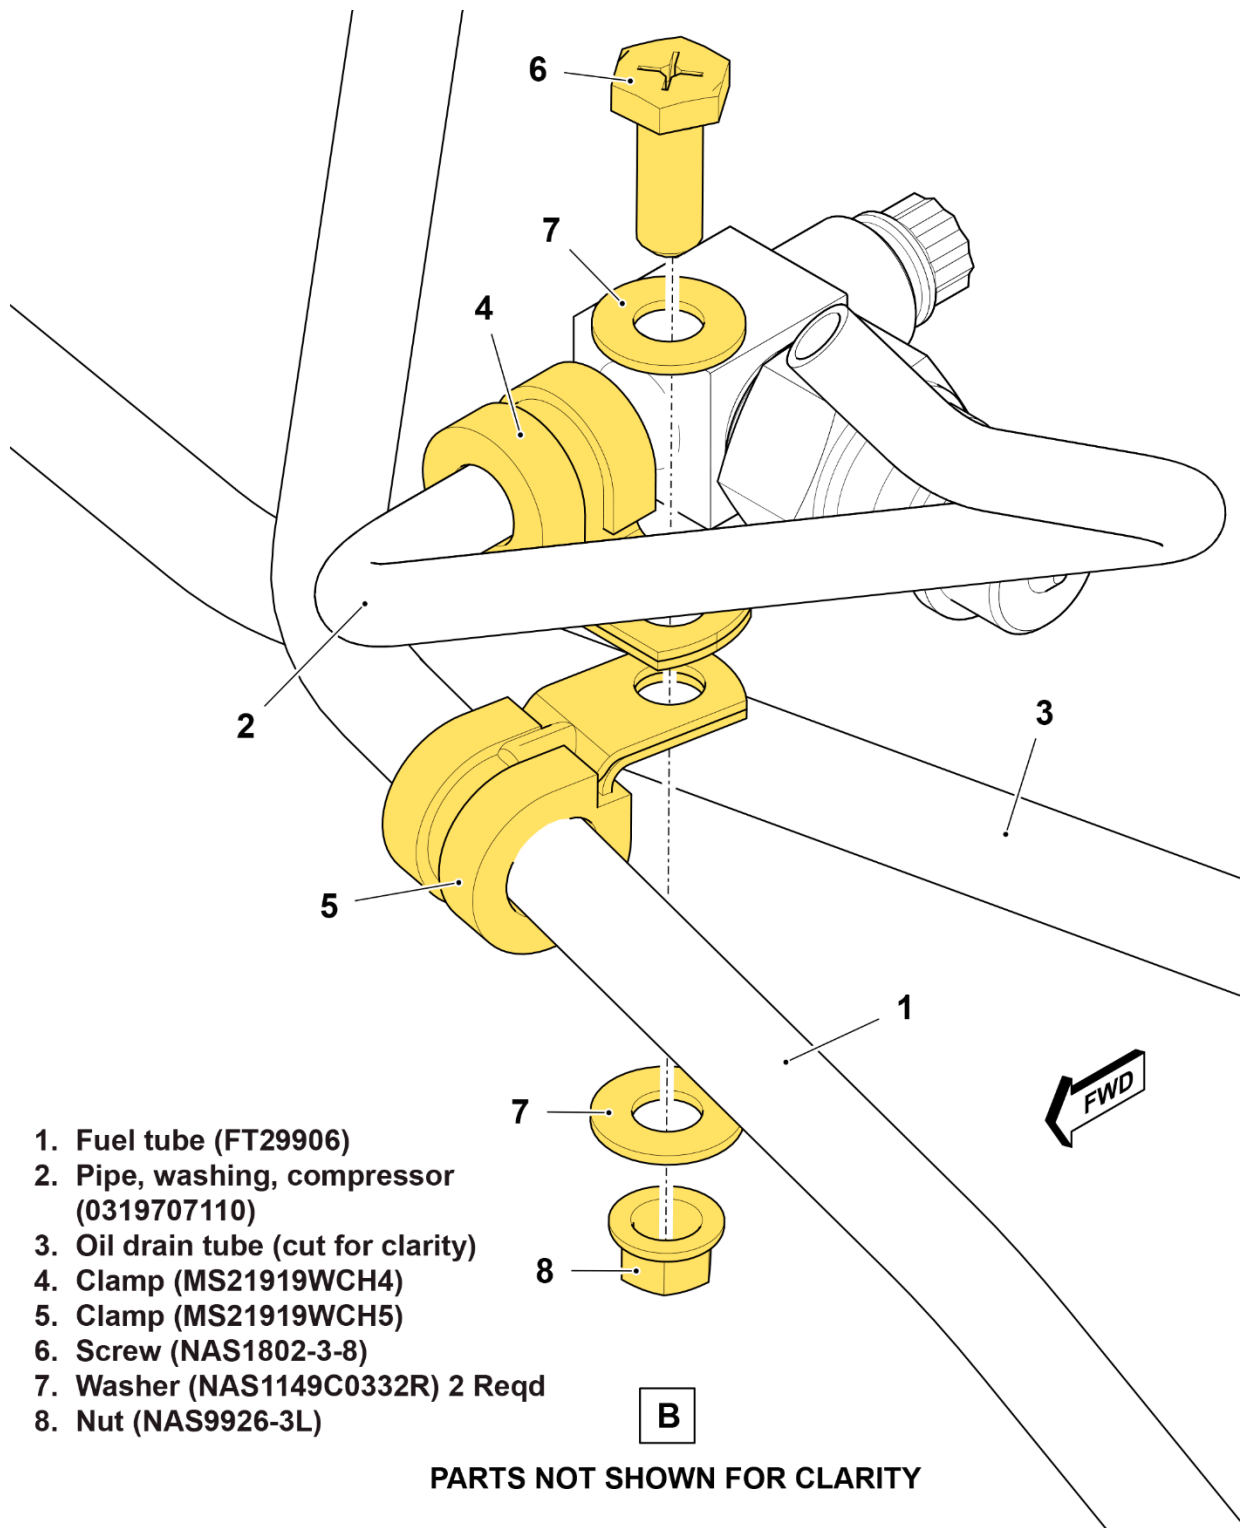
Bell has received field reports of chafing between the engine fuel drain tube and the engine compressor wash tube. This Alert Service Bulletin (ASB) requires operators to carry out a one-time visual inspection on these lines and replace any damaged parts as necessary. It also introduces the addition of clamps and associated hardware to improve the clearance between these tube assemblies.

Make sure there is a minimum clearance of 0.010 inch (0.254 mm) between the fuel drain tube (1, Figure 1) and the compressor wash tube (2). Loosening and tightening of the tube end fittings for repositioning of the tubes may be required.

3. Visually inspect the clearance between the fuel drain tube (1, Figure 1) and the engine compressor wash tube (2). If the tubes are contacting each other, or if there is evidence of chafing damage on either tube, go to step 4, otherwise go to step 7.
4. Remove the fuel drain tube (1) ([DMC-505-A-71-70-05-00A-520A-A](#)).

5. If there is chaffing damage on the fuel drain tube (1), measure the depth.
 - a. If the damage depth is less than 0.010 inch (0.254 mm) the fuel drain tube (1) is considered serviceable and can remain in service. Go to step 6.
 - b. If the damage depth is more than 0.010 inch (0.254 mm), replace the fuel drain tube (1) with a serviceable fuel drain tube meeting the intent of the bulletin.

Position of the clamps should be adjusted to achieve a minimum 0.159 inch (4.0mm) clearance between the fuel drain tube (1) and the compressor wash tube (2). Loosening and tightening of the tube end fittings for repositioning of the tubes may be required.

3. Install the clamps (4 and 5, Figure 1) with screw (6), washers (7) and nut (8). Torque the nut (8) 30 to 40 inch-pounds (3.4 to 4.5 Nm).
4. Install the aft engine cowling (443T) ([DMC-505-A-71-10-02-00A-720A-A](#)).
5. Make an entry in the helicopter logbook and historical service records indicating compliance with **PART II** of this Alert Service Bulletin.
