ALERT SERVICE BULLETIN

505-22-32

MODEL AFFECTED: 505

SUBJECT: ELECTRICAL HARNESSSES, INSPECTION OF.

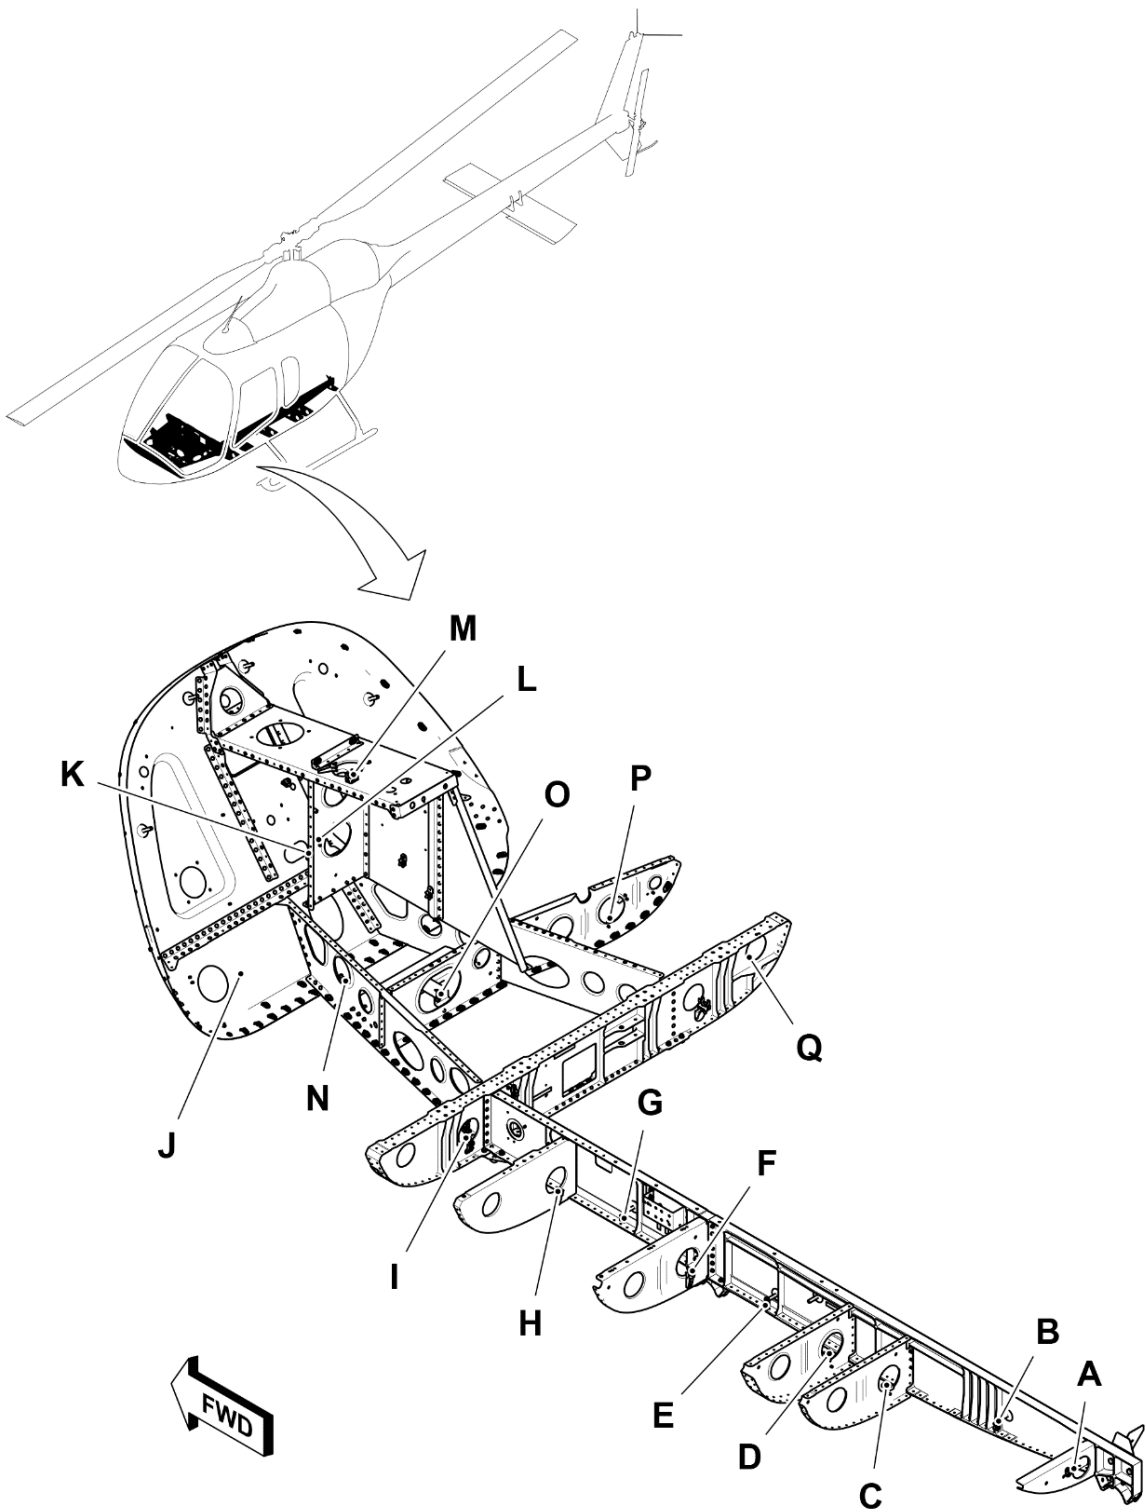
Figure 1 – Helicopter Station Locations

Potential fouling occurs under floor starting at FWD canted bulkhead STA 65 to AFT bulkhead at STA 180, including all structural frames and areas in between (STA 65, 82, 98, 109, 127, 146, 155 and 180).

For the next inspection step, look for damaged wires in the vicinity of the clamping arrangements and between clamping, especially where close to structure and/or air conditioning lines. Inspect the harnesses for chaffing or damage.

3. Do a detailed visual inspection of the wire harnesses at the following clamping/attachment locations (FS = Fuselage Stations, BL= Buttock Line).

- A. BL-12, FS180
- B. BL-12, between FS155 and FS180
- C. BL-12, FS155
- D. BL-12, FS146
- E. BL-12, between FS127 and FS146
- F. BL-12, FS127
- G. BL-12, between FS109 and FS127
- H. BL-12, FS109
- I. BL-12, FS98

- J. BL-12, FS65. (Canted Bulkhead)
- K. BL0, FS65. (Canted Bulkhead)

- L. BL0, FS67
- M. BL-2, FS70 top of pedestal
- N. BL0, FS82 FWD Keel Beam
- O. BL0, FS80 below pedestal

- P. BL22, FS82
- Q. BL24, FS98

Wire bundles should have a minimum clearance of 0.375 Inches (9.53 mm) from tubing/structure.

4. Repair damaged wires/bundles and identify/address the source of the chafing. Refer to Chafing Control Guide (CSSD-PSE-90-001) and Electrical Standard Practice Manual (BHT-ELEC-SPM).
 - a. If the fouling condition cannot be rectified using the information within these manuals, contact Bell Product Support Engineering at productsupport@bellflight.com with the following information:
 - (1) Include the helicopter serial number in the subject line of the email.
 - (2) Include the ASB number 505-22-32 in the subject line of the email.
