ALERT SERVICE BULLETIN

505-22-34

MODEL AFFECTED: 505

SUBJECT: ANTI-TORQUE ROTOR CONTROL CABLE ASSEMBLIES, INSPECTION OF.

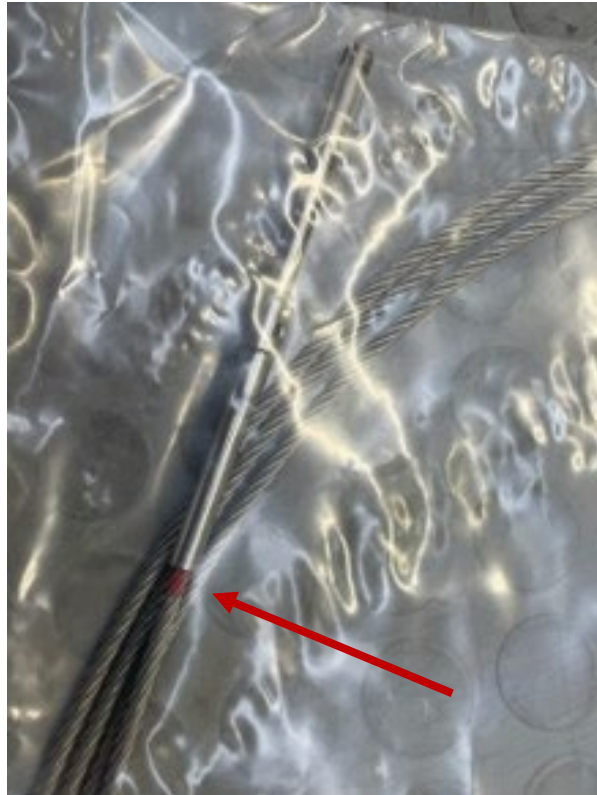
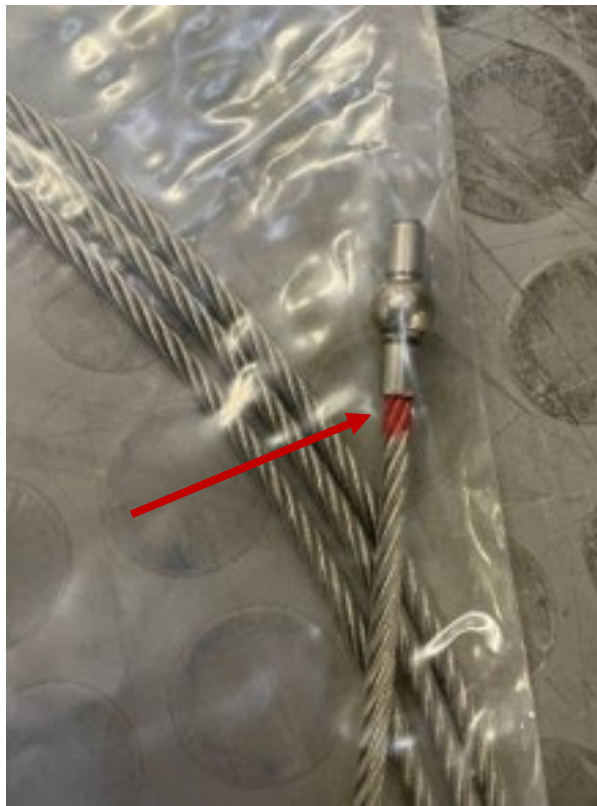
Figure 1 –Typical Slippage Indicators as Received from Supplier

Bell has been made aware that some anti-torque rotor control cable assemblies may have been delivered through Spares or installed on helicopters with missing or faded slippage indicators applied at the junction between the cable and the swaged fittings (Figure 1).

Figure 1 shows anti-torque rotor control cable assemblies with the slippage indicators correctly applied all the way up to the swaged device (ball joint, turnbuckle, or clevis). If the cable has slipped, a gap between the slippage indicator lacquer on the cable and the lacquer on the swaged device will be visible.

5. Verify the left and right forward and left and right aft cable assemblies at the ball joints, turnbuckles, and clevis in the locations identified (Figure 2) for the presence of slippage indicators and any signs of slippage.
 - a. If slippage indicators are missing or faded to the extent that it is not possible to determine that the cable has not slipped, perform a tension check of the cables ([DMC-505-A-67-20-00-00A-360B-A](#)), and add torque seal lacquer (C-049) at the junction between the swaged device and the cable. Perform **PART II** of this bulletin within the compliance period. A cable assembly that required tension adjustments during operation may be an indication of cable assembly slippage. If in doubt, replace the suspected cable assembly before next flight.
 - b. If there are no signs of slippage go to step 6.

- c. If there are signs of slippage, replace the defective cable assembly before next flight with a serviceable cable assembly meeting the intent of this bulletin using the following data modules as applicable, then go to step 6:

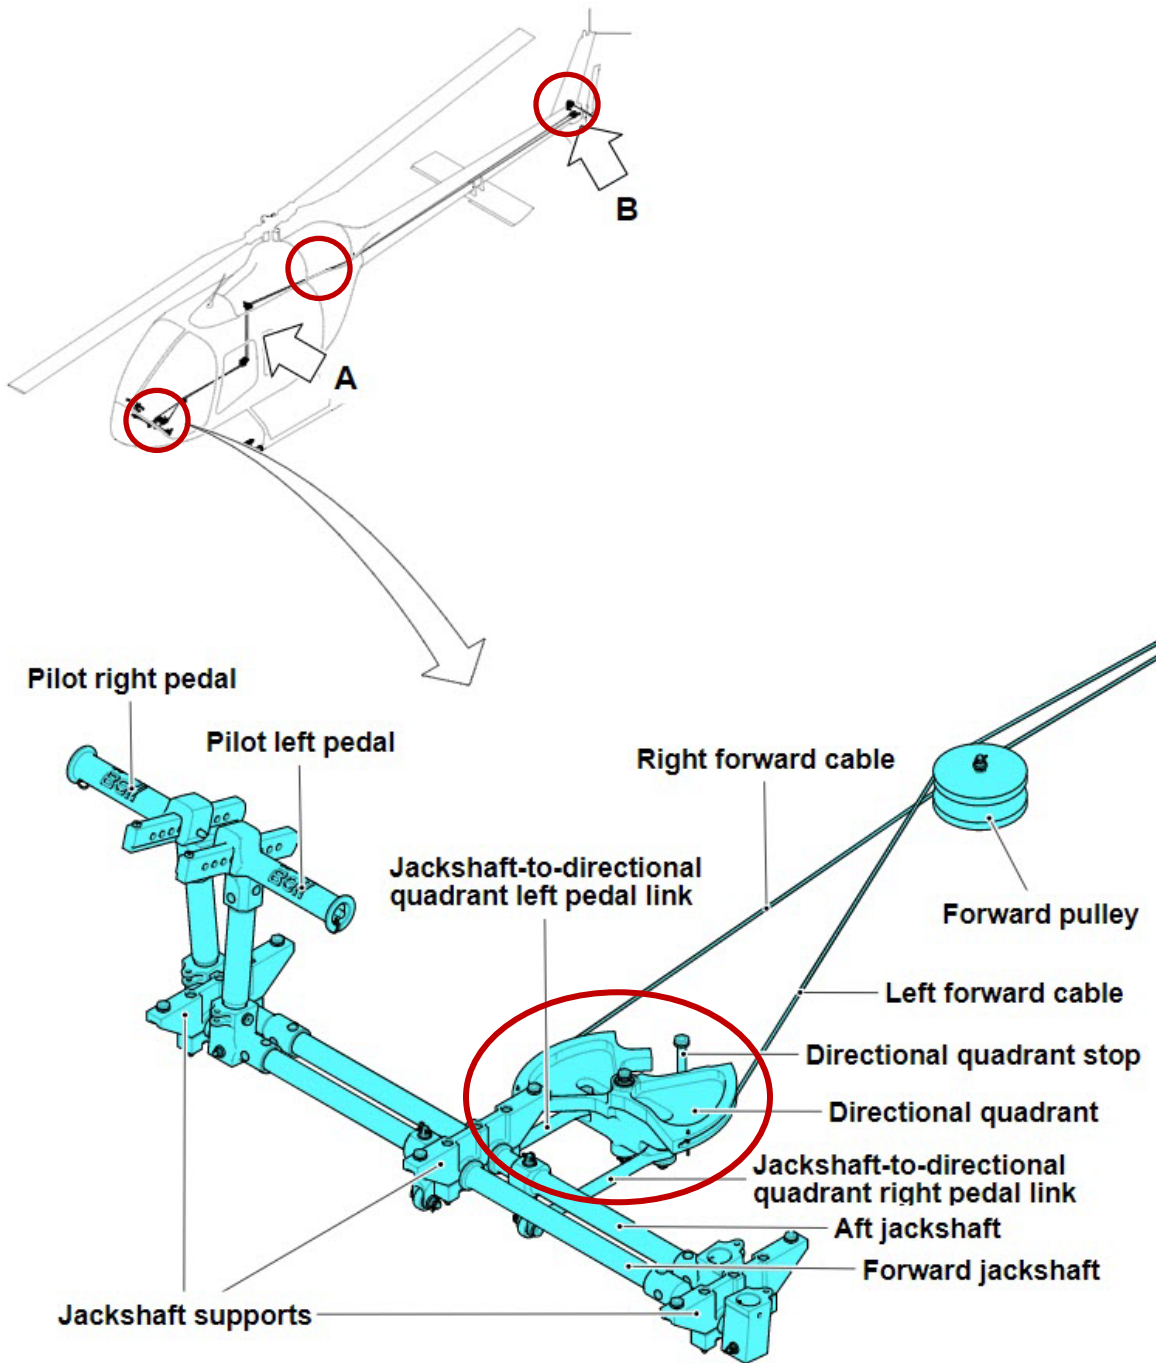
Figure 2 – Anti-Torque Rotor Control System (sheet 1 of 2)

5. Verify the left and right forward and left and right aft cable assemblies at the ball joints, turnbuckles, and clevis in the locations identified (Figure 2) for the presence of slippage indicators and any signs of slippage.

- a. If slippage indicators are missing or faded to the extent that it is not possible to determine that the cable has not slipped, perform a tension check of the cables ([DMC-505-A-67-20-00-00A-360B-A](#)), and add torque seal lacquer (C-049) at the junction between the swaged device and the cable. Perform **PART II** of this bulletin within the compliance period. A cable assembly that required tension adjustments during operation may be an indication of cable assembly slippage. If in doubt, replace the suspected cable assembly before next flight

- b. If there are no signs of slippage go to step 6.
 - c. If there are signs of slippage, replace the defective cable assembly before next flight with a serviceable cable assembly meeting the intent of this bulletin using the following data modules as applicable, then go to step 6:
