## ALERT SERVICE BULLETIN

**UH-1H-22-22**

**MODEL AFFECTED:** UH-1H

**SUBJECT:** MAIN ROTOR SCISSORS & SLEEVE HUB ASSEMBLY COLLECTIVE IDENTIFICATION 204-011-405-013

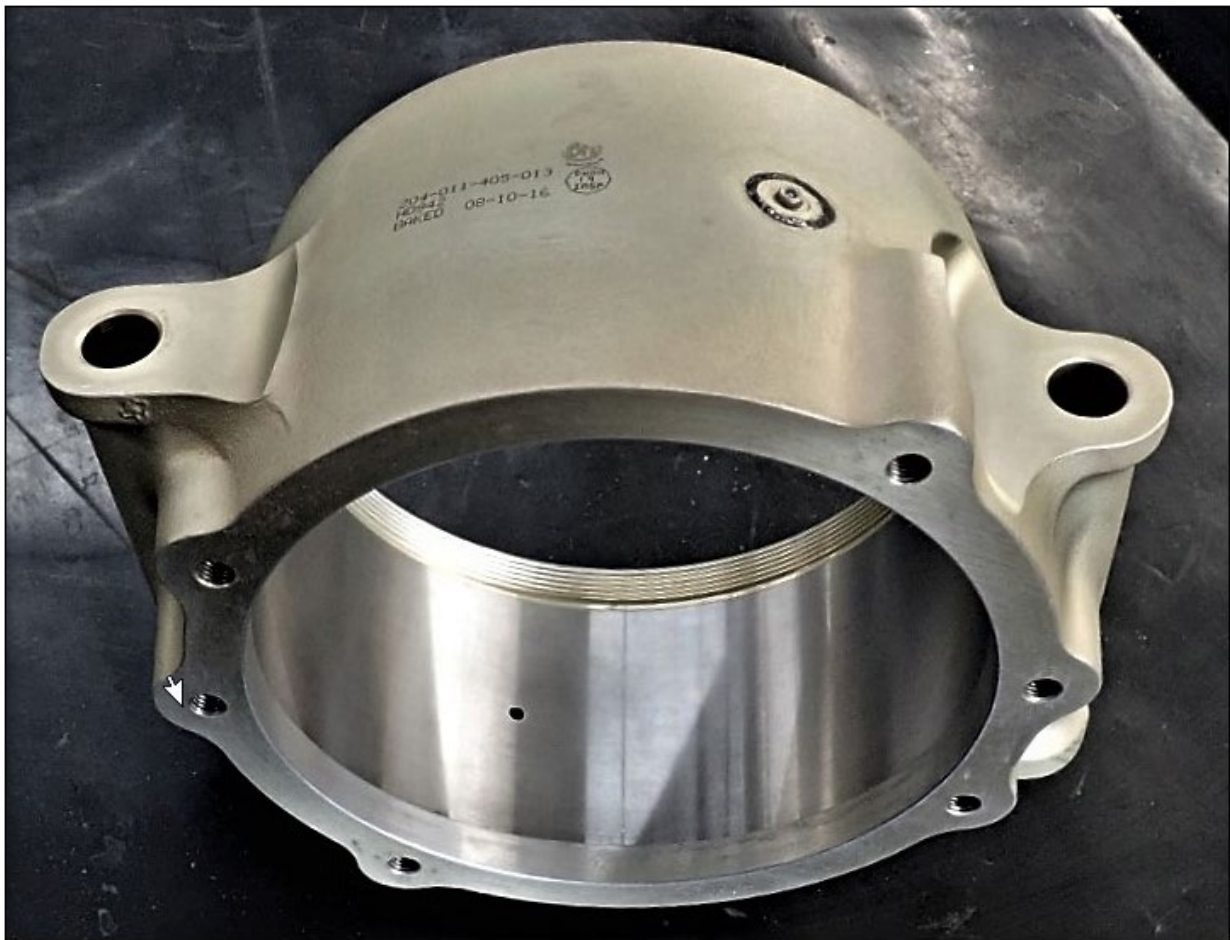
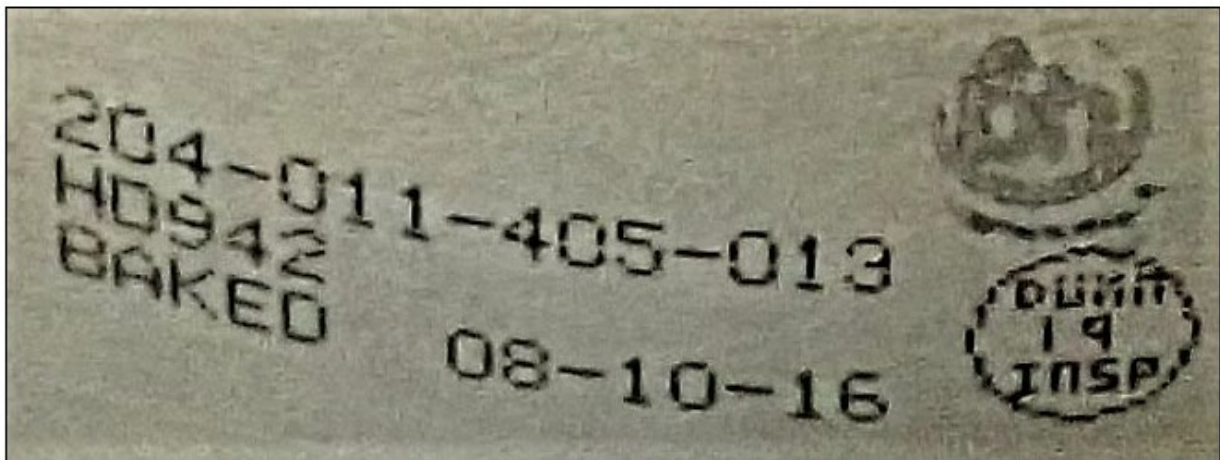
Figure 1 – Hub Assembly Ink-Stamped Part Number and Serial Number

Bell has been made aware that some Scissors & Sleeve Hub Assemblies 204-011-405-013 were delivered without a serial number or with an ink-stamped serial number only. Since the Hub Assembly is a life-limited item listed in the Maintenance Manual (MM) Chapter 1, a permanently marked part number and serial number shall be assigned to it.

2. Confirm if there is a Historical Service Record (HSR) for the Hub Assembly (204-011-405-013) and that it contains the serial and part numbers.
3. Gain access to the Hub Assembly 204-011-405-013 and inspect for the presence of part number and serial number matching the Historical Service Record (HSR) at the location shown on Figure 1.

4. If the Hub Assembly is not correctly marked, as shown in Figure 1, proceed with **PART II**.
5. If the Hub Assembly is correctly marked, make an entry in the helicopter logbook and historical service records indicating findings and compliance with **Part I** of this Alert Service Bulletin.

2. If the Hub Assembly has an ink-stamped part and serial number matching the HSR (refer to example shown in Figure 1), permanently mark the part and serial number on the Hub Assembly by vibro-etching or dot-peening (Figure 2).
3. If the Hub Assembly does not have a part number and serial number, create a unique serial number for each Hub Assembly. Using one or two prefix letters consistent with the company name of the operator or repair facility accompanied by a dash and 4 or 5 digits is considered as an industry serial number marking standard. Vibro-etch or
