ALERT SERVICE BULLETIN

UH-1H-II-22-32

MODEL AFFECTED: UH-1H-II

SUBJECT: MAIN ROTOR SCISSORS & SLEEVE HUB ASSEMBLY 204-011-405-013 IDENTIFICATION

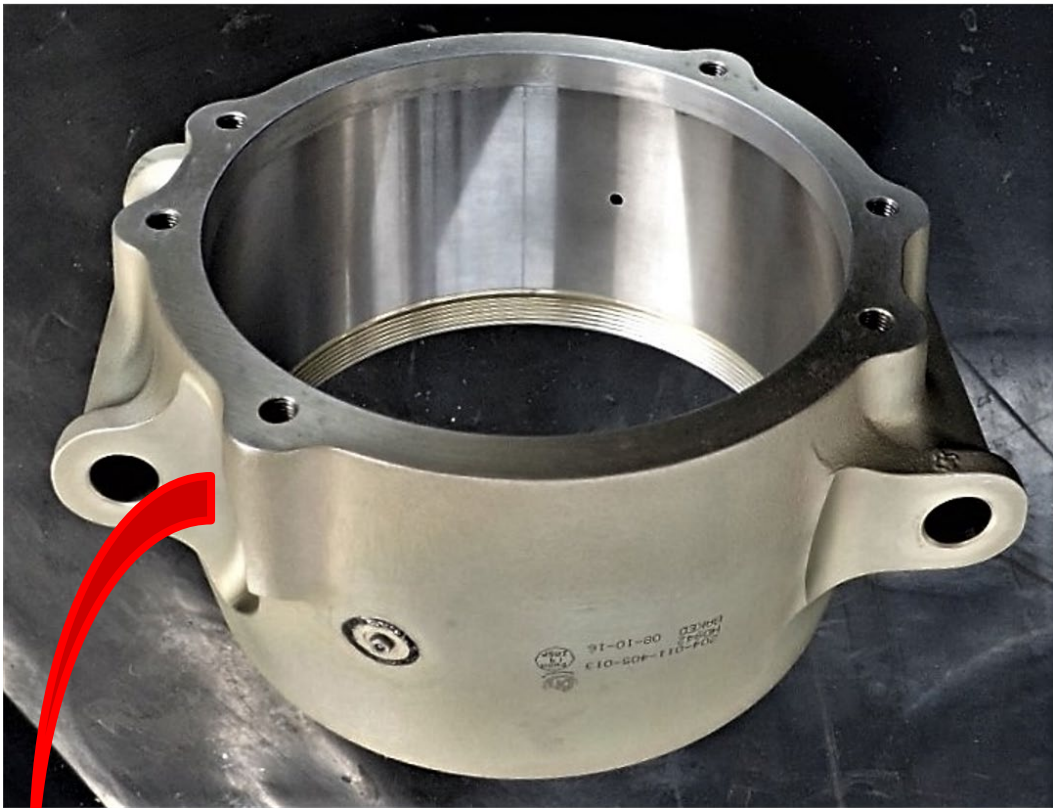
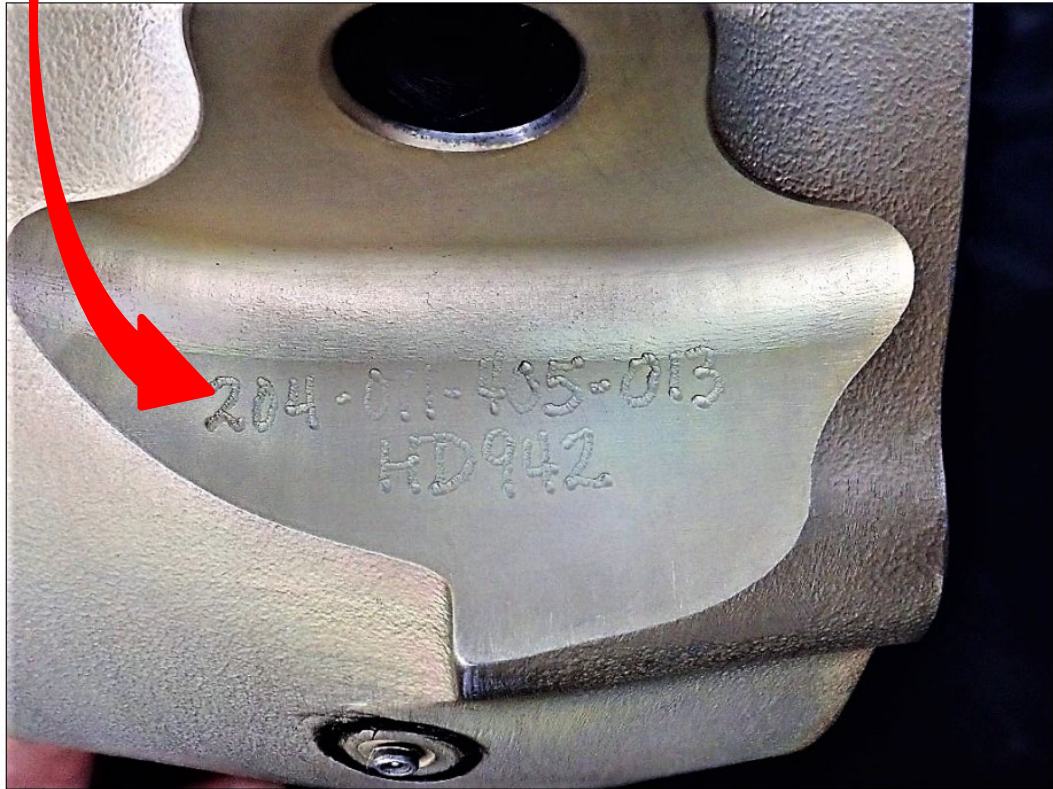
Figure 2 – Vibro-Etched Part Number and Serial Number Location

Maximum depth of vibro-etching or dot-peening shall not exceed 0.005-inch (.127 mm). Part and serial numbers shall be marked in the scalloped area of the hub as shown in Figure 2 of this ASB; to a minimum height of 0.062-inch (1.57 mm) and no closer than 0.100-inch (2.54 mm) to any edge

2. If the Hub Assembly has an ink-stamped part and serial number matching the HSR (refer to example shown in Figure 1), permanently mark the part and serial number on the Hub Assembly by vibro-etching or dot-peening (Figure 2).
3. If the Hub Assembly does not have a part number and serial number, create a unique serial number for each Hub Assembly. Using one or two prefix letters consistent with the company name of the operator or repair facility accompanied by a dash and 4 or 5 digits is considered as an industry serial number marking standard. Vibro-etch or

dot-peen the Hub Assy with the part number and the assigned serial number (Figure 2). For example, Papa Tango Aviation Inc. could use “204-011-405-013 / PT-01234”.

4. After marking the part and serial number identification, apply brush cadmium plating solution (C-108) to the affected area (BHT-ALL-SPM). As an alternate and if brush cadmium plating isn't available, apply two coats of polyamide epoxy primer (C-204).
5. If no Historical Service Record exists for the Hub Assy, create one as follows:
 - a. Print a blank form from www.bellhelicopter.net under the “GENERAL INFO” tab.
 - b. Enter the Hub Assembly part number and the serial number created above.
 - c. Add the following note beside the serial number: “Serial number created as per ASB UH-1H-II-22-32.
 - d. Enter the actual flight hours or the flight hour value calculated.
 - e. Ensure the Hub Assembly information is entered on the HSR.
6. The Hub Assembly 204-011-405-013 is a life-limited item that should have been tracked by the operator even if the part was not correctly identified.
