INFORMATION LETTER

206L-14-97
24 February 2014

**SUBJECT: TACTAIR HYDRAULIC SERVO ACTUATOR (HSA) CYLINDER
EXTENSION ASSEMBLY P/N C42642-88 PRODUCT IMPROVEMENT**

SB42C42642-67-04

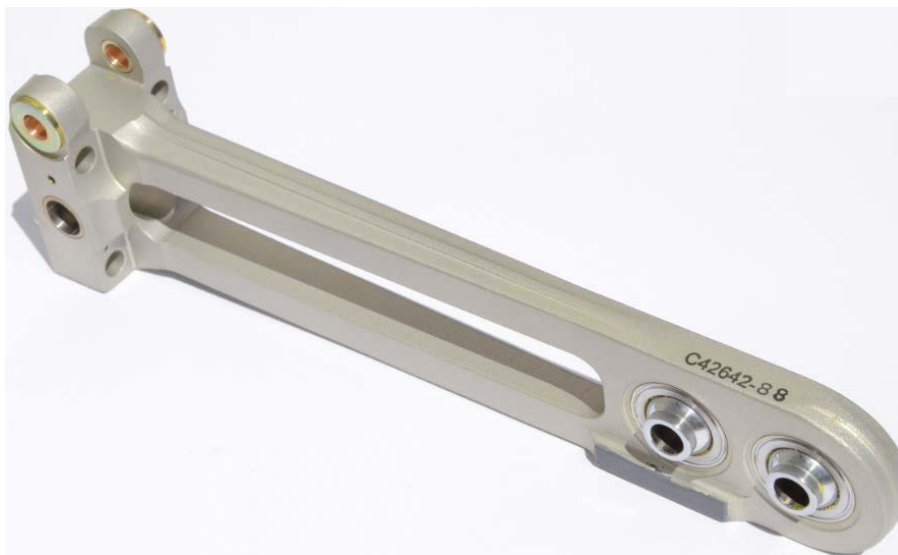
Figure 1

The purpose for this Service Bulletin is to document the maintenance procedures required to replace the current Cylinder Extension Assembly P/N C42642-69 during the HSA Repair or Overhaul with the new Cylinder Extension Assembly P/N C42642-88 to improve the HSA P/N 42C42642-1 and 42C42642-101 configurations. The improvements of this new Cylinder Extension Assembly P/N C42642-88 are designed to prevent bending of the old Cylinder Extension Assembly P/N C42642-69, which can occur during helicopter hard landings and to increase service life of the HSA.

New Cylinder Extension Assembly P/N C42642-88

- D. Repair HSA in accordance with Overhaul Manual referenced in paragraph 1.K except Cylinder Extension Assembly P/N C42642-69.
- E. Assemble HSA in accordance with Overhaul Manual referenced in paragraph 1.K except install new Cylinder Extension Assembly P/N C42642-88, as shown in figure 1, in place of old Cylinder Extension Assembly P/N C42642-69.
