OPERATION SAFETY NOTICE

212-16-52  
205B-16-19  
14 March 2016

**SUBJECT: MAIN ROTOR BLADE 212-015-501-115 FOUND CRACKED.**

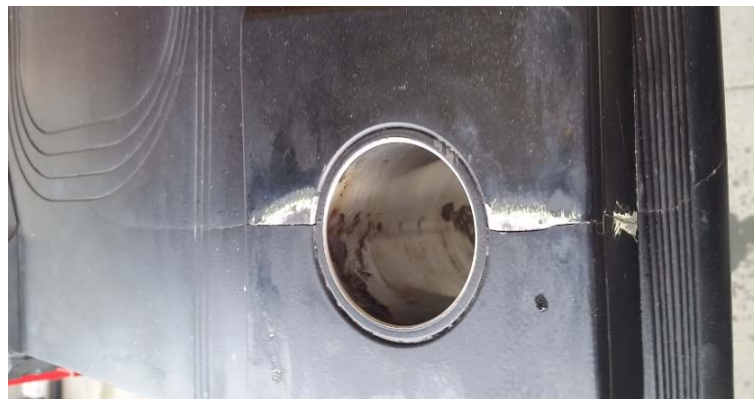
Bell Helicopter has been informed that a Model 212 main rotor blade was found cracked during a daily inspection. The chordwise crack was found on the lower surface at blade station 28.0 in the center of the blade bolt hole. The cracking found is similar to the case discussed in ASB 212-08-130 and 205B-08-51 except that the grip plate is not cracked at blade station 36.0. The investigation conducted in 2008 led to the introduction of a 25 hour repetitive 3X-power magnifying glass Special Inspection for presence of void.

This OSN is issued to emphasize the importance of thoroughly inspecting the blade as instructed by the applicable Maintenance Manual 25 Hour Special Inspection initially introduced by ASB 212-08-130 and 205B-08-51. As soon as we have the result of the investigation, we will inform Owners/Operators of our findings and follow with additional recommendations, if required.
