OPERATION SAFETY NOTICE

GEN-11-43

11 February 2011

SUBJECT: NAS1291 NUTS AND NAS626 BOLTS

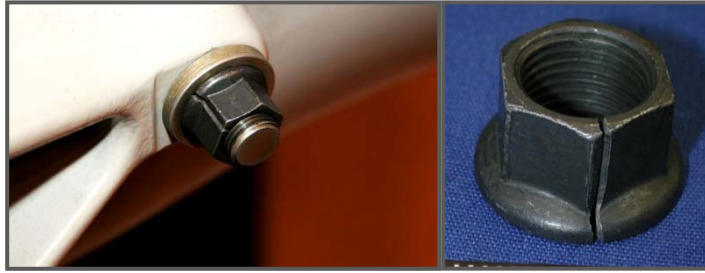
Bell Helicopter recently investigated reports of NAS1291-7/-9/-10 self-locking nuts and NAS626-24 bolts cracking after installation. Investigation has revealed that the nuts had a high concentration of hydrogen and the cracking was the result of hydrogen embrittlement. Root cause of the bolt failure was a result of a quenching crack during manufacture.

Figure 1: Typical NAS1291 nut application and crack due to hydrogen embrittlement.

This OSN is released to remind all operators of the importance of inspecting standard hardware for condition and to replace if required. Corrosion, loss of tare torque and cracks are all reasons for replacement.

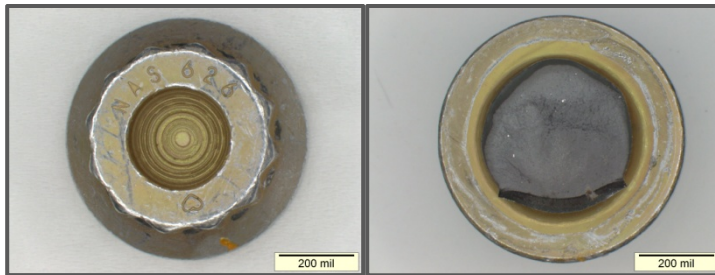
Figure 2: Broken NAS626-24 bolt has a result of incorrect quenching operation during manufacture
