TECHNICAL BULLETIN Bell Helicopter TEXTRON

No. 214ST-04-174

SUBJECT: SCISSORS AND SLEEVE ASSEMBLY, SLEEVE

UPPER NUT, P/N 214-010-418-001, ADDITIONAL MAINTENANCE MANUAL INSPECTION

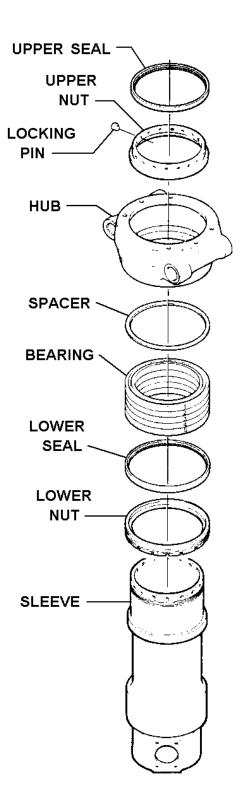
FIGURE 1

Several instances of lost torque to the Scissors and Sleeve Assembly Sleeve Upper Nut, P/N 214-010-418-001, have been reported. A loose upper nut will allow the collective hub bearing to spin and can result in damage to the bearing, sleeve, hub assembly, upper nut, and/or upper seal. As a result, BHTI has determined that additional inspection tasks are necessary.

TORQUE CHECK UPPER NUT PER TEXT
- NOTE -

UPPER NUT HAS LEFT HAND THREADS

COLLECTIVE SLEEVE AND HUB ASSEMBLY STACK-UP

- b. Using the wrench assembly portion of the T101709 Wrench set, verify torque on hub upper nut is between 350 to 450 foot-pounds.
- c. If nut torque is between the specified range and loss of torque is not evident, proceed to d. If torque is below minimum specified, or a loss of torque is evident, proceed to e.
- d. Install locking pin into the upper hub nut and secure with lockwire (refer to BHT-214ST-CR&O Chapter 62).
- e. Remove scissors and sleeve assembly, disassemble, and inspect for damage (Paragraph 62-46 and BHT-214ST-CR&O, Chapter 62).
- 3. Revision to Maintenance Manual, Chapter 5, Special Inspections, paragraph 5-22, **Between 5 to 25 Hours Flight Operation After Installation.**
