**TECHNICAL BULLETIN**  
**Bell Helicopter** **TEXTRON**

No. 205B-06-29

**MODEL AFFECTED:** 205B

**SUBJECT:** VERTICAL FIN COVER HINGE PIN IMPROVED  
INSTALLATION

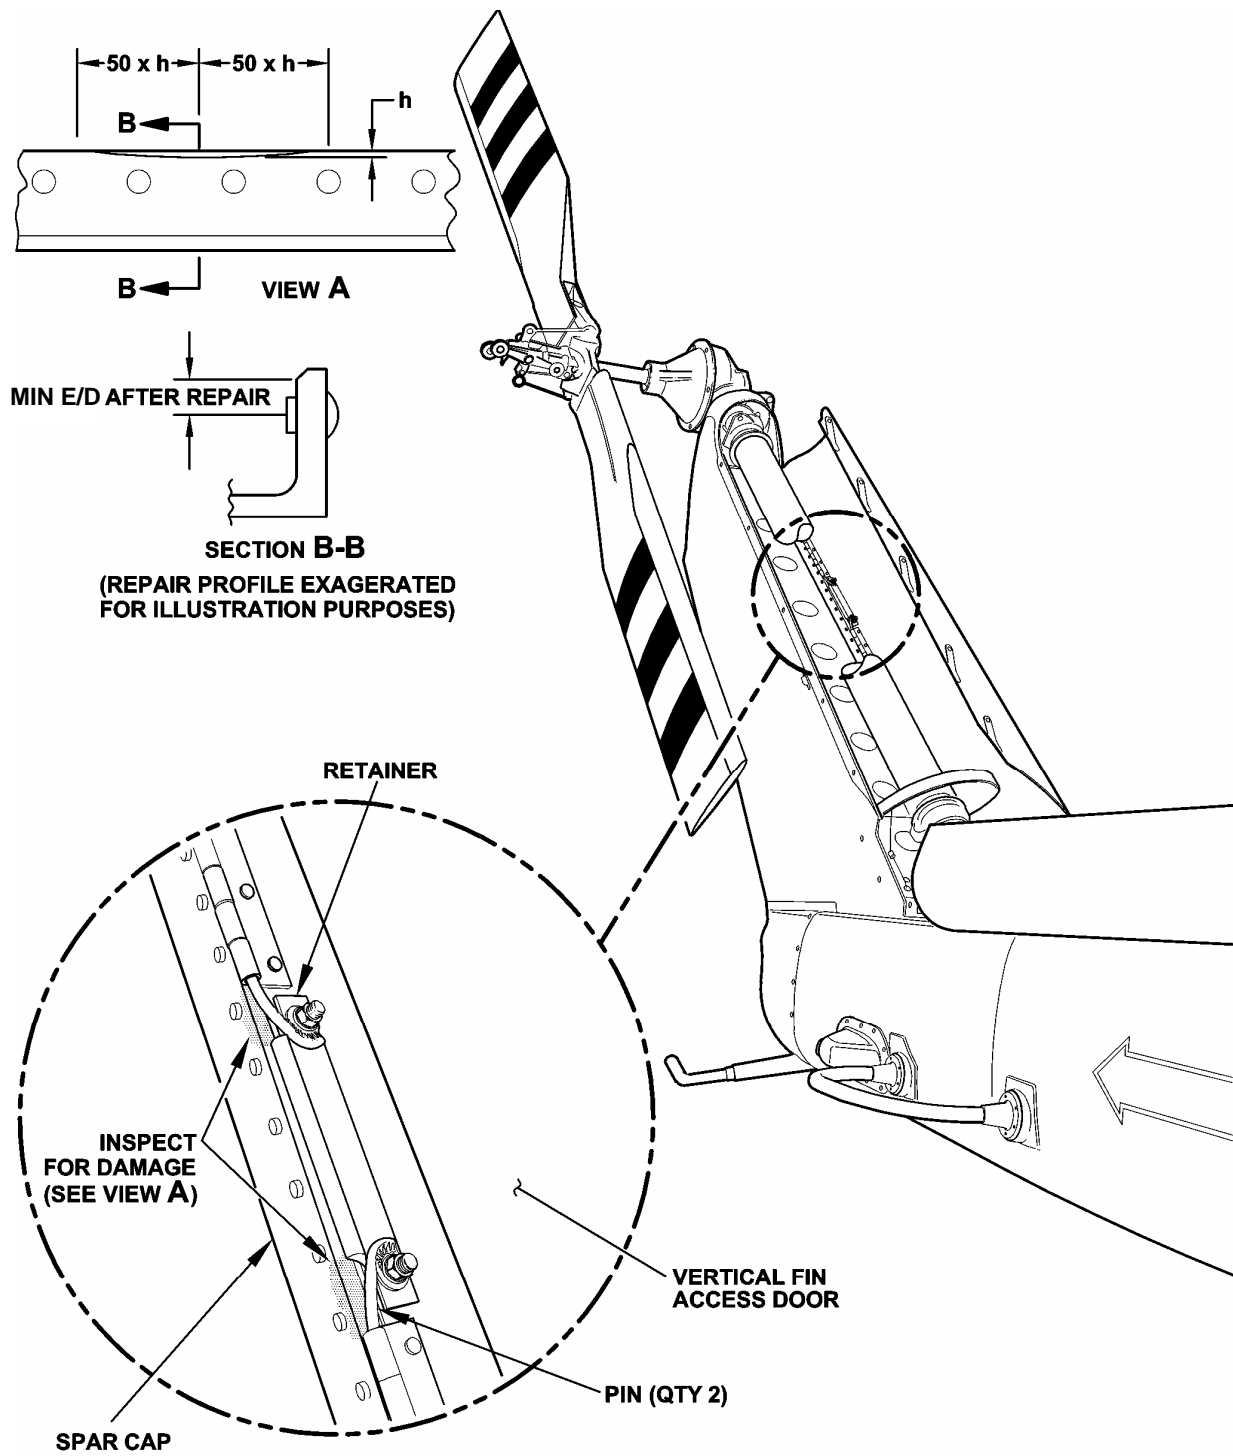
**Figure 1**  
New Hinge Pin Installation

Bell Helicopter has designed a new installation for the vertical fin cover to prevent chaffing damage to the left hand spar cap caused by improperly bent hinge pins. This technical bulletin allows retrofit of the installation on earlier aircraft.

5. Inspect spar cap as indicated in Figure 1, View A, for any chafing damage caused by improperly installed hinge pins.
  - a. Chafing damage of 0.040 inch-deep or less (up to the full width of the flange) may be blended to a length-to-depth ratio of 50:1 (in each direction from the deepest point) and refinished, provided the distance between the center of the nearest rivet and the repaired area is at least 1.5 time the rivet diameter (min E/D). Remove minimum amount of material and polish repair area using 400-grit sandpaper. Removal of the hinge from the fin may be required.

- b. Perform a Fluorescent Penetrant Inspection per Standard Practices Manual, followed by application of chemical film to the repaired area per Structural Repair Manual Section 3-2-14. Refinish area in accordance with Standard Practices Manual.

6. Reinstall door by inserting Pins P/N 209-031-816-119. Attach pins to door using existing screws, 209-031-816-123 Retainer and MS21042L3 Nuts, as shown on Figure 1. Close door.
7. Make an entry in helicopter historical records indicating compliance with this technical bulletin.
8. Make helicopter safe for flight.
