MODEL AFFECTED: 205B

SUBJECT: UPPER CREW DOOR HINGE STRUCTURE,
REINFORCEMENT OF.

HELICOPTERS AFFECTED: All model 205B helicopters.

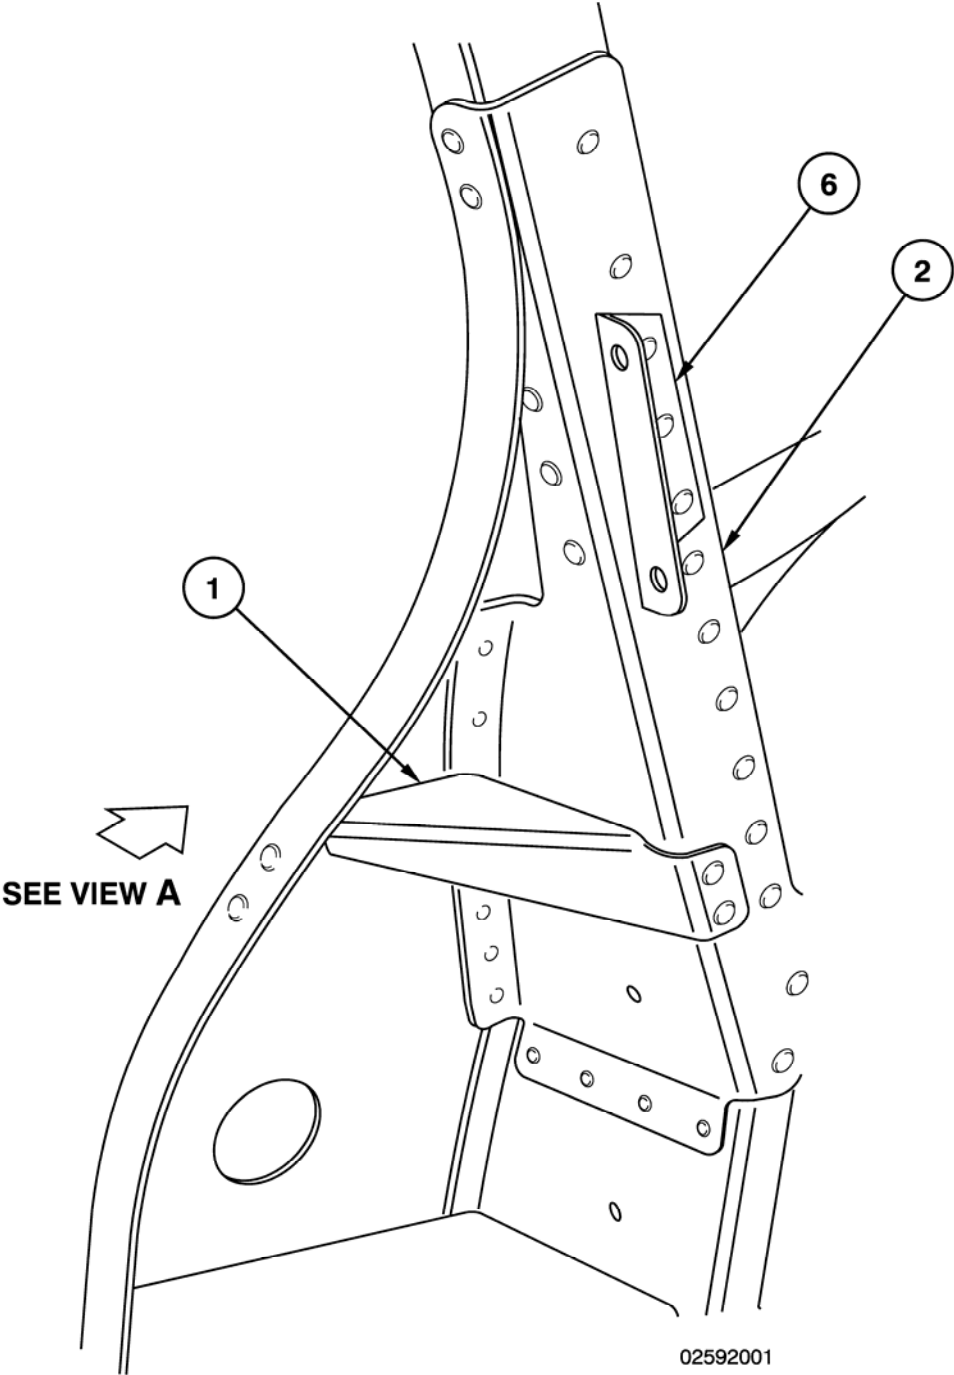
Figure 1 (Sheet 1 of 2)

Bell Helicopter has received some reports of cracking occurring at supports P/N 204-030-662-013 & -014 caused by the crew doors repeatedly hitting their open stop, especially under windy conditions. This bulletin provides the instructions for a simple reinforcement to the surrounding area.

5. On left side, remove instrument panel support fitting (6).
6. Remove support (1) and support (2) as a unit. Remove support (1) from support (2).
7. Fit doubler (3) and radius block (4); refer to View A. See note 1 in Figure 1. Verify for possible interference with support (1) and trim doubler as required. Trim radius block to follow edge of doubler (3) and support (2). Secure with Cleco fasteners.
