TECHNICAL BULLETIN

212-11-211
21 March 2011

MODEL AFFECTED: 212

SUBJECT: NUMBER ONE ENGINE JACKSHAFT SUPPORT INSPECTION AND MODIFICATION OF.

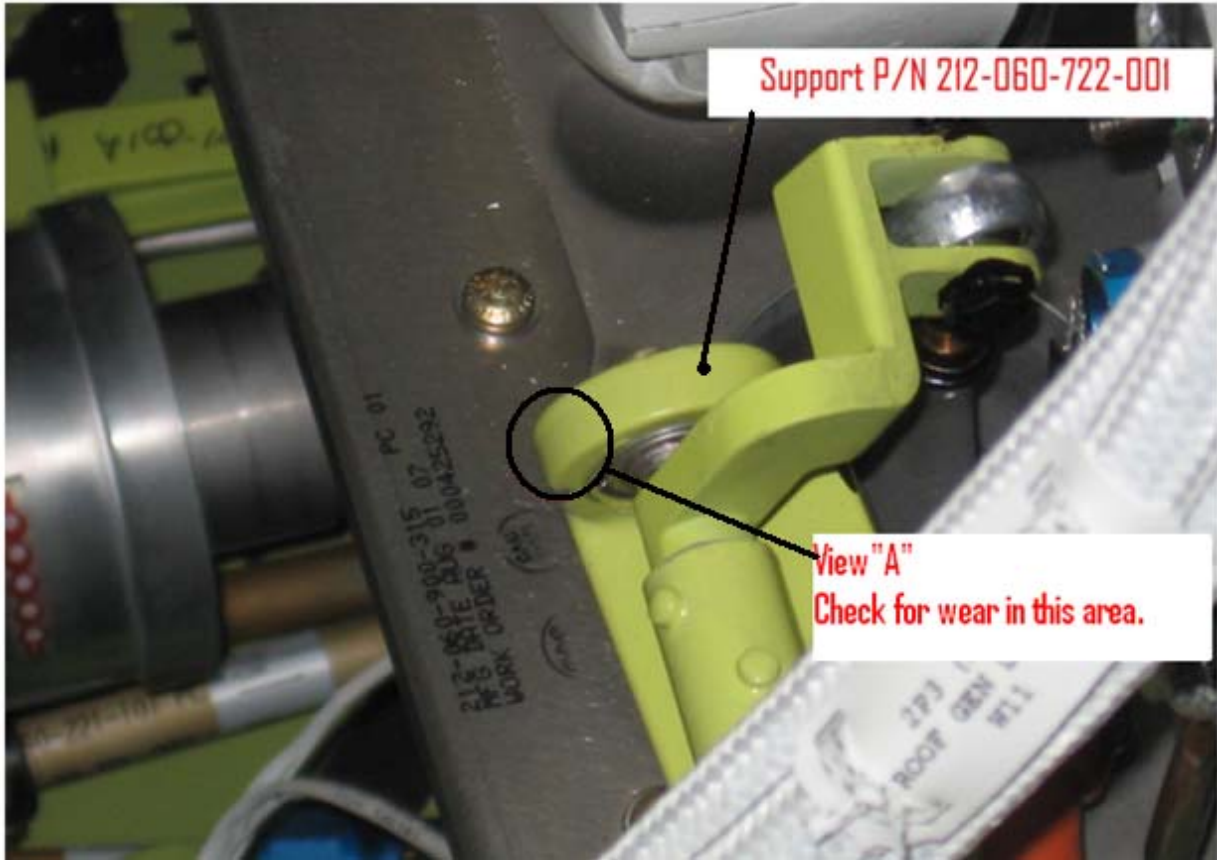
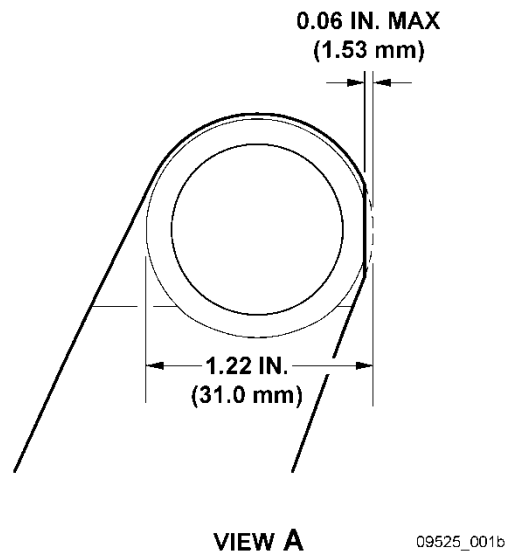
5. Maximum permissible wear on the 1.22" (31.0 mm) Diameter boss is 0.060" (1.53mm) after clean up Figure 2 View A.
6. Blend damaged area including any sharp edges smooth with minimum material removal using 400 grit paper (C- 423).
