TECHNICAL BULLETIN

212-11-212  
6 April 2011

**MODEL AFFECTED:** 212

**SUBJECT:** GENERATOR GROUNDING, IMPROVEMENT OF.

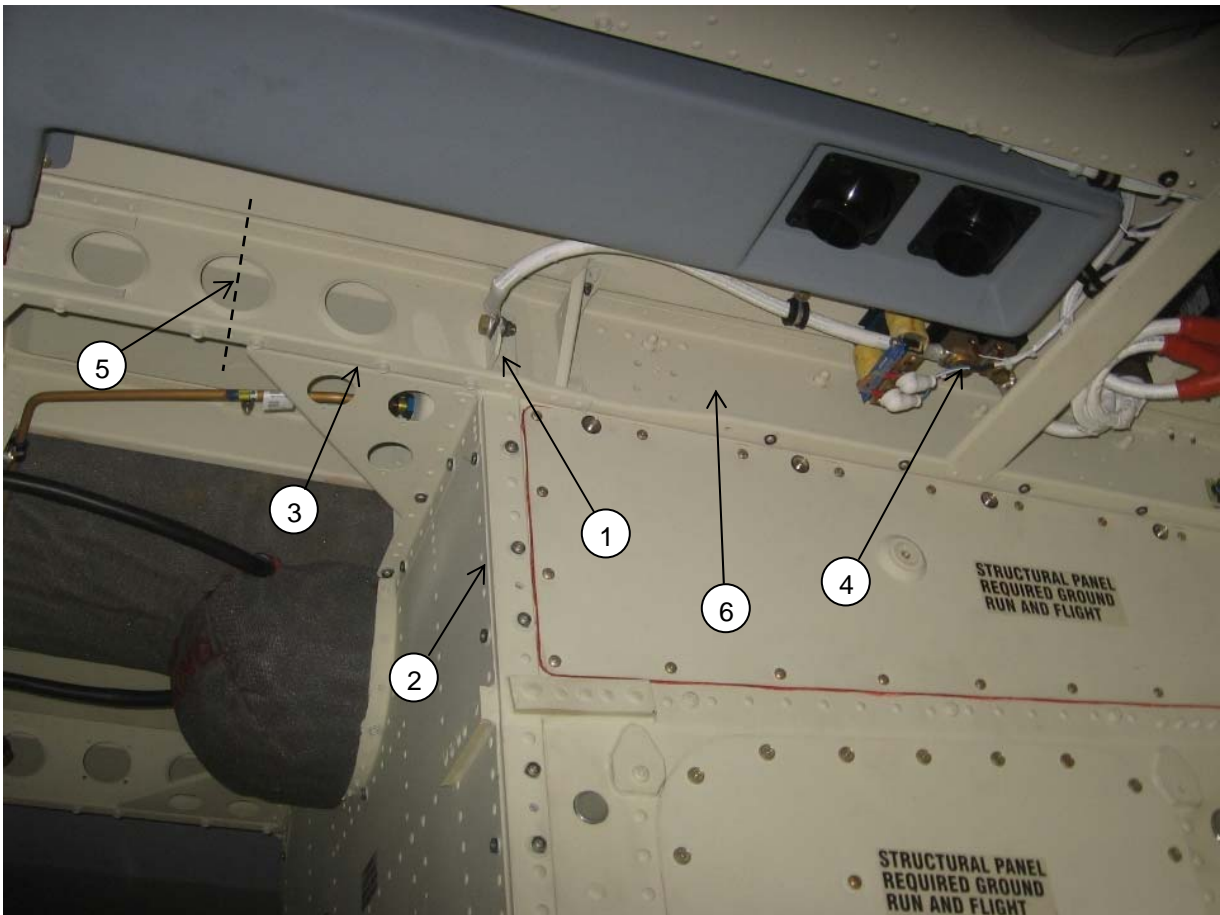
**Figure 1**  
LH Ground Tab Installation  
(RH side typical)

Erratic operation of the electrical system such as unstable generator paralleling, radio noise interference or other anomalies of the electrical or avionic system(s) may be attributed to improper grounds. This bulletin details a procedure to inspect and improve the generator grounds to reduce the power losses through the airframe. Accomplishment on the #1 and #2 generator ground tabs is recommended.

3. Locate the two generator ground tabs P/N 212-030-042-003 located on roof section at FS 129 (1, Figure 1).
4. Disconnect ground cable from both ground tabs. Retain attaching hardware.

5. Using paint remover (C-436), remove finish from a suitable area on both ground tabs and corner angles.
6. Using a suitable milliohm meter measure the resistance across each generator ground tab (1) and the corresponding Angle (2) as described in the Electrical Standard Practices Manual (BHT-ELEC-SPM).

7. If resistance is greater than 0.25 milliohms, perform the following modification. If resistance is less than 0.25 milliohms, go to step 9.
  - a. Remove ground tab (1) by drilling out attaching rivets.

- b. Using paint remover (C-436), remove any paint on contact area of grounding tab (1) and Frame (3). Inspect contact area for corrosion. Remove corrosion as required, as per BHT-ALL-SRM Chapter 3.

- d. Re-install grounding tab using 100-048-5-6 Pins (heads outboard) and 30-015-5 Collars. Refer to BHT-ALL-SRM, Chapter 3 for the procedure.
  - e. Verify if resistance is less than 0.25 milliohms. If so, go to step 9.

8. If resistance is still greater than 0.25 milliohms, perform the following modification.
- a. Remove ground tab (1).
  - b. Cut Frame (3) at approx. FS 119.31, as shown in Structural Repair Manual, paragraph 4-6-11. Limit the width of the cut to a minimum to allow acceptable edge distance on existing rivets as the same aft section of frame will be reused (unless damaged). Take note of type and location of rivets.

- c. Remove remaining rivets to allow removal of the aft section of frame (3).
  - d. Using paint remover (C-436), remove any paint on contact area of Angle (2), Web (6) and back side of Frame (3). Inspect contact area for corrosion. Remove corrosion as required, as per SRM Chapter 3.

- e. Prepare bonding surface as described in ESPM, Chapter 8.
  - f. Re-install aft section of frame using paragraph. 4-6-11 of the BHT-MED-SRM.
  - g. Re-install grounding tab using new pins and collars.

- h. Confirm resistance is less than 0.25 milliohms.
9. Connect ground cables using retained hardware.
10. Verify for continuity between the generator shunt (4) and local ground.

11. Apply sealant (C-392) to seal edges of ground cable lug, grounding tab (1), angle (2) and frame (3) to prevent moisture ingress.
12. Refinish all bare metal surfaces using Chemical Film (C-100) and primer (C-204).
