**TECHNICAL BULLETIN**

**212-15-214**

**MODEL AFFECTED:** 212

**SUBJECT:** TAIL ROTOR GEARBOX INPUT QUILL LEAK, PREVENTION OF

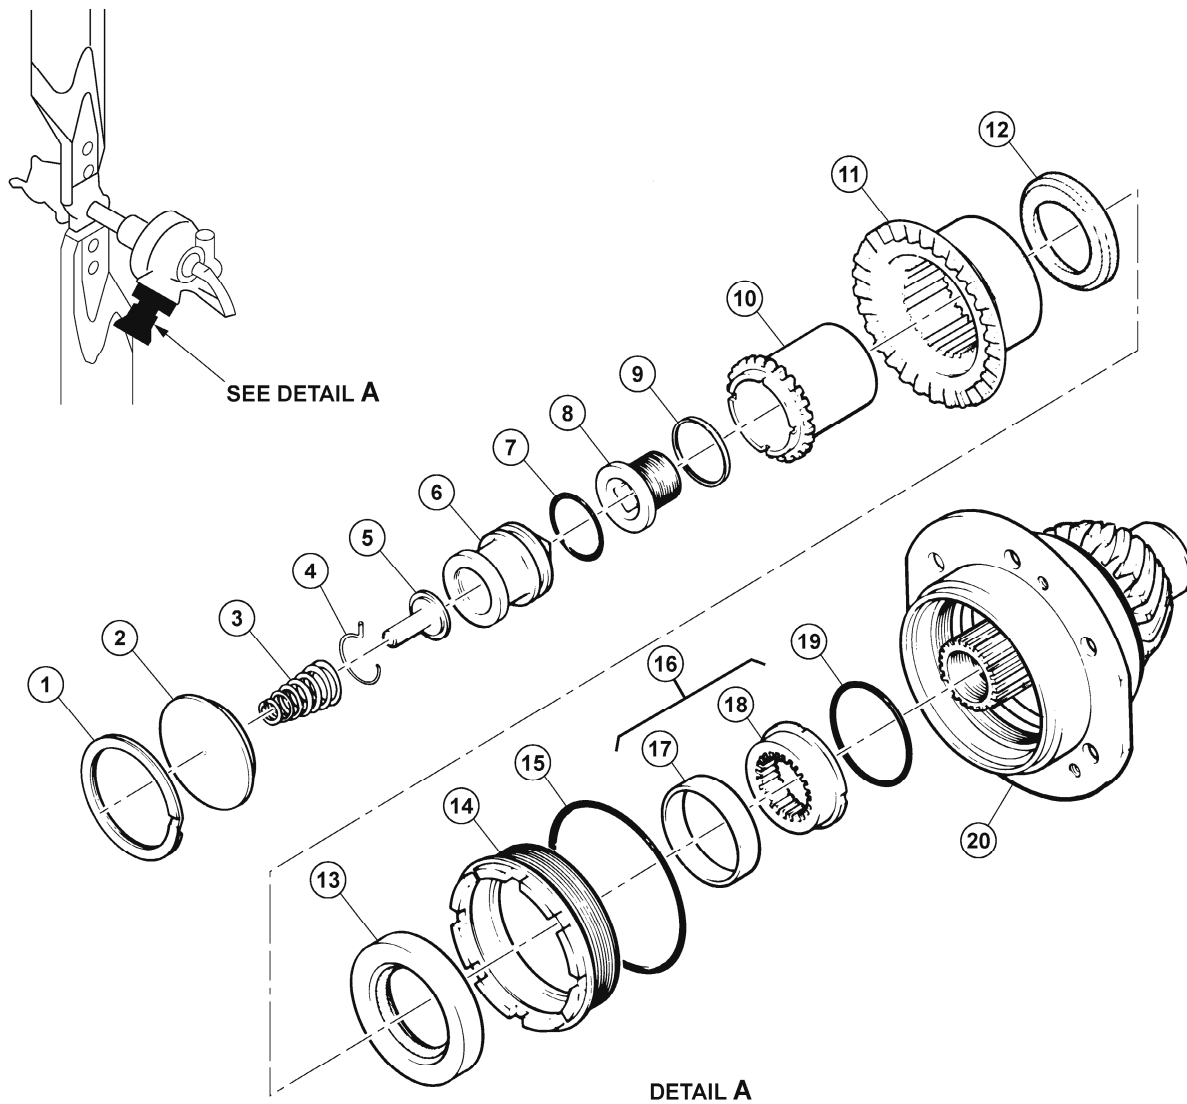
**Figure 1**

There have been some reported cases of oil leakage from the tail rotor gearbox input quill not caused by the seal. These occurrences have been noticed on both new production gearboxes and those with some time in service. The introduction of a revised spacer, along with the addition of a packing, will prevent the oil leakage between the spacer and the bearing. Applicability of this bulletin to any spare part shall be determined prior to its installation on an affected helicopter.

This bulletin provides the instructions to install the new spacer assembly 212-040-457-101 to prevent the oil leak between the spacer and the bearing.

1. Disassemble the tail rotor gearbox input quill to the extent necessary to remove the original spacer assembly (Figure 1, Item 16) in accordance with the BHT-212-CR&O, Chapter 65.
2. Install packing P/N AS3209-217 (Figure 1, Item 19) on the pinion assembly followed by the new spacer assembly 212-040-457-101.
3. Assemble the tail rotor gearbox input quill in accordance with the BHT-212-CR&O, Chapter 65.
4. Make an entry in the helicopter logbook and historical service records indicating compliance with this Technical Bulletin.
