TECHNICAL BULLETIN

429-24-71
28 February 2024

MODEL AFFECTED: 429

SUBJECT: 429-010-108-101 and -105 GRIP ASSEMBLY
CORROSION PROTECTION

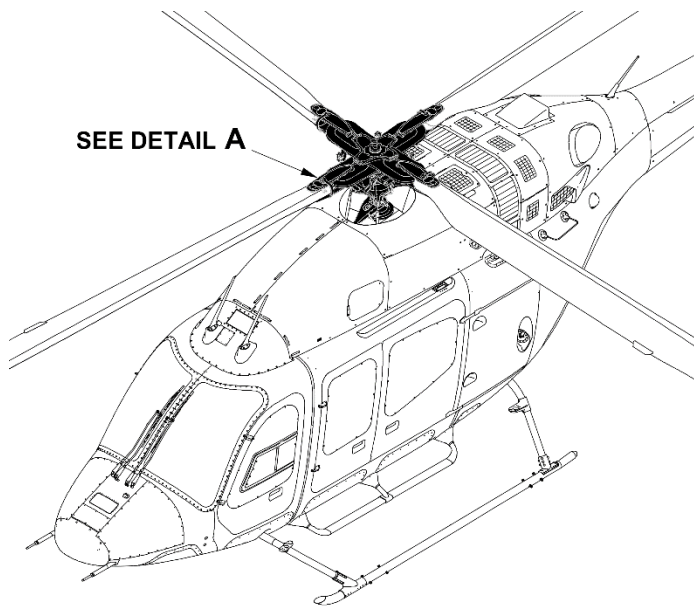
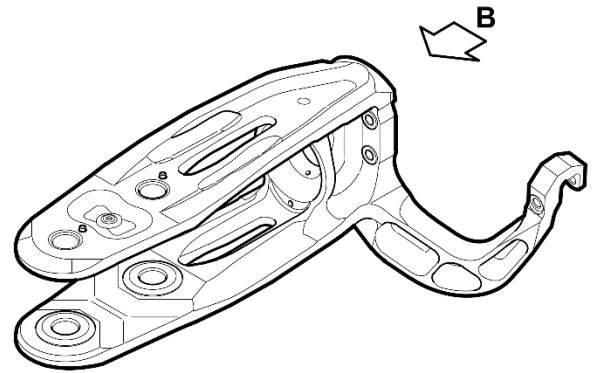
DETAIL A

Figure 1 – Main Rotor Grip Down Stop Surface

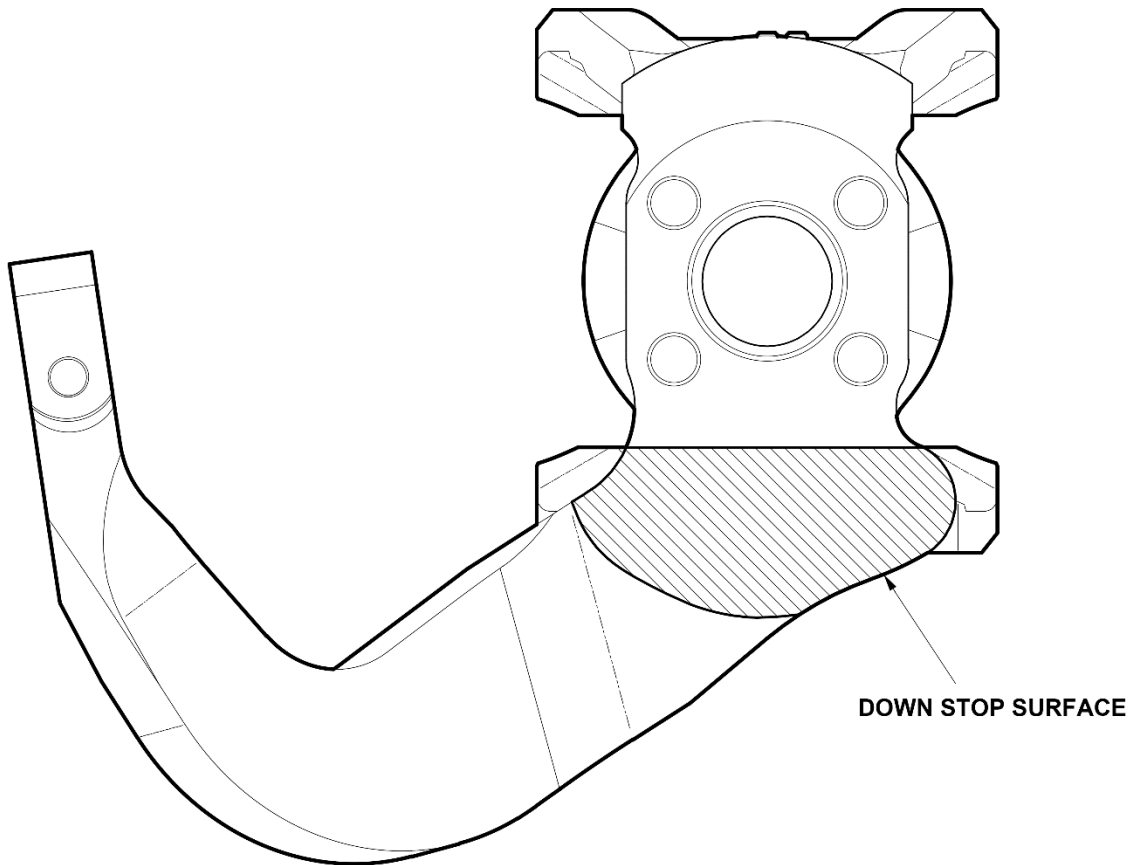
VIEW B

Bell was made aware of damage to the tungsten carbide coating on the down stop surface of the grip assembly on helicopters operating in corrosive environments. The damage is caused by corrosion occurring underneath the coating resulting in bubbling or flaking of the tungsten carbide. This bulletin provides instructions to apply an organic finish on the tungsten carbide coating as preventative maintenance on grip assemblies that do not exhibit any corrosion damage.

2. Thoroughly clean the grip assembly down stop surface (Figure 1, View B) with a cloth dampened with acetone (C-316) or equivalent.
3. Apply one coat of primer (C-204).
4. Apply two coats of polyurethane coating (C-245) Light Gull Gray #16440.
5. Make an entry in the helicopter logbook and historical service records indicating compliance with this Technical Bulletin.
