## **TECHNICAL BULLETIN**

**505-24-31**  
6 February 2025

**MODEL AFFECTED:** 505

**SUBJECT:** ENGINE OIL TANK SIGHT GLASS, INSPECTION AND REWORK OF

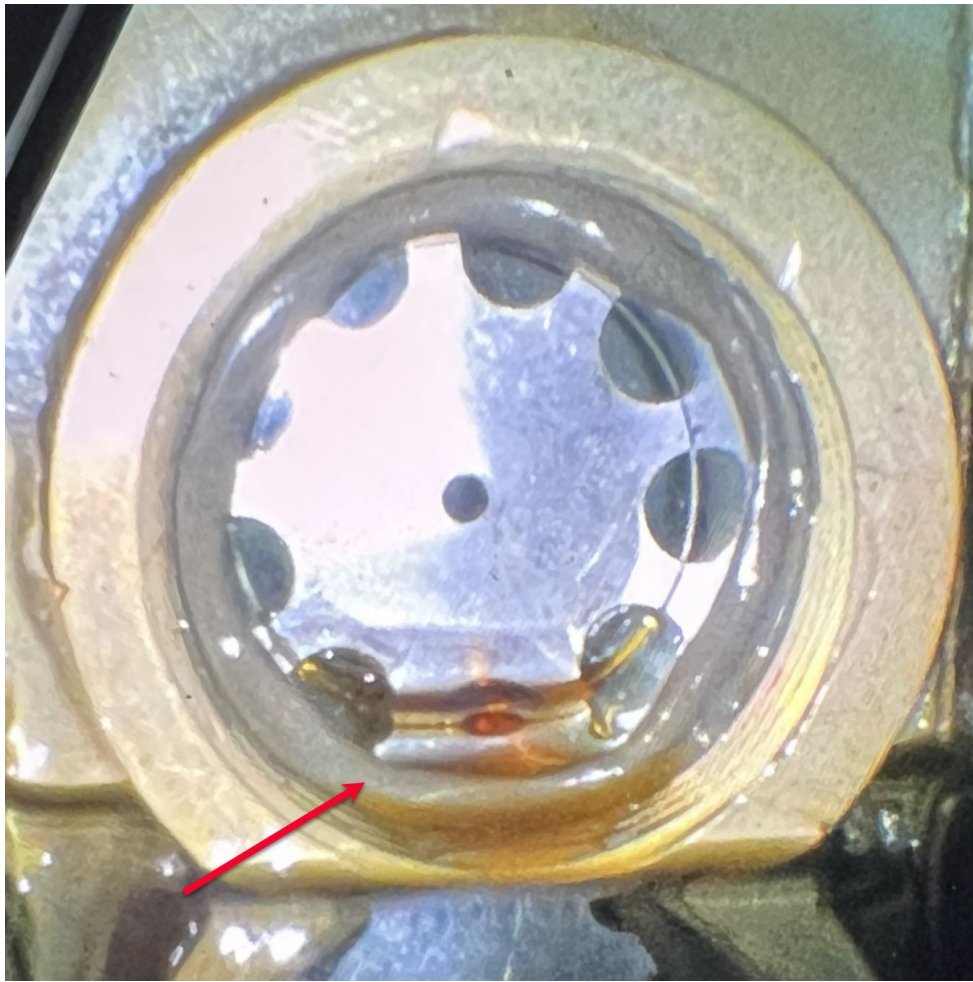
Bell has been made aware that some 505 oil tanks SLS-065-100-037 and -065 have been manufactured with excessive sealant applied to the sight glass threads during installation. The excessive sealant squeezes out the back side of the sight glass and creates a dam (Figure 1), which traps oil at the bottom of the sight glass and presents a false oil level indication (Figure 2). In most cases reported to Bell, this false oil level is clearly below the MIN line. Since the engine oil level check is called out in the 505 Flight Manual postflight check, we encourage operators and maintainers to top up the engine oil per the 505 Maintenance Manual when the oil level is found below the MIN line during the postflight check.

Figure 1 – Internal View of the Sight Glass with Excessive Sealant Shown

This TB provides procedures to inspect the engine oil tank sight glass for the presence of excessive sealant. If sealant is found to be exceeding the limit specified in this TB, the sight glass should be removed and re-installed per the procedure in this TB.

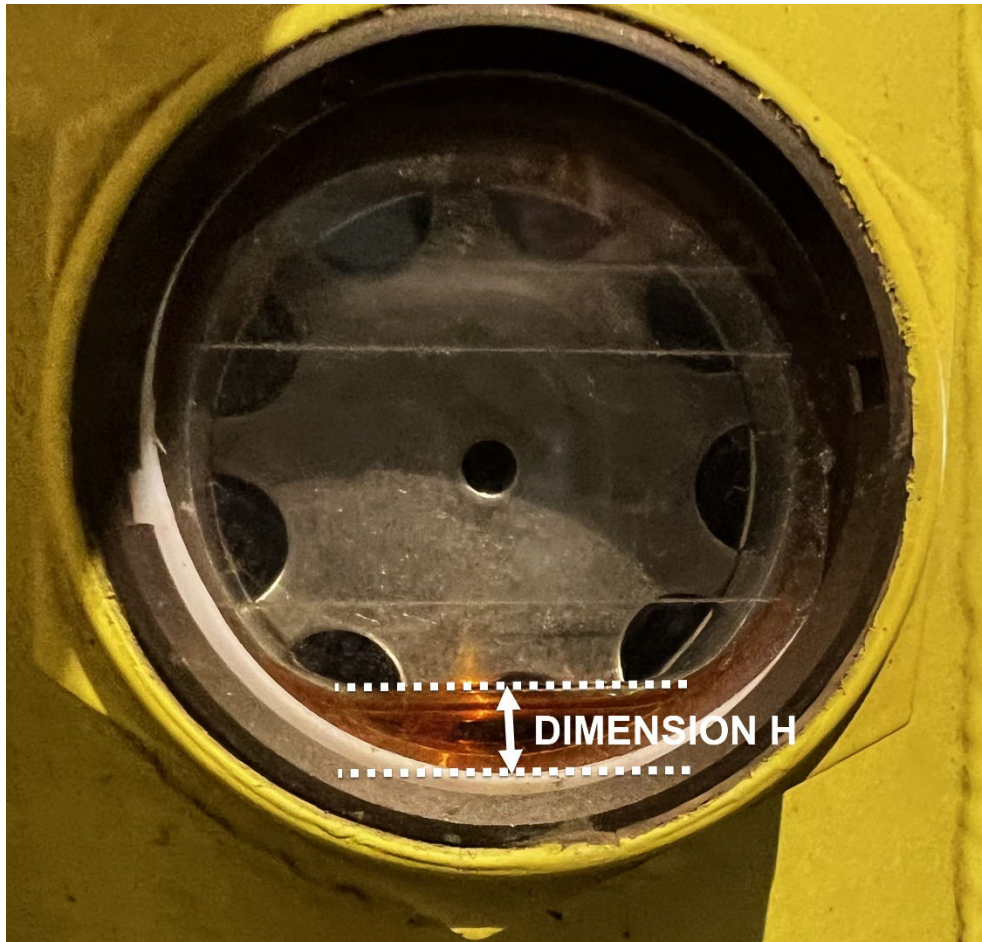
3. Reduce the engine oil quantity through the filler port using a syringe to bring the engine oil level below the sight glass.
4. Inspect the sight glass and make sure there is no oil trapped at the bottom of the sight glass (Figure 2).
  - a. If there is no oil trapped at the bottom of the sight glass, go to step 23.
  - b. If there is oil trapped at the bottom of the sight glass, go to the next step.
5. Measure the Dimension H shown in Figure 2 and make sure it is less than 0.125 inch (3.175 mm).
  - a. If the Dimension H is less than 0.125 inch (3.175 mm), go to step 23.
  - b. If the Dimension H is greater than 0.125 inch (3.175 mm), go to the next step.
6. Remove the engine oil tank assembly (DMC-505-A-79-10-01-00A-520A-A).

Figure 2 – External View of the Sight Glass with Oil Trapped at the Bottom

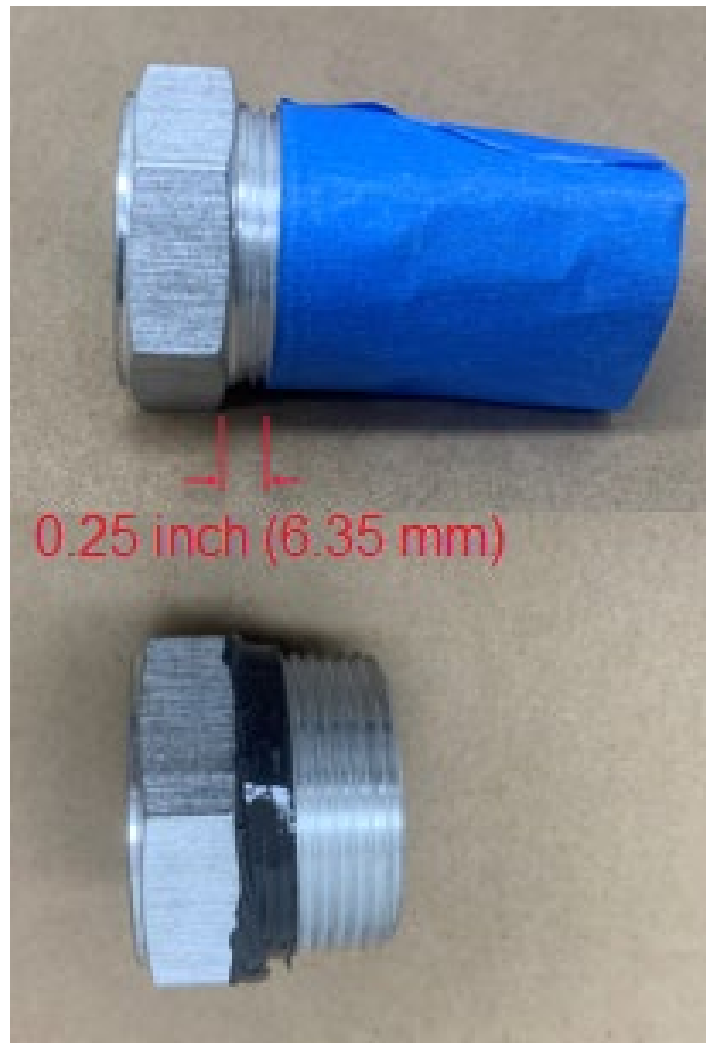
Figure 3 – Sealant Application to the Sight Glass Threads

13. Dry the oil tank and the sight glass with shop air.
14. Apply sealant (C-308) to the top 0.25 inch (6.35 mm) of the sight glass threads and the bottom face of the hex per Figure 3.
15. Wet install the sight glass into the oil tank sight glass boss.

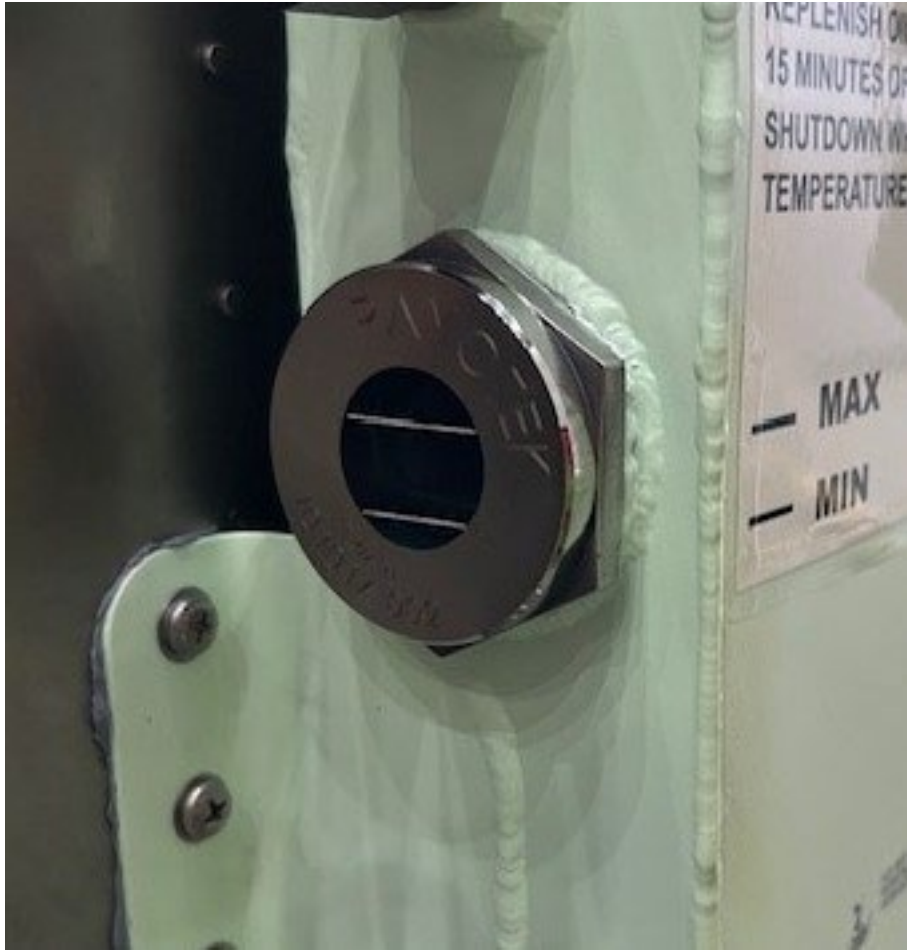
Figure 4 – Sight Glass 101017-002

Make sure the etched lines in the sight glass align with the 'MIN' and the 'MAX' markings on the oil tank level decal. Pre TB 505-21-28, the markings are MIN OIL LEVEL and ADD 1 QT instead. If it is difficult to align them, install a new sight glass (Figure 4) and etch the lines after.
