## ALERT SERVICE BULLETIN

**212-21-167**

**MODEL AFFECTED:** 212

**SUBJECT:** MAIN ROTOR SCISSORS & SLEEVE HUB  
ASSEMBLY COLLECTIVE 204-011-405-013  
IDENTIFICATION

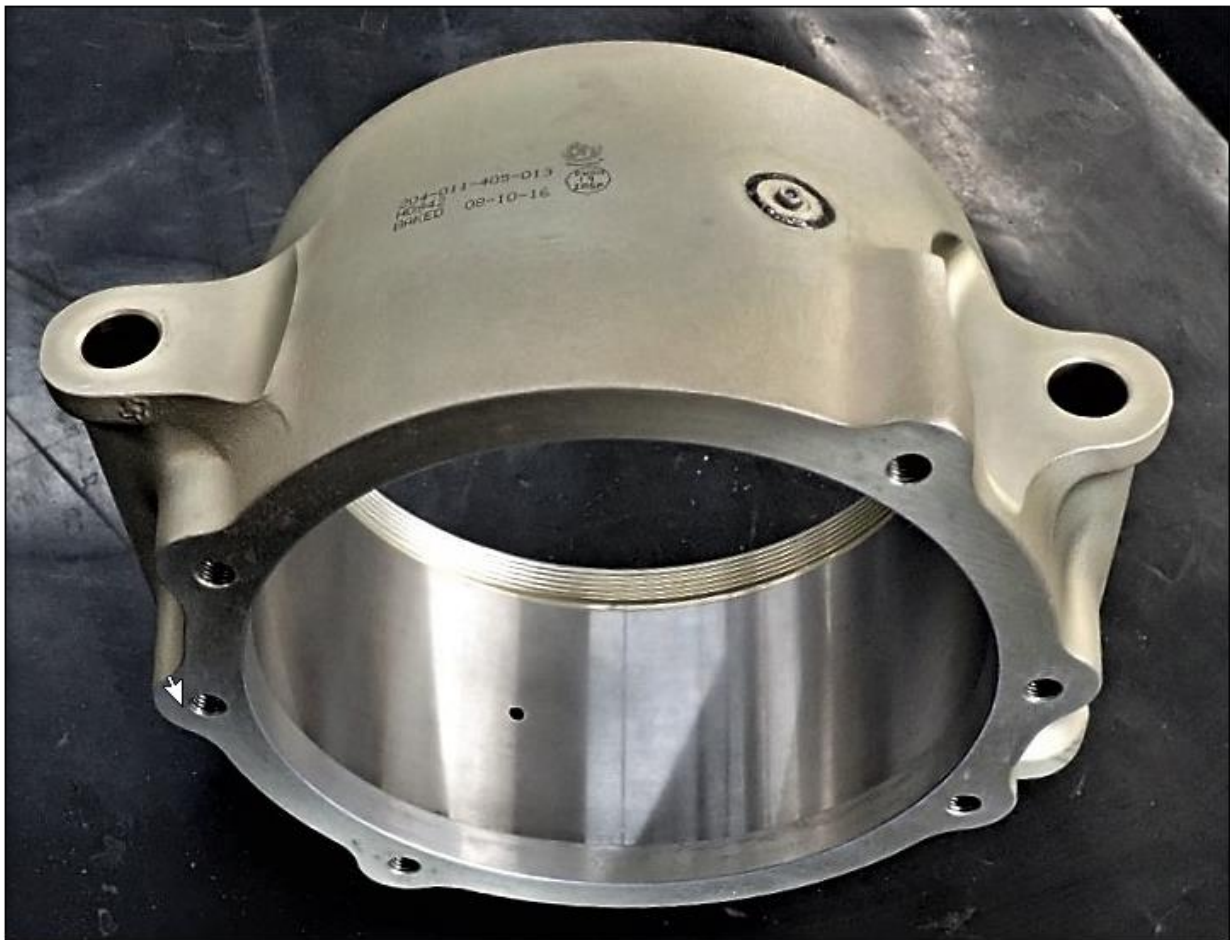
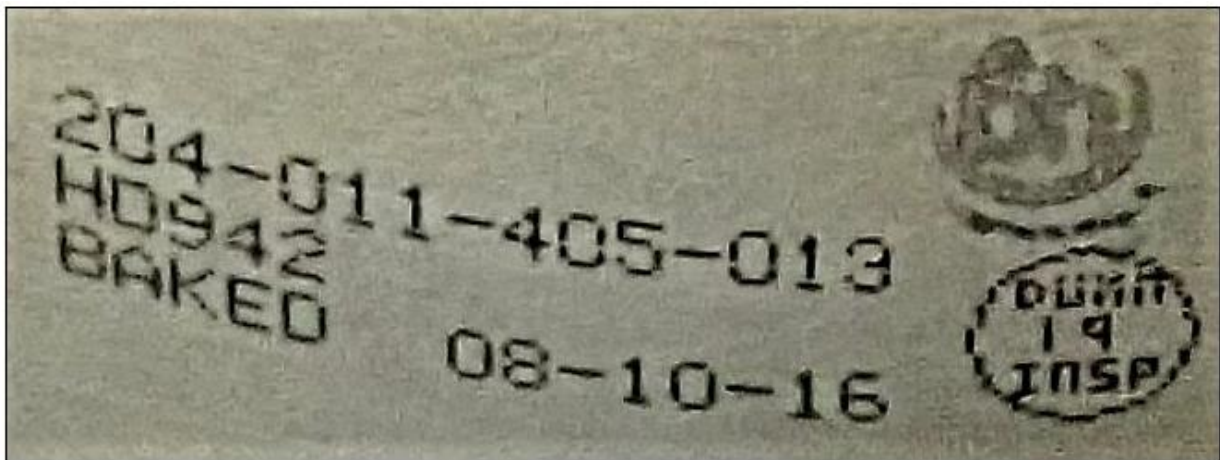
3. Gain access to the Hub Assembly 204-011-405-013 and inspect for the presence of part number and serial number matching the Historical Service Record (HSR) at the location shown on Figure 1.
4. If the Hub Assembly is not correctly marked, as shown in Figure 1, proceed with **PART II**.
5. If the Hub Assembly is correctly marked, as shown in Figure 2, make an entry in the helicopter logbook and historical service records indicating findings and compliance with **Part I** of this Alert Service Bulletin.
6. If **Part II** of this ASB is not going to be accomplished immediately, make an entry in the helicopter logbook and historical service records indicating compliance with **Part I** of this Alert Service Bulletin with an annotation to accomplish **Part II** within the required compliance time stated in this ASB.

Figure 1 – Hub Assembly Ink-Stamped Part Number and Serial Number

2. If the Hub Assembly has an ink-stamped part and serial number matching the HSR (refer to example shown in Figure 1), permanently mark the part and serial number on the Hub Assembly by vibro-etching or dot-peening (Figure 2).
3. If the Hub Assembly does not have a part number and serial number, create a unique serial number for each Hub Assembly. Using one or two prefix letters consistent with the company name of the operator or repair facility accompanied by a dash and 4 or 5 digits is considered as an industry serial number marking standard. Vibro-etch or dot-peen the Hub Assy with the part number and the assigned serial number (Figure 2).

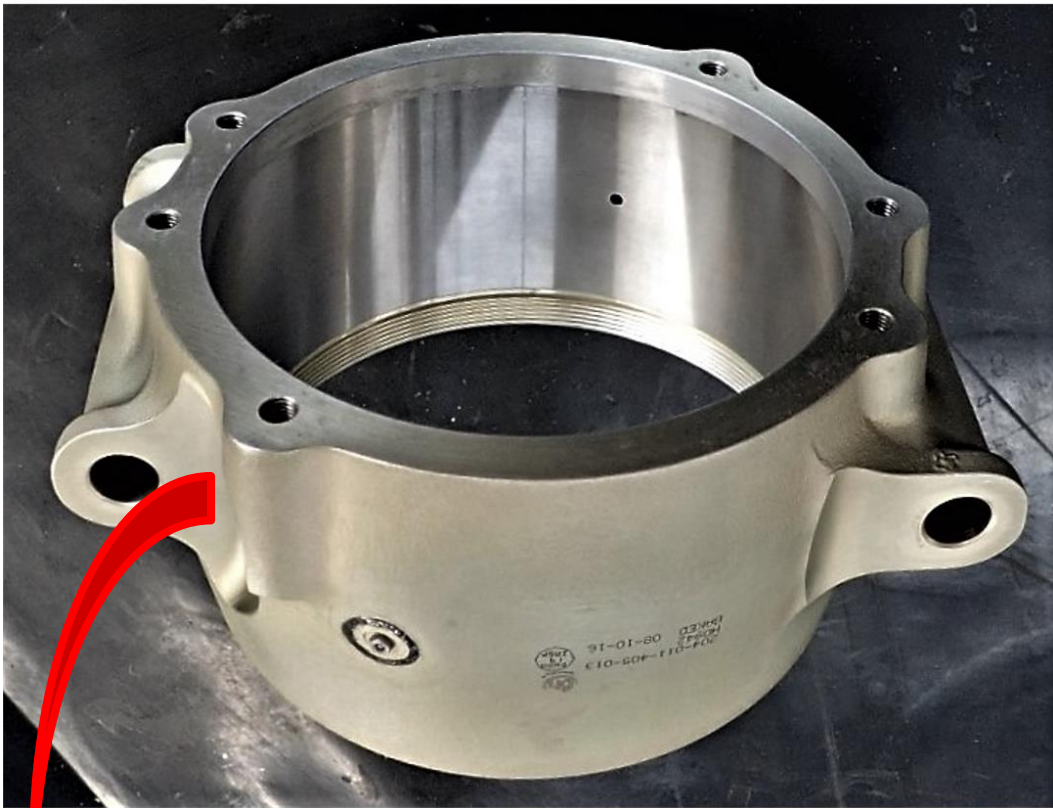
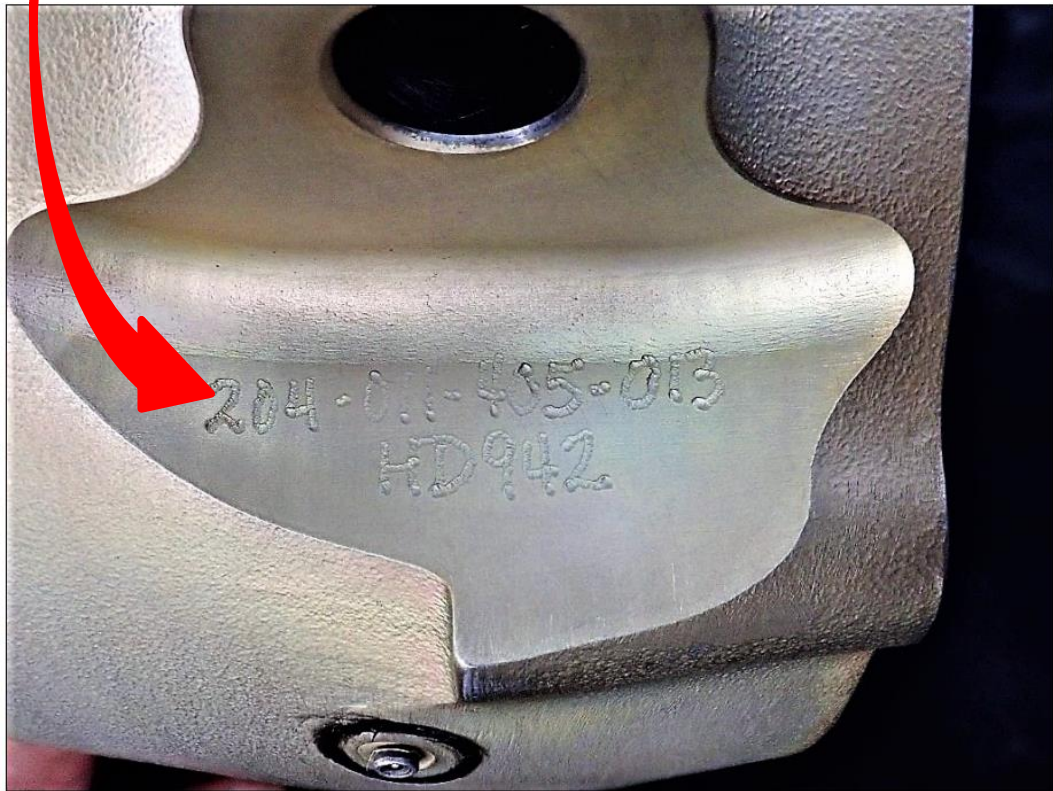
Figure 2 – Vibro-Etched Part Number and Serial Number Location

Maximum depth of vibro-etching or dot-peening shall not exceed 0.005-inch (.127 mm). Part and serial numbers shall be marked in the scalloped area of the hub as shown in Figure 2 of this ASB; to a minimum height of 0.062-inch (1.57 mm) and no closer than 0.100-inch (2.54 mm) to any edge.

4. After marking the part and serial number identification, apply brush cadmium plating solution (C-108) to the affected area (BHT-ALL-SPM). As an alternate and if brush cadmium plating isn't available, apply two coats of polyamide epoxy primer (C-204).
5. If no Historical Service Record exists for the Hub Assy, create one as follows:
  - a. Print a blank form from [www.bellhelicopter.net](http://www.bellhelicopter.net) under the “GENERAL INFO” tab.
