## **ALERT SERVICE BULLETIN**

**407-21-124**

**MODEL AFFECTED:** 407

**SUBJECT:** FUEL SYSTEM STANDPIPE ASSEMBLY 407-062-032-103, ONE-TIME INSPECTION AND REWORK OF.

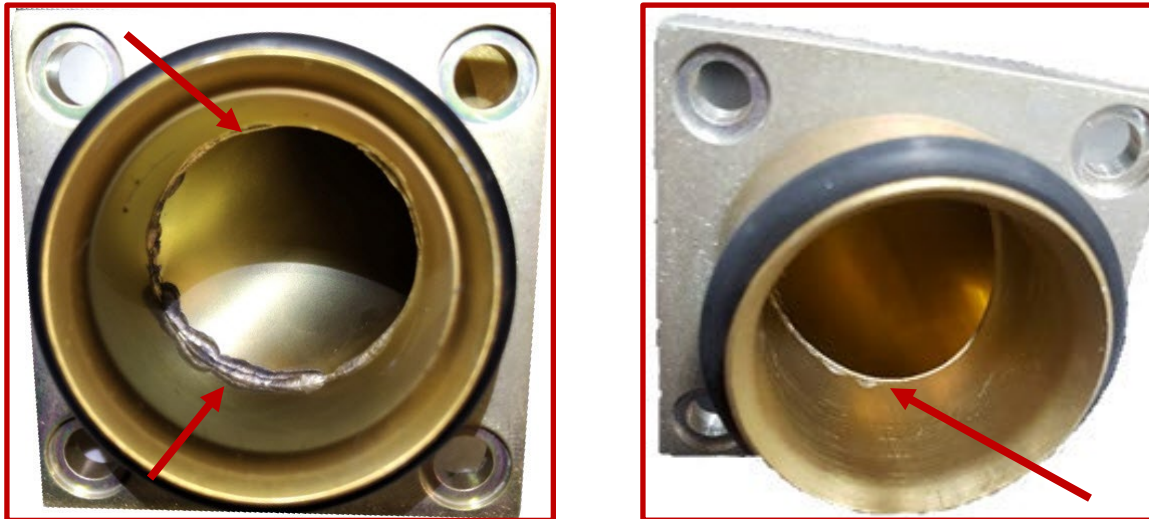
**Figure 1 – Examples of Non-Conforming Internal Welds Joints**

Bell has been made aware of a quality escape from our current supplier of the fuel system standpipe assembly 407-062-032-103. Some standpipes may have been delivered with sharp edges at the internal weld joints (Figure 1). If not corrected, this could lead to fuel quantity system wiring damage and loss of, or erratic, fuel quantity indication.

3. Inspect interior of fuel system standpipe for evidence of sharp edges of the two internal weld joints (Figure 1).
  - a. If no sharp edges are present, go to step 4.

- b. If sharp edges are present, lightly deburr edges of weld joints using aluminum oxide abrasive cloth or paper (commercial) (Figure 2). Make sure not to exceed 0.015 inch (0.38 mm) depth into the tube material at a 45 degree angle to the weld joints.

- c. Using a clean cloth (C-516) dampened with isopropyl alcohol (C-385), remove all sanding residue.
  - d. Touch up bare metal surfaces with chemical film material (C-100) (BHT-ALL-SPM, Chapter 3, and Paragraph 3-16). Go to step 4.
