#### **ALERT SERVICE BULLETIN**

412-22-188 PSL # 961

SUBJECT: AIR CONDITIONING STC SR00066DE AFT

EVAPORATOR RETURN SCREEN

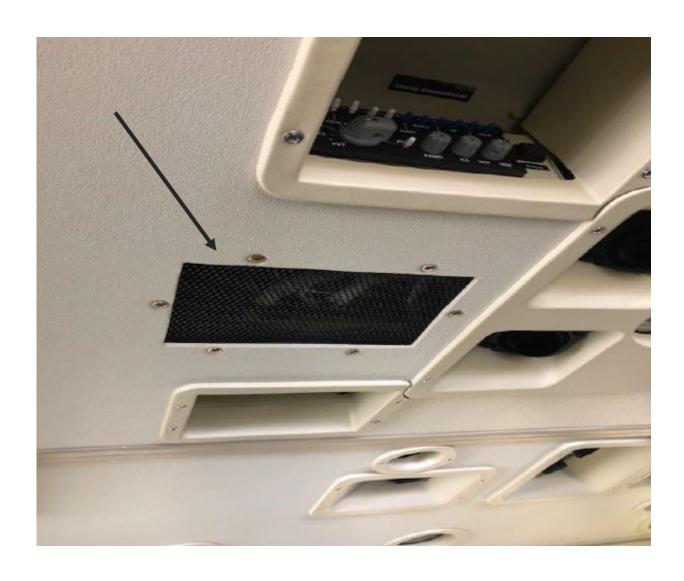
Figure 1. Deluxe Interior kit 412-705-500-147

Bell has been made aware that the opening in the headliner for the aft evaporator air return may have been omitted on some helicopters that had the air-conditioning STC SR00066DE installed in conjunction with an interior kit at the Bell Mirabel facility. The absence of the aft evaporator air return opening in the headliner may affect the performance of the air conditioning system. **PART I** of this Bulletin mandates a verification for the opening required in the headliner and installation of the S-6510EC-101 screen. If required, depending on the type of interior kit installed, accomplish either

# PART II. For helicopters having the Deluxe Interior kit 412-705-500-147 (Figure 1).

- 1. Prepare helicopter for maintenance and remove the center headliner.
- 2. Locate the position of the 5.5 x 8 inches opening in the headliner and make the required opening (Air Comm Corporation STC #SR00066DE).
- 3. Install the S-6510EC-101 screen with six AN525-10R screws, NAS1149F0332P washers and NAS9926-3L nuts. It is acceptable to use MS21042L3 or 90-132L3 nuts if available. Install headliner.
- 4. Make an entry in the helicopter historical service records indicating compliance with this Alert Service Bulletin.
