## **ALERT SERVICE BULLETIN**

**429-14-15**

**MODEL AFFECTED:** 429

**SUBJECT:** GOODRICH EXTERNAL HOIST

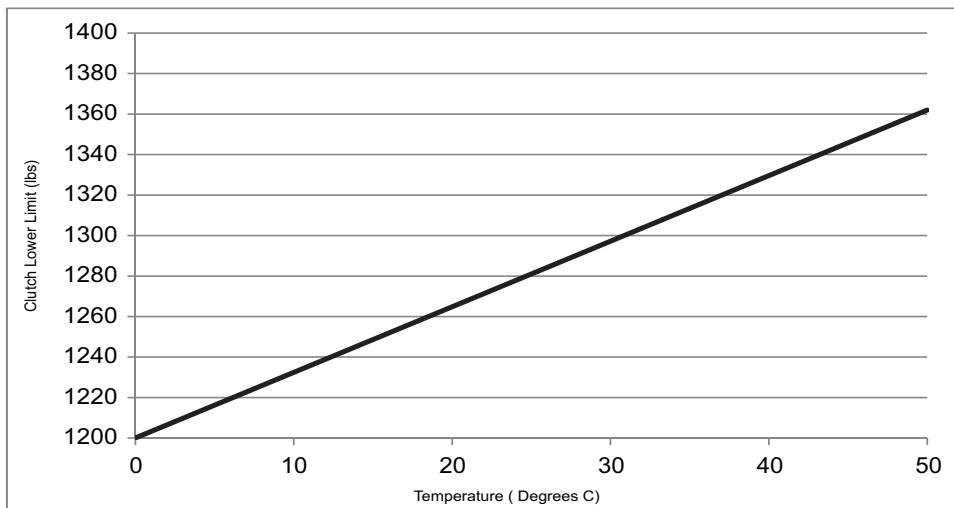
TABLE 2. Lower Load Limit, 600 lb hoists

Figure 1. Lower limit for the 600 lb capacity hoists

- b. If the test results indicate a value below the acceptable lower limit per Table 2, Figure 1 of the Goodrich ASB 44301-10-18, Revision 6, remove the hoist from service before the next hoist operation.

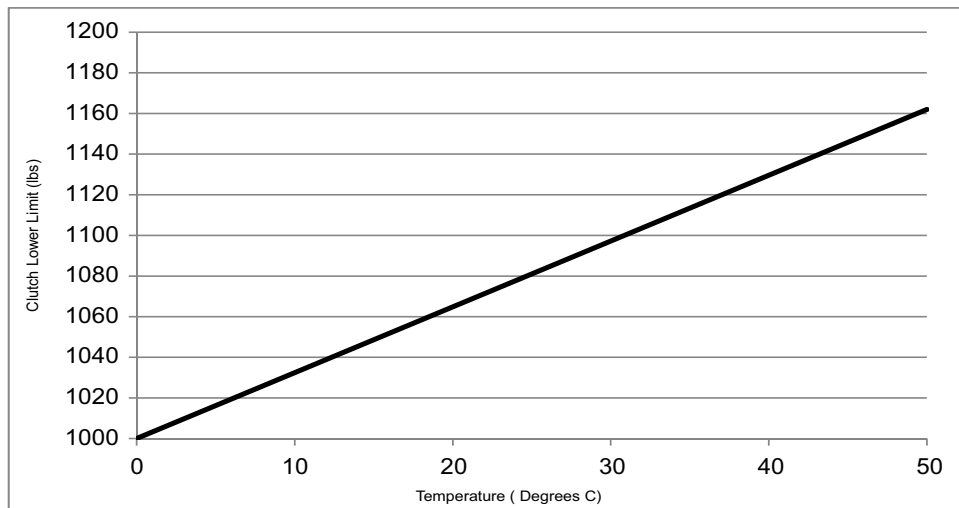
TABLE 3. Lower Load Limit, 500 lb hoists

Figure 2. Lower limit for the 500 lb capacity hoists

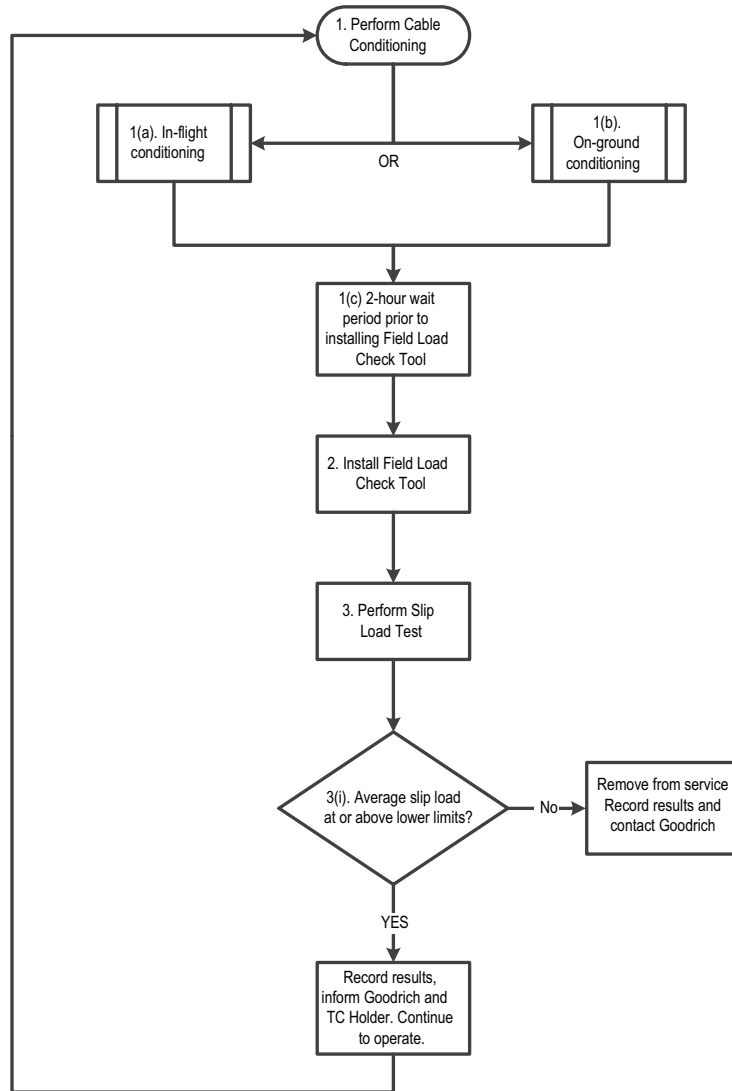
Figure 3. Load check flowchart

- (i) If the test results indicate a value above the allowable limits per Table 1, record the results, inform Goodrich and the TC holder, and continue operations.
- (j) If the test results indicate a value below the acceptable lower limit per Table 1, obtain a return authorization for the failed hoist using the standard RMA process through Goodrich at the address listed below. Send results of testing to Goodrich.

Note: If the hoist fails the load check, the hoist shall be removed from service. Regardless of pass or fail, the test result shall be forwarded by email to Goodrich and the type certificate (TC) holder.
