ALERT SERVICE BULLETIN

429-15-16

MODEL AFFECTED: 429

SUBJECT: TAIL ROTOR PITCH LINK BEARING, INSPECTION AND UPGRADE OF.

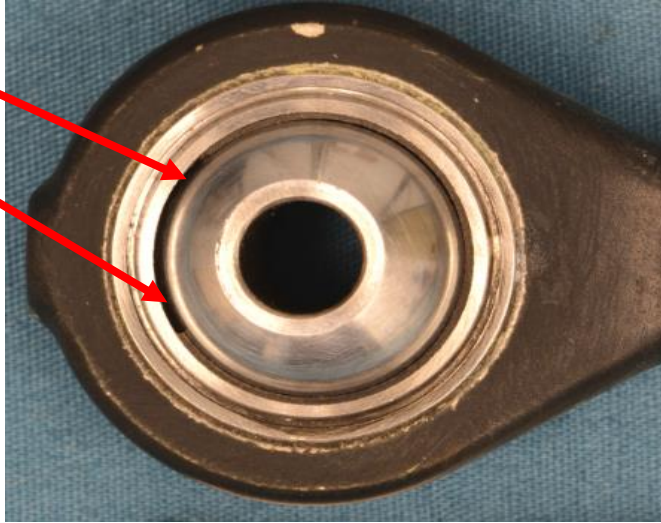
Figure 1 – Tail Rotor Pitch Link Bearing Liner

Bell Helicopter has received reports of tail rotor pitch link assemblies 429-012-112-101/-103 with bearings 429-312-107-103 worn beyond the published limits and bearing liner failures. Tail rotor pitch link assemblies 429-012-112-101/-103 were required to be modified per Alert Service Bulletin (ASB) 429-15-26 by March 7, 2016.

Missing Liner

- i. Perform **Part II** of this ASB or replace the affected tail rotor pitch link assembly with an acceptable part.
 - ii. If **Part II** has already been accomplished on the affected tail rotor pitch link assembly, replace the bearing per the instructions in the 429 Maintenance Manual (DMC-429-A-67-20-00-11A-600A-A) or replace the tail rotor pitch link assembly with an acceptable part.
5. Inspect the tail rotor pitch link assembly sealant (C-251) for condition.
 - a. Make sure there are no pin holes or voids present in the sealant.
 - b. The thickness of the sealant should not exceed 0.025 inch (0.64 mm), should extend over the roll staked lip by a minimum of 0.030 inch (0.76 mm), and remain clear of the bearing ball.

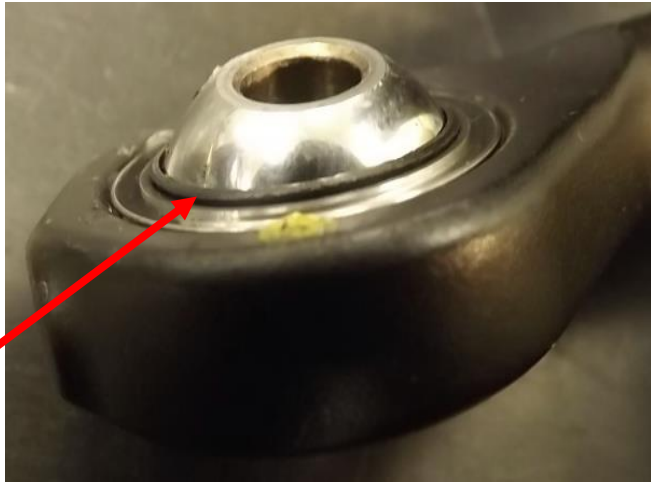
Bearing Liner Extruding

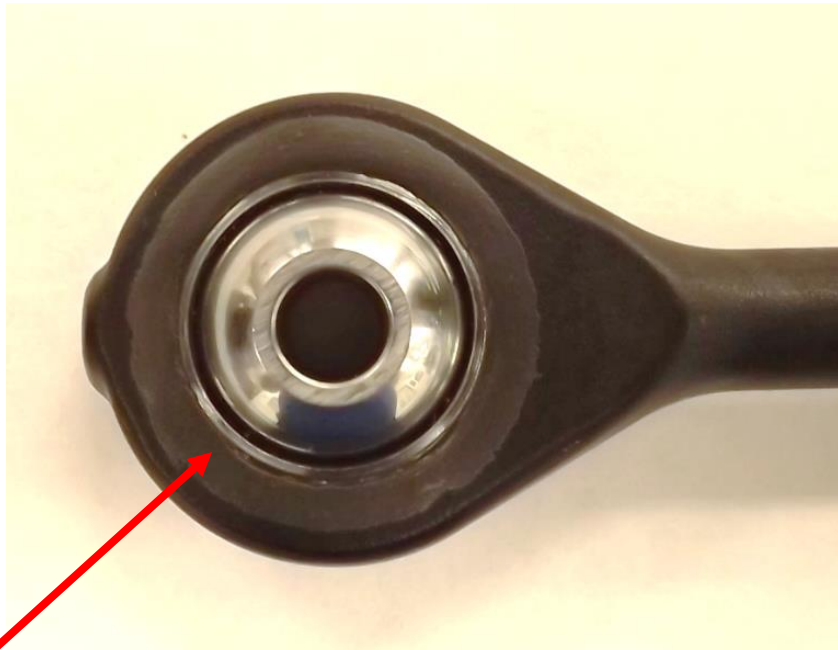
Figure 2 – Example of Sealant (C-251) Installation

Sealant (C-251)

3. Install the new bearing 429-312-107-103 (DMC-429-A-67-20-00-11A-600A-A).
4. Clean the affected area with isopropyl alcohol (C-285). Apply corrosion preventative sealant (C-251) to the bearing roll stake lip and the pitch link (Figure 2).
 - a. Make sure there are no pin holes or voids present in the sealant.
 - b. The thickness of the sealant should not exceed 0.025 inch (0.64 mm), should extend over the roll staked lip by a minimum of 0.030 inch (0.76 mm), and remain clear of the bearing ball.
5. Reidentify the tail rotor pitch link assembly with a white permanent fine point marker, or equivalent, as follows:
 - a. Reidentify the pitch link assembly 429-012-112-101FM as 429-012-112-**111FM**.
 - b. Reidentify the pitch link assembly 429-012-112-103FM as 429-012-112-**113FM**.
 - c. Apply a coat of DEVCON 2-TON (C-298) on top of the new part number after the ink dries.
