## ALERT SERVICE BULLETIN

**505-20-15**

**MODEL AFFECTED:** 505

**SUBJECT:** ENGINE OIL TANK P/N SLS-065-100-037,  
INSPECTION OF

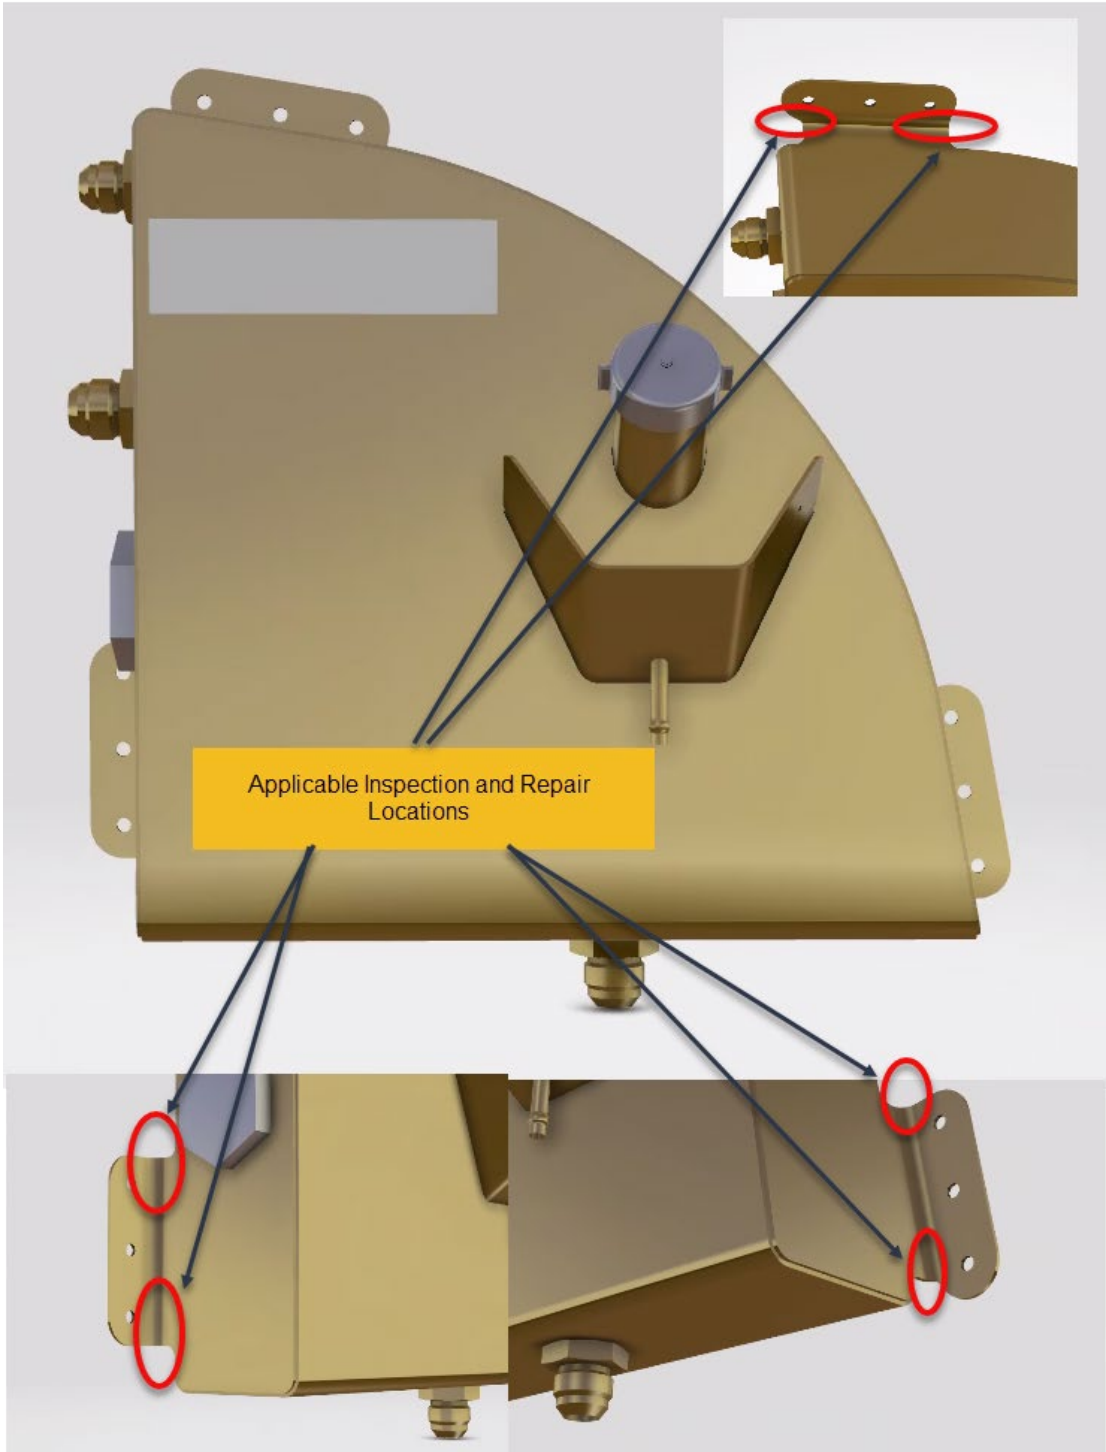
**FIGURE 2 – Area to be inspected**

Bell has become aware of a condition where some engine oil tanks may have developed crack(s) in the bend radius of the mounting attachment flanges during the manufacturing process.

3. Inspect without removing the tank from the firewall, as follows:
  - a. Clean the surface of the three mounting attachment flanges in the affected area (Figure 2) with acetone (C-316). Cracks will typically originate at the edge of the mounting flange.

- b. Visually inspect the three mounting attachment flanges from the forward side of the oil tank for cracks in the radius with a strong light source and a 10x power magnification (Figure 2).

A single crack in mounting attachment flanges longer than 0.050" (1.27 mm) shall be trimmed but not to exceed the repair dimensions in (Figure 3). Repair trimming can be applied to any of the six indicated locations from Figure 2 as required with the maximum of one repair per mounting attachment flange.

3. Remove oil tank assembly (DMC-505-A-79-10-01-00A-520A-A).
4. Perform FPI to forward and aft side including the weld bead of all attachment mounting flanges to confirm the absence of crack(s) in the area to be inspected shown in Figure 2 using instructions and materials detailed in Chapter 6 of Standards Practices manual (BHT-SPM-ALL)
