## ALERT SERVICE BULLETIN

**505-20-19**

**MODEL AFFECTED:** 505

**SUBJECT:** MAIN ROTOR BLADES P/N 206-015-001-119 ROOT END DOUBLERS, INSPECTION OF.

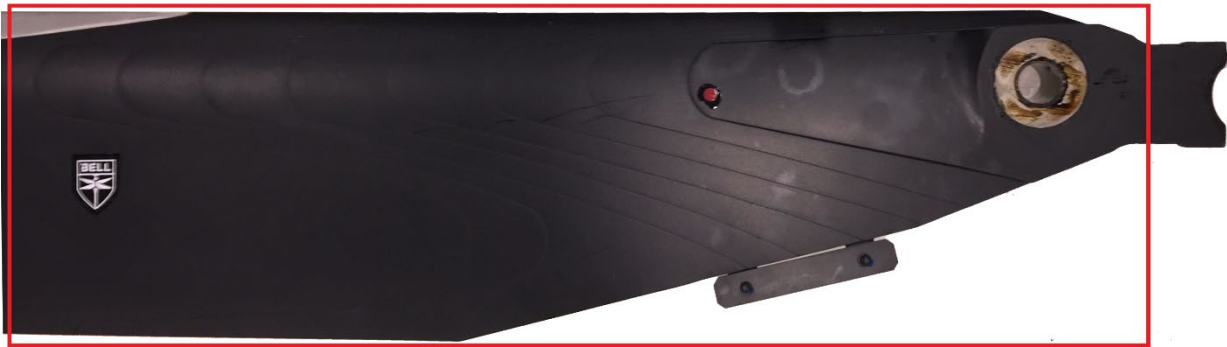
**Figure 1.** Area to be inspected with 3X- power magnifying glass, from STA 15.0 to STA 58.0 (upper and lower surfaces).

2. Wipe the area to be inspected (Figure 1 and 2) with an alcohol-soaked cloth (C-385) and wipe dry with a clean cloth.

3. Visually inspect the main rotor blade upper and lower grip plates and doublers for signs of cracks, corrosion, and edge voids as follows. Pay particular attention to the bond lines between the doublers, grip plates, and skin:
  - a. Using a 3X power magnifying glass and strong light source carry out a detailed visual inspection of the top and bottom inspection areas (Figure 1).
  - b. Check for evidence of a dark line between the doublers, grip plates, and skin with excess alcohol bleeding out for possible edge voids (Figure 2).

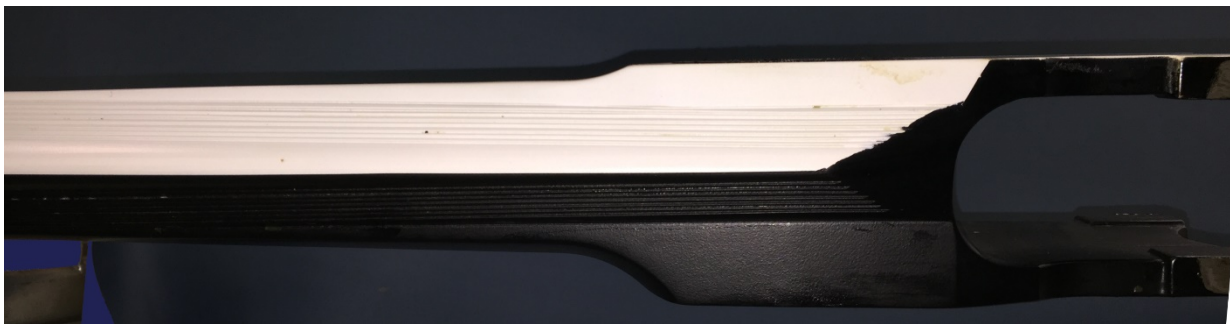
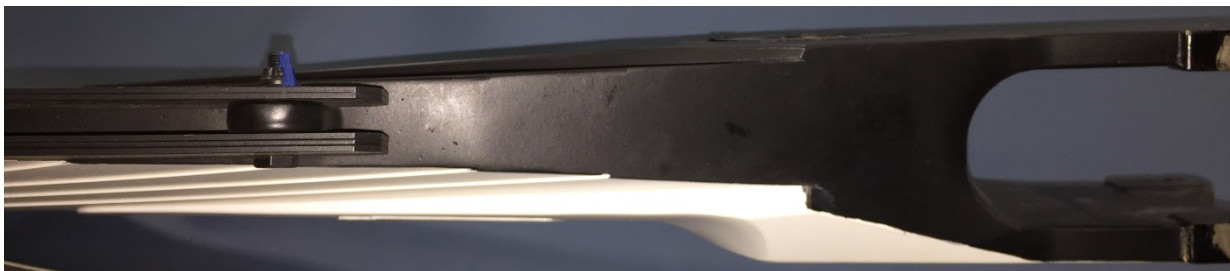
Any potential cracks in the bond lines between the doublers or grip plates will be indicated by the presence of excess alcohol bleeding out of an edge void. This excess alcohol in the void will appear as a dark line between the bond lines of the doublers. Proceed with the inspection of an area immediately after the alcohol wipe.

**Figure 2.** Inspect the leading edge from STA 15.0 to STA 58.0 and trailing edge from STA 15.0 to STA 56.0 of the blade for crack between each doublers and the grip plates.

- c. If cracks in the finish are found between doublers, grip plates and skin edges, sand the affected area in a spanwise direction with an abrasive cloth or paper (C-406) 180 to 220 grit to determine if the grip plate/doublers are cracked or voided.

- d. If edge voids between the grip plate/doublers/skin are found, determine the depth and length with a 0.0015 inch (0.038 mm) feeler gauge. If edge voids are suspected near the outboard tip of the grip plate/doublers, carry out a tap test of the affected area. Contact Product Support Engineering for voids limits and repair instructions.
